**SUBJECT: NOTICE OF SELF-IMPLEMENTING ON-SITE CLEANUP AND DISPOSAL OF PCB REMEDIATION WASTE AT POTENTIAL RELEASE SITE (PRS) 3-056(c) AT LOS ALAMOS NATIONAL LABORATORY**

**Notice for Self-Implementing On-site Cleanup and Disposal of PCB  
Remediation Waste at Potential Release Site 3-056(c)  
at Los Alamos National Laboratory**

# Voluntary Corrective Action Plan for Potential Release Site

03-056(c)

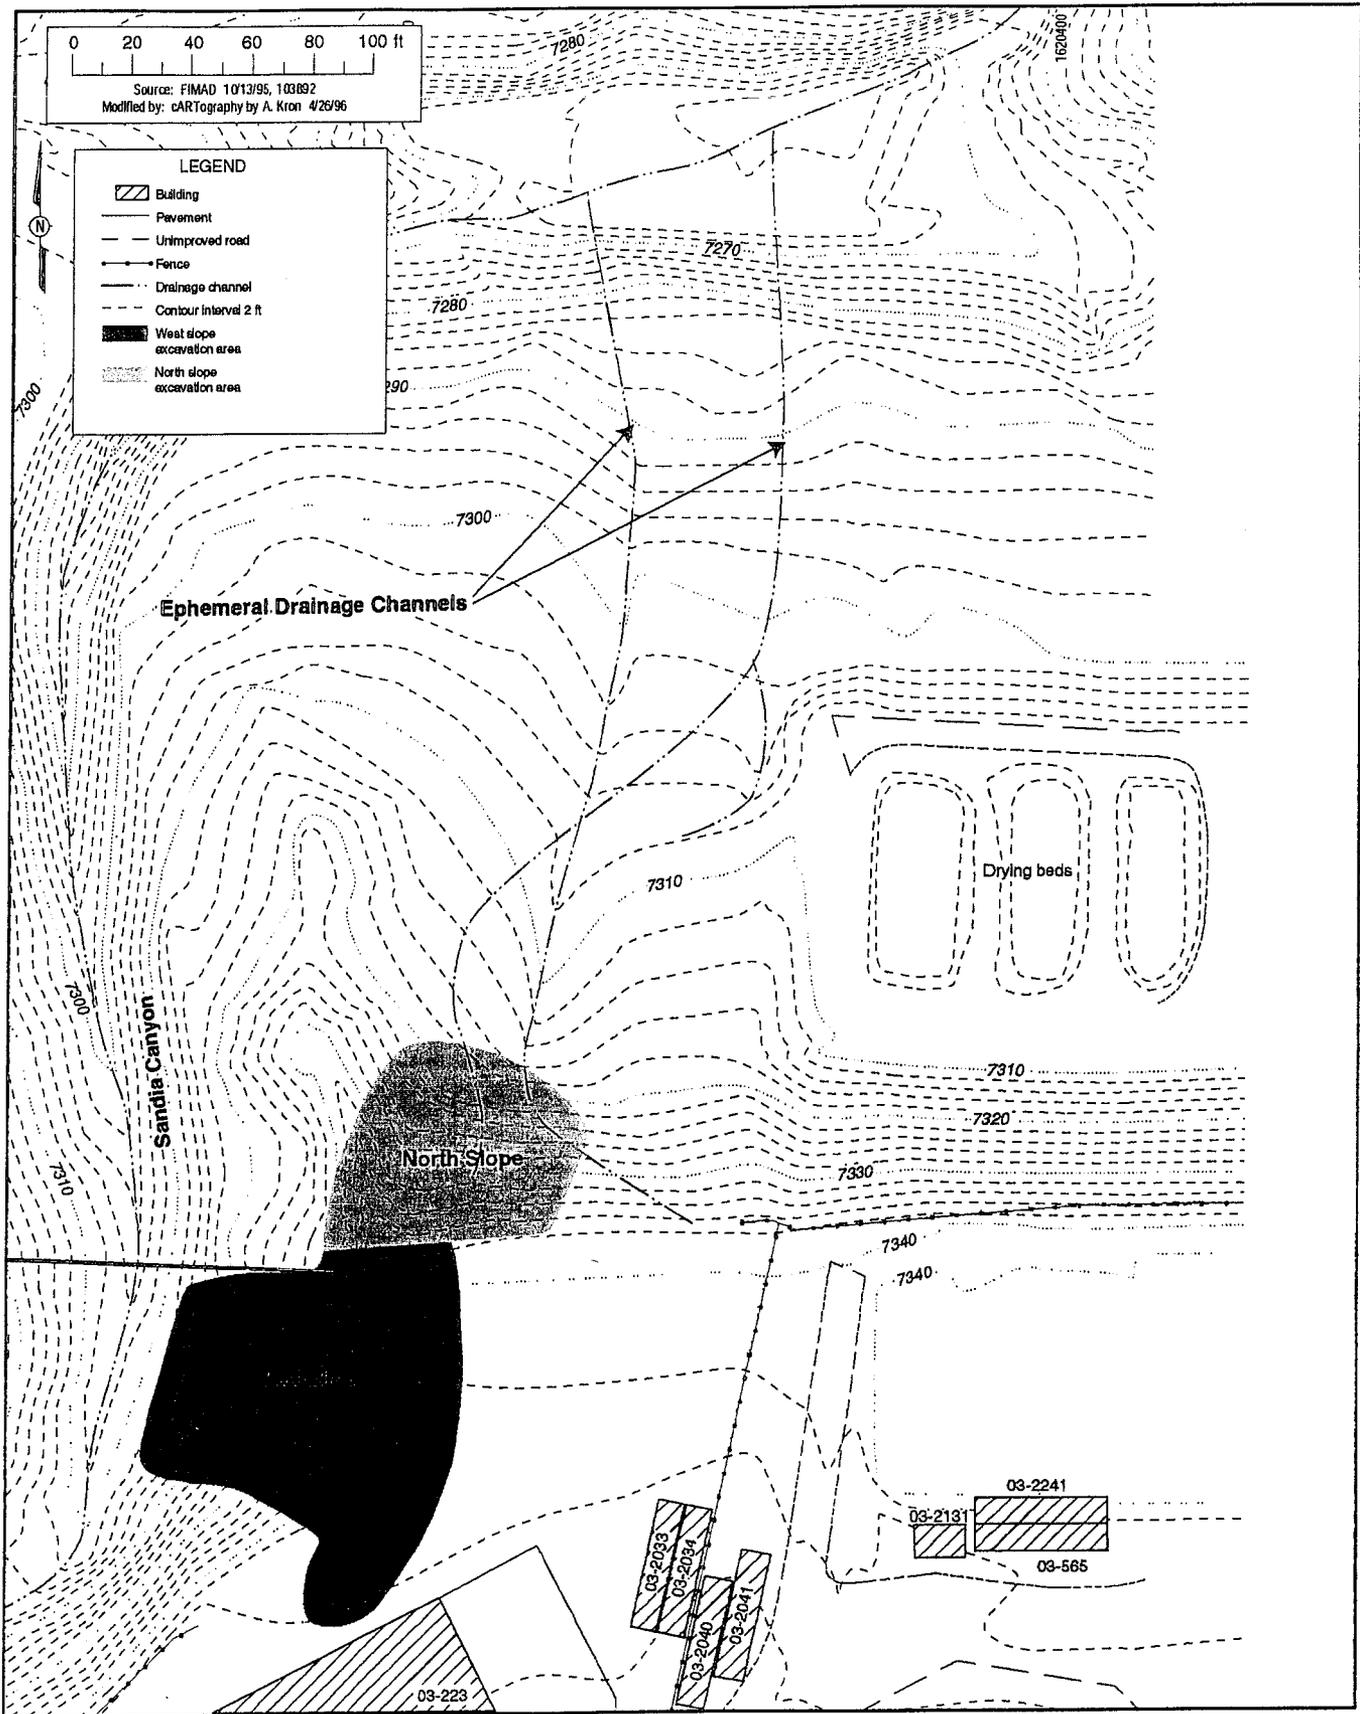
Figure 1.0-2. PRS 03-056(c) including North Slope, West Slope, and ephemeral drainages.

This document describes the voluntary corrective action (VCA) to be conducted at potential release site (PRS) 03-056(c) within Technical Area 3 (TA-3) of Los Alamos National Laboratory (LANL). Polychlorinated biphenyls (PCB)-contaminated soils and tuff will be identified, bounded, and removed in accordance with Resource Conservation and Recovery Act (RCRA) corrective actions. Because the PCB-contaminated soil and tuff at the site are considered PCB remediation waste as defined in Toxic Substances Control Act (TSCA) at 40 CFR (Code of Federal Regulations) 761.3, waste management disposal activities will be conducted in accordance with the requirements of 40 CFR 761.61. Remediation activities are scheduled to begin during the fall of 1999. All VCA activities will be conducted by LANL's Environmental Restoration (ER) Project team and its subcontractors. Figure 1.0-1 shows the location of TA-3 relative to other TAs. Figure 1.0-2 shows the location of the PRS within TA-3.

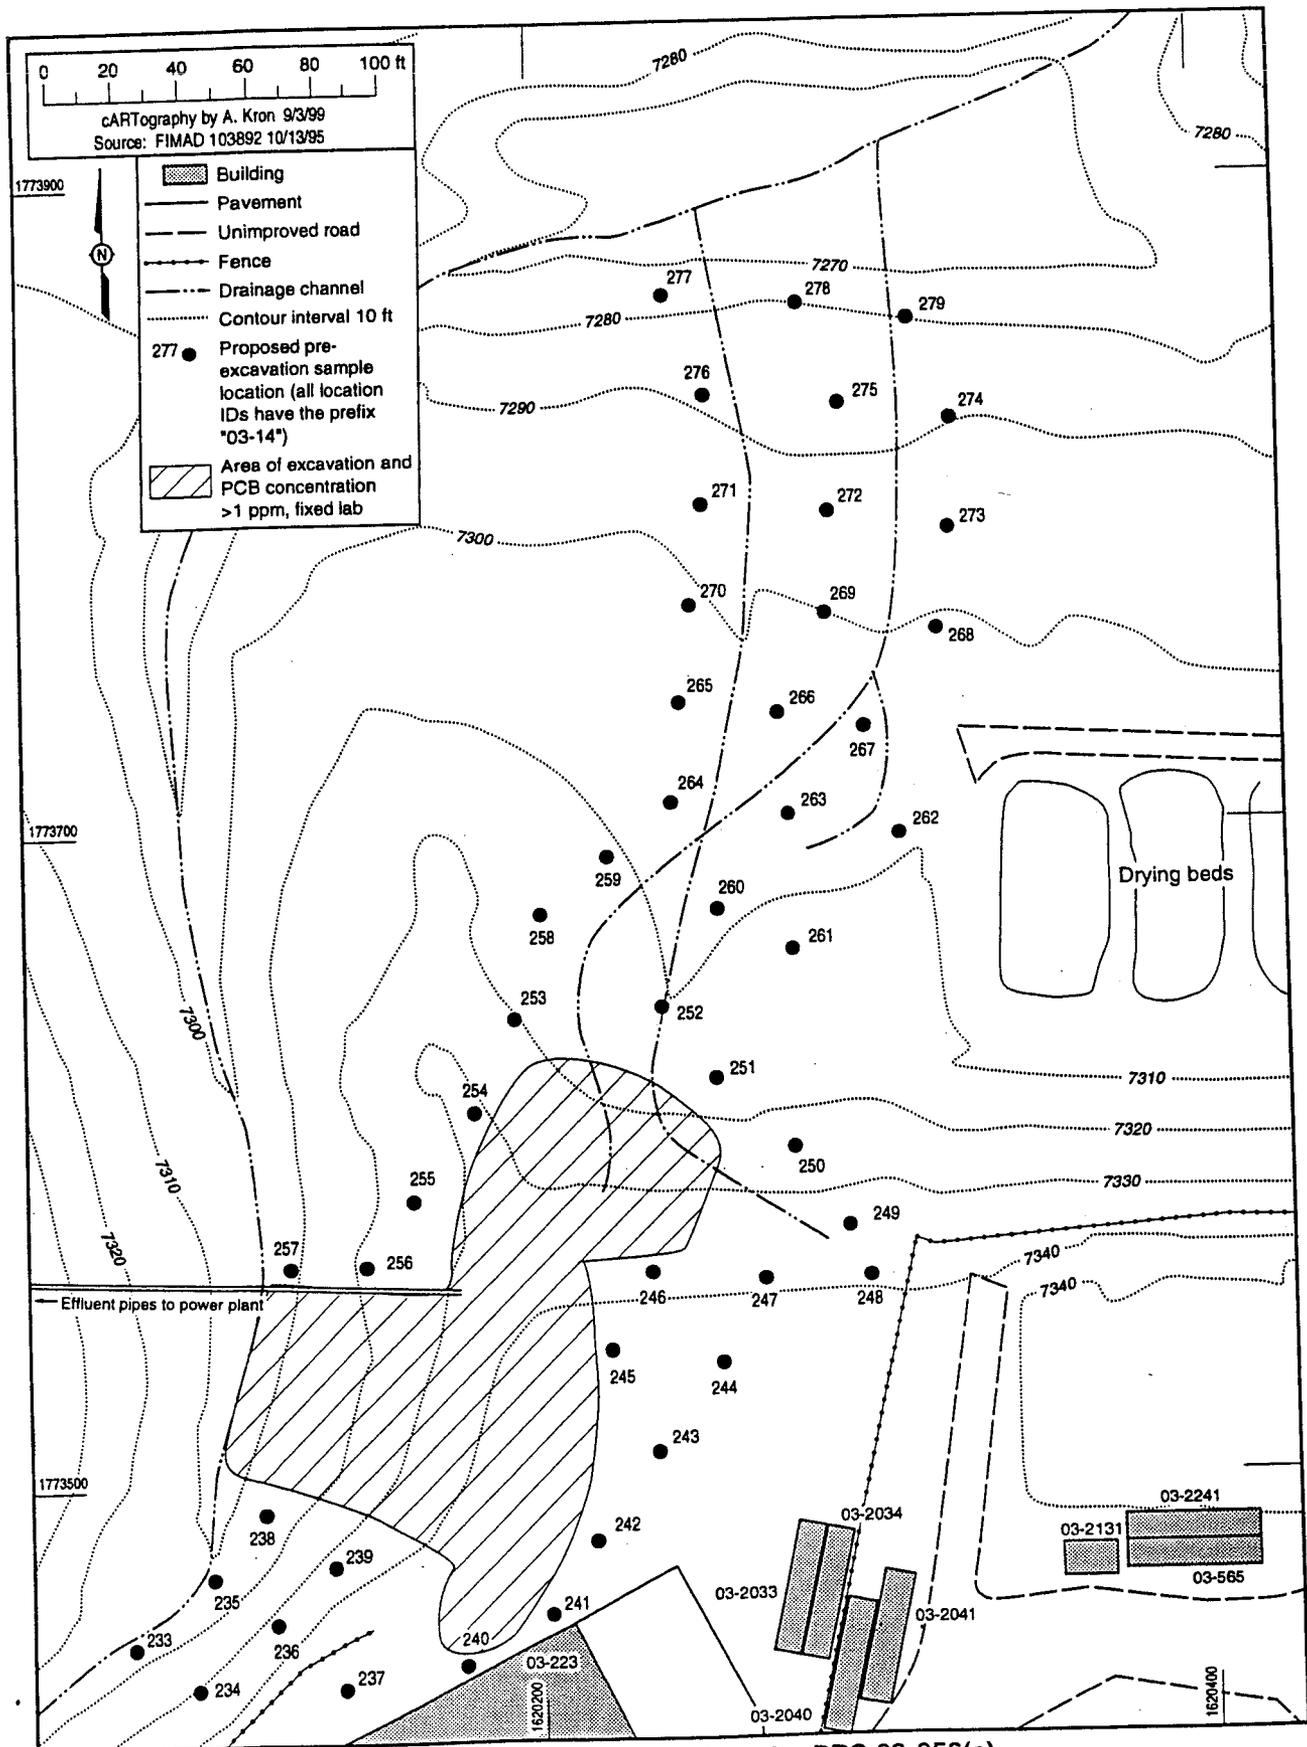
Figure 4.2-1. Proposed pre-excitation sample locations for PRS 03-056(c).

The intent of the sampling is to characterize and estimate the limits of the existing contamination. The sampling will be biased to those areas that are most likely to contain PCBs. These include the bordering areas of known contamination and topographic lows within soil and fractured tuff that are most likely to receive input from surface water run-off. Best professional judgment will be used to determine the sample locations in the field. This sampling approach will bias the results on the high side and will be useful in determining the lateral extent of contaminated mass. Field screening will be used to direct the laboratory sampling. Details are discussed below.

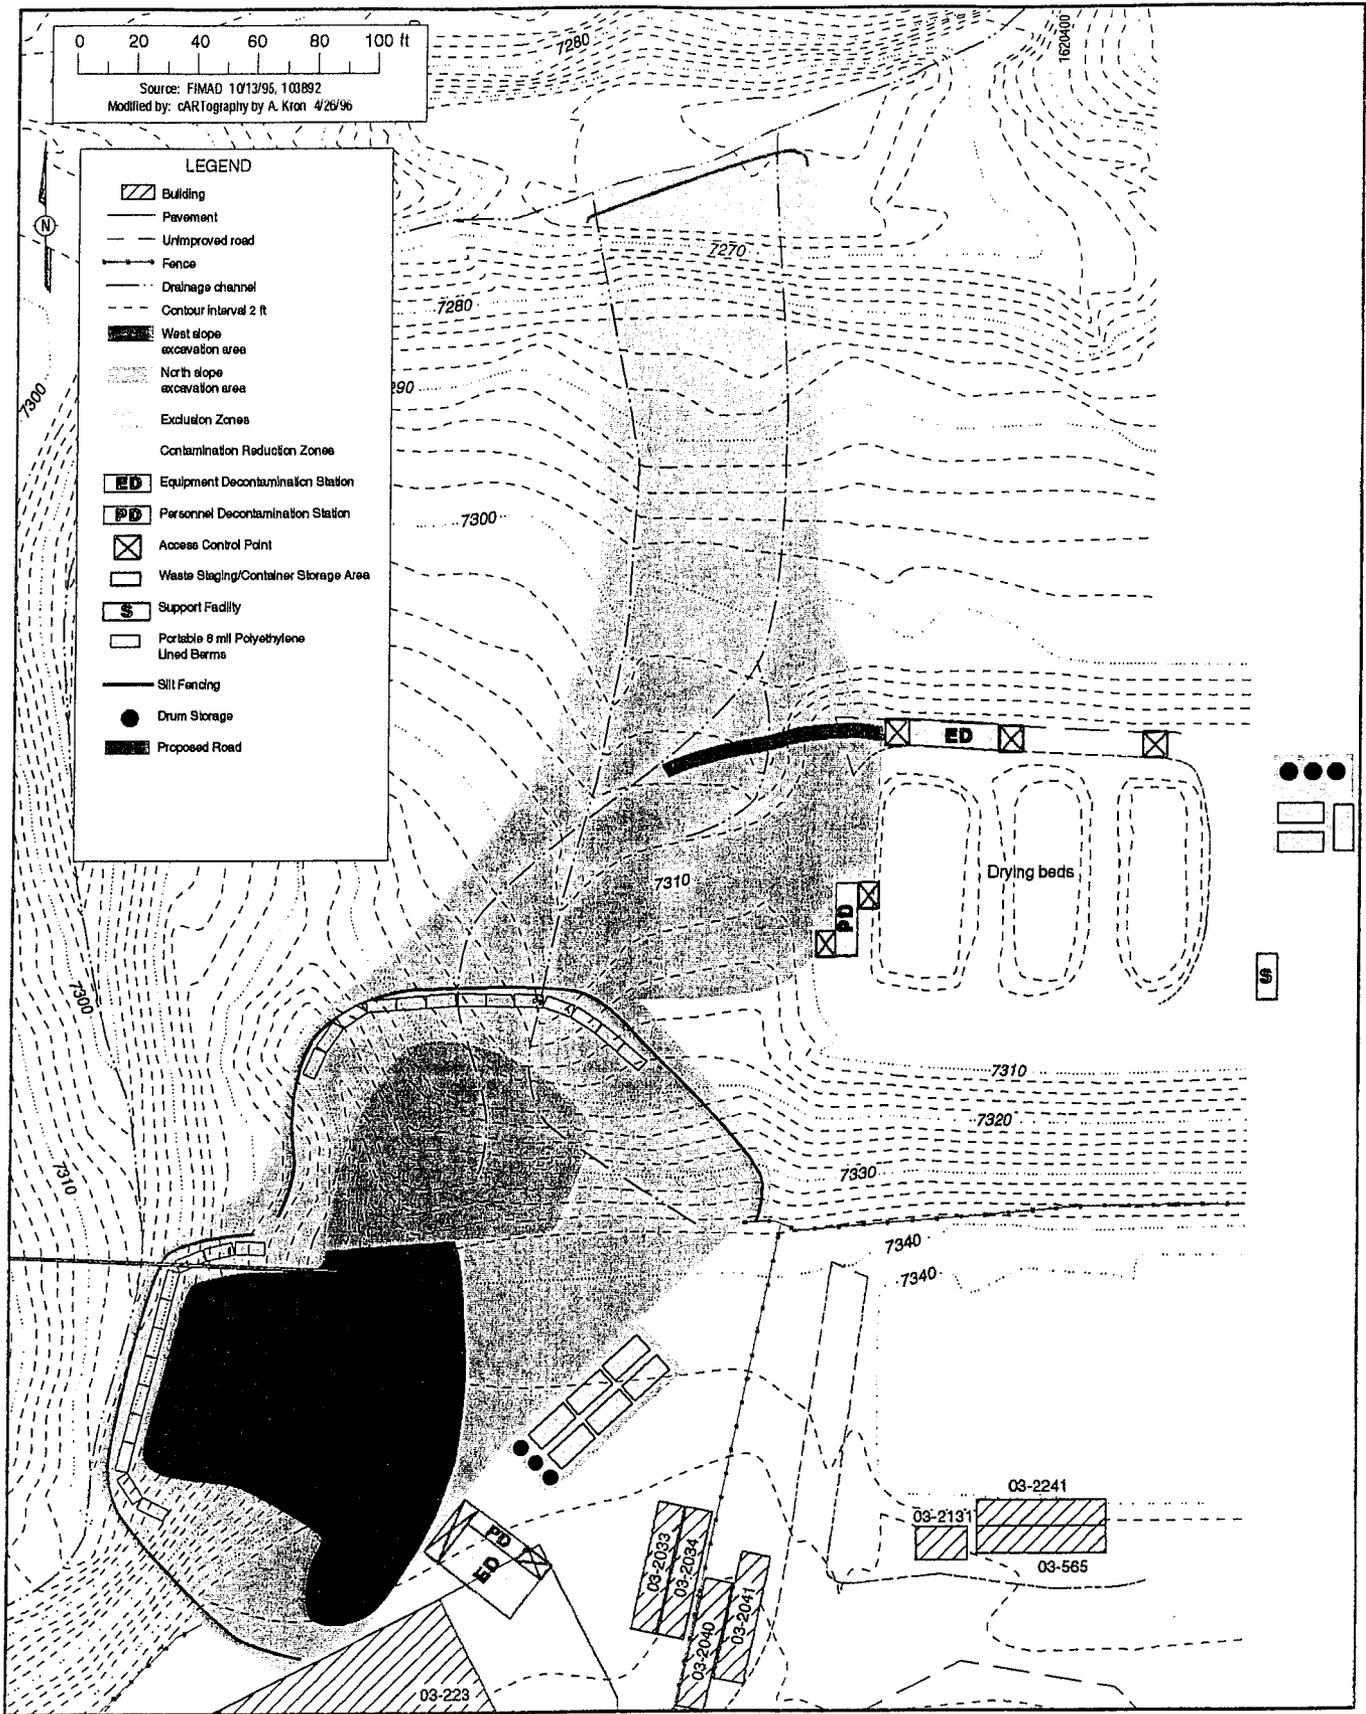
Figure 4.3-1. Proposed site logistics plan for the VCA at PRS 03-056(c)

Entrances and exits will be provided through access control points where supplies, rest areas, and initial decontamination measures will be established. To minimize the potential for cross-contamination, separate access points may be established for personnel and equipment. The CRZ will act as a buffer between the contaminated areas and the clean areas at the site (Figure 4.3-1). The CRZ reduces the potential for clean areas to be contaminated or affected by worker activities in the EZ. Decontamination of personnel and equipment will be performed in the "contamination reduction corridor" within the CRZ; separate corridors may be established for the West Slope, the North Slope, and drainage areas within PRS 03-056(c). The CRZs will also accommodate a temporary rest area.

Support Zones will be established outside of the EZ and the CRZs. They will be considered clean (Figure 4.3-1). The SZ will contain administrative and technical support personnel, a clean equipment staging area, a supply trailer, a water storage tank, non-contaminated heavy equipment and vehicle parking areas, protective equipment supply area, sampling equipment, fire extinguishers, spill control supplies, first aid equipment, tools, and a sample preparation area. Strict use of control zones will prevent the spread of contamination into the SZ.

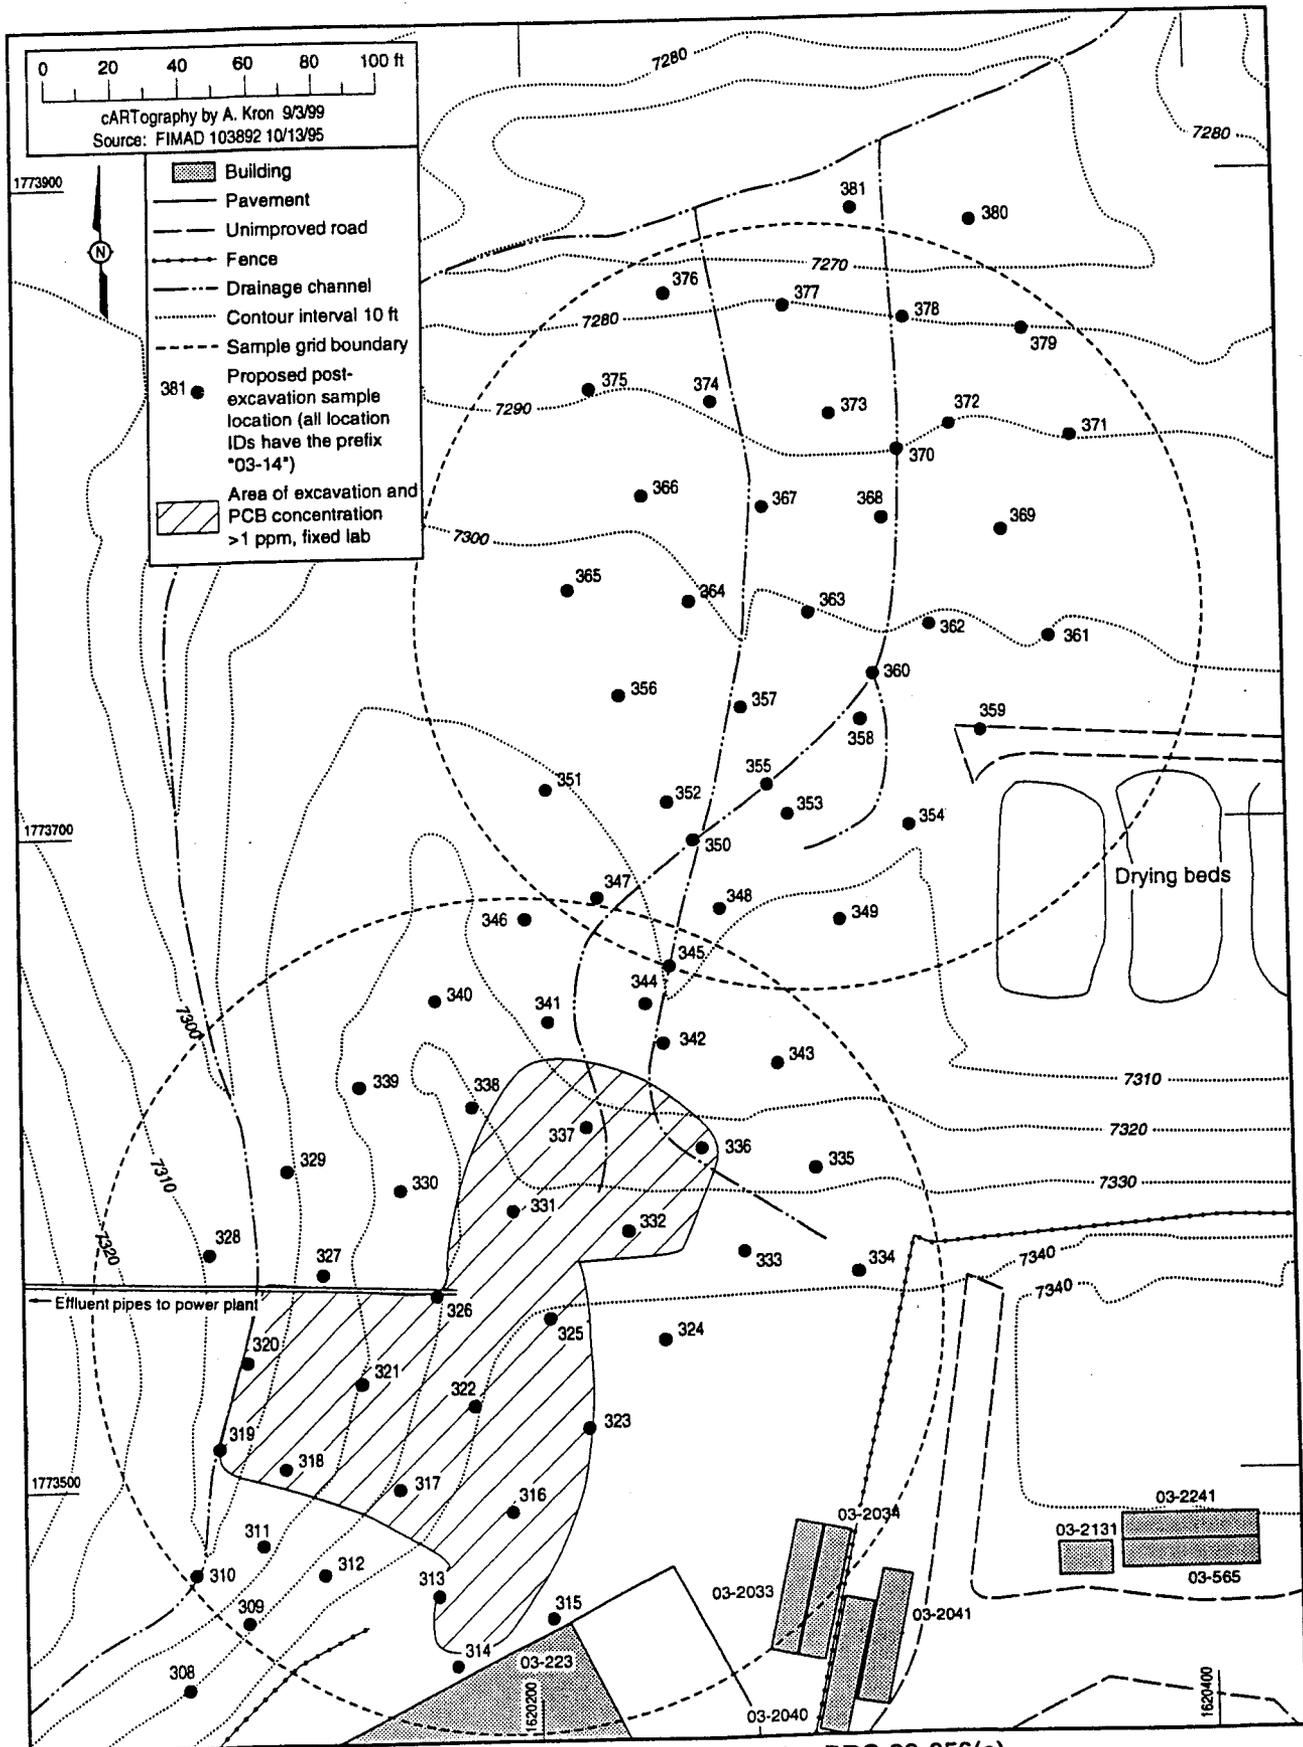
Figure 5.0-1. Proposed post-excitation sample locations for PRS 03-056(c).

The data collected during the supplementary sampling and the extent of the excavation will be used to set the boundaries of the confirmation sampling. The proposed sampling strategy considers the verification sampling strategy in EPA's latest guidance contained in 40 CFR 761 (Subpart O), with modification for site-specific characteristics and existing site knowledge at this PRS. Rather than propose a Cartesian-grid sampling approach as recommended by EPA in 40 CFR 761 (Subpart O), LANL proposes sampling on hexagonal grids that have been centered on the cleanup areas and that extend beyond the boundaries of the PRS. The hexagonal grid combined with previous sample data will provide sufficient spatial coverage of the area under investigation without unnecessary duplication. Two hexagonal grids will be set up: one to cover the North and West slopes, and the other to cover the ephemeral slope drainages. For each grid, equilateral triangles will be set up using up to 37 points. The grid sampling layout is presented in Figure 5.0-1. The points will be set up in the field before or during sample collection. Each point within the grids will be marked, and unique sample location numbers will be designated for each point. Table 5.0-1 presents proposed confirmation field-screening sample information. The points will be surveyed using a Trimble™ GPS Total Station. Field screening will be used to direct the laboratory sampling. Details are discussed below.

Grab samples will be taken from each grid location to determine whether the cleanup criterion has been met. If field screening indicates PCB concentrations are greater than 1 ppm, excavation will continue until either concentrations are less than 1 ppm or until a decision point has been met, as set forth in Section 4.3.3. Samples will be collected from 0–0.5 ft depths using LANL-ER-SOP-6.09, Rev. 0, "Spade and Scoop Method for Collection of Soil Samples", and LANL-ER-SOP-6.10, Rev. 1, "Hand Auger and Thin-Wall Tube Sampler." If the sample is within tuff, it will be collected using the backhoe bucket (or equivalent), a manually operated drill, or by chiseling pieces of tuff. The soil or tuff will be described and logged into the sample collection log forms (LANL-ER-SOP-01.04, "Sample Control and Field Documentation," Rev. 3). The samples will be brought to the field chemistry trailer to be screened for PCBs using the immunoassay field-screening kit (EPA SW-846 Method 4020). The immunoassay test kit will be chosen to have a working accuracy to 0.5 ppm for PCBs. This accuracy is sufficient to meet the performance-required objectives and cleanup level.

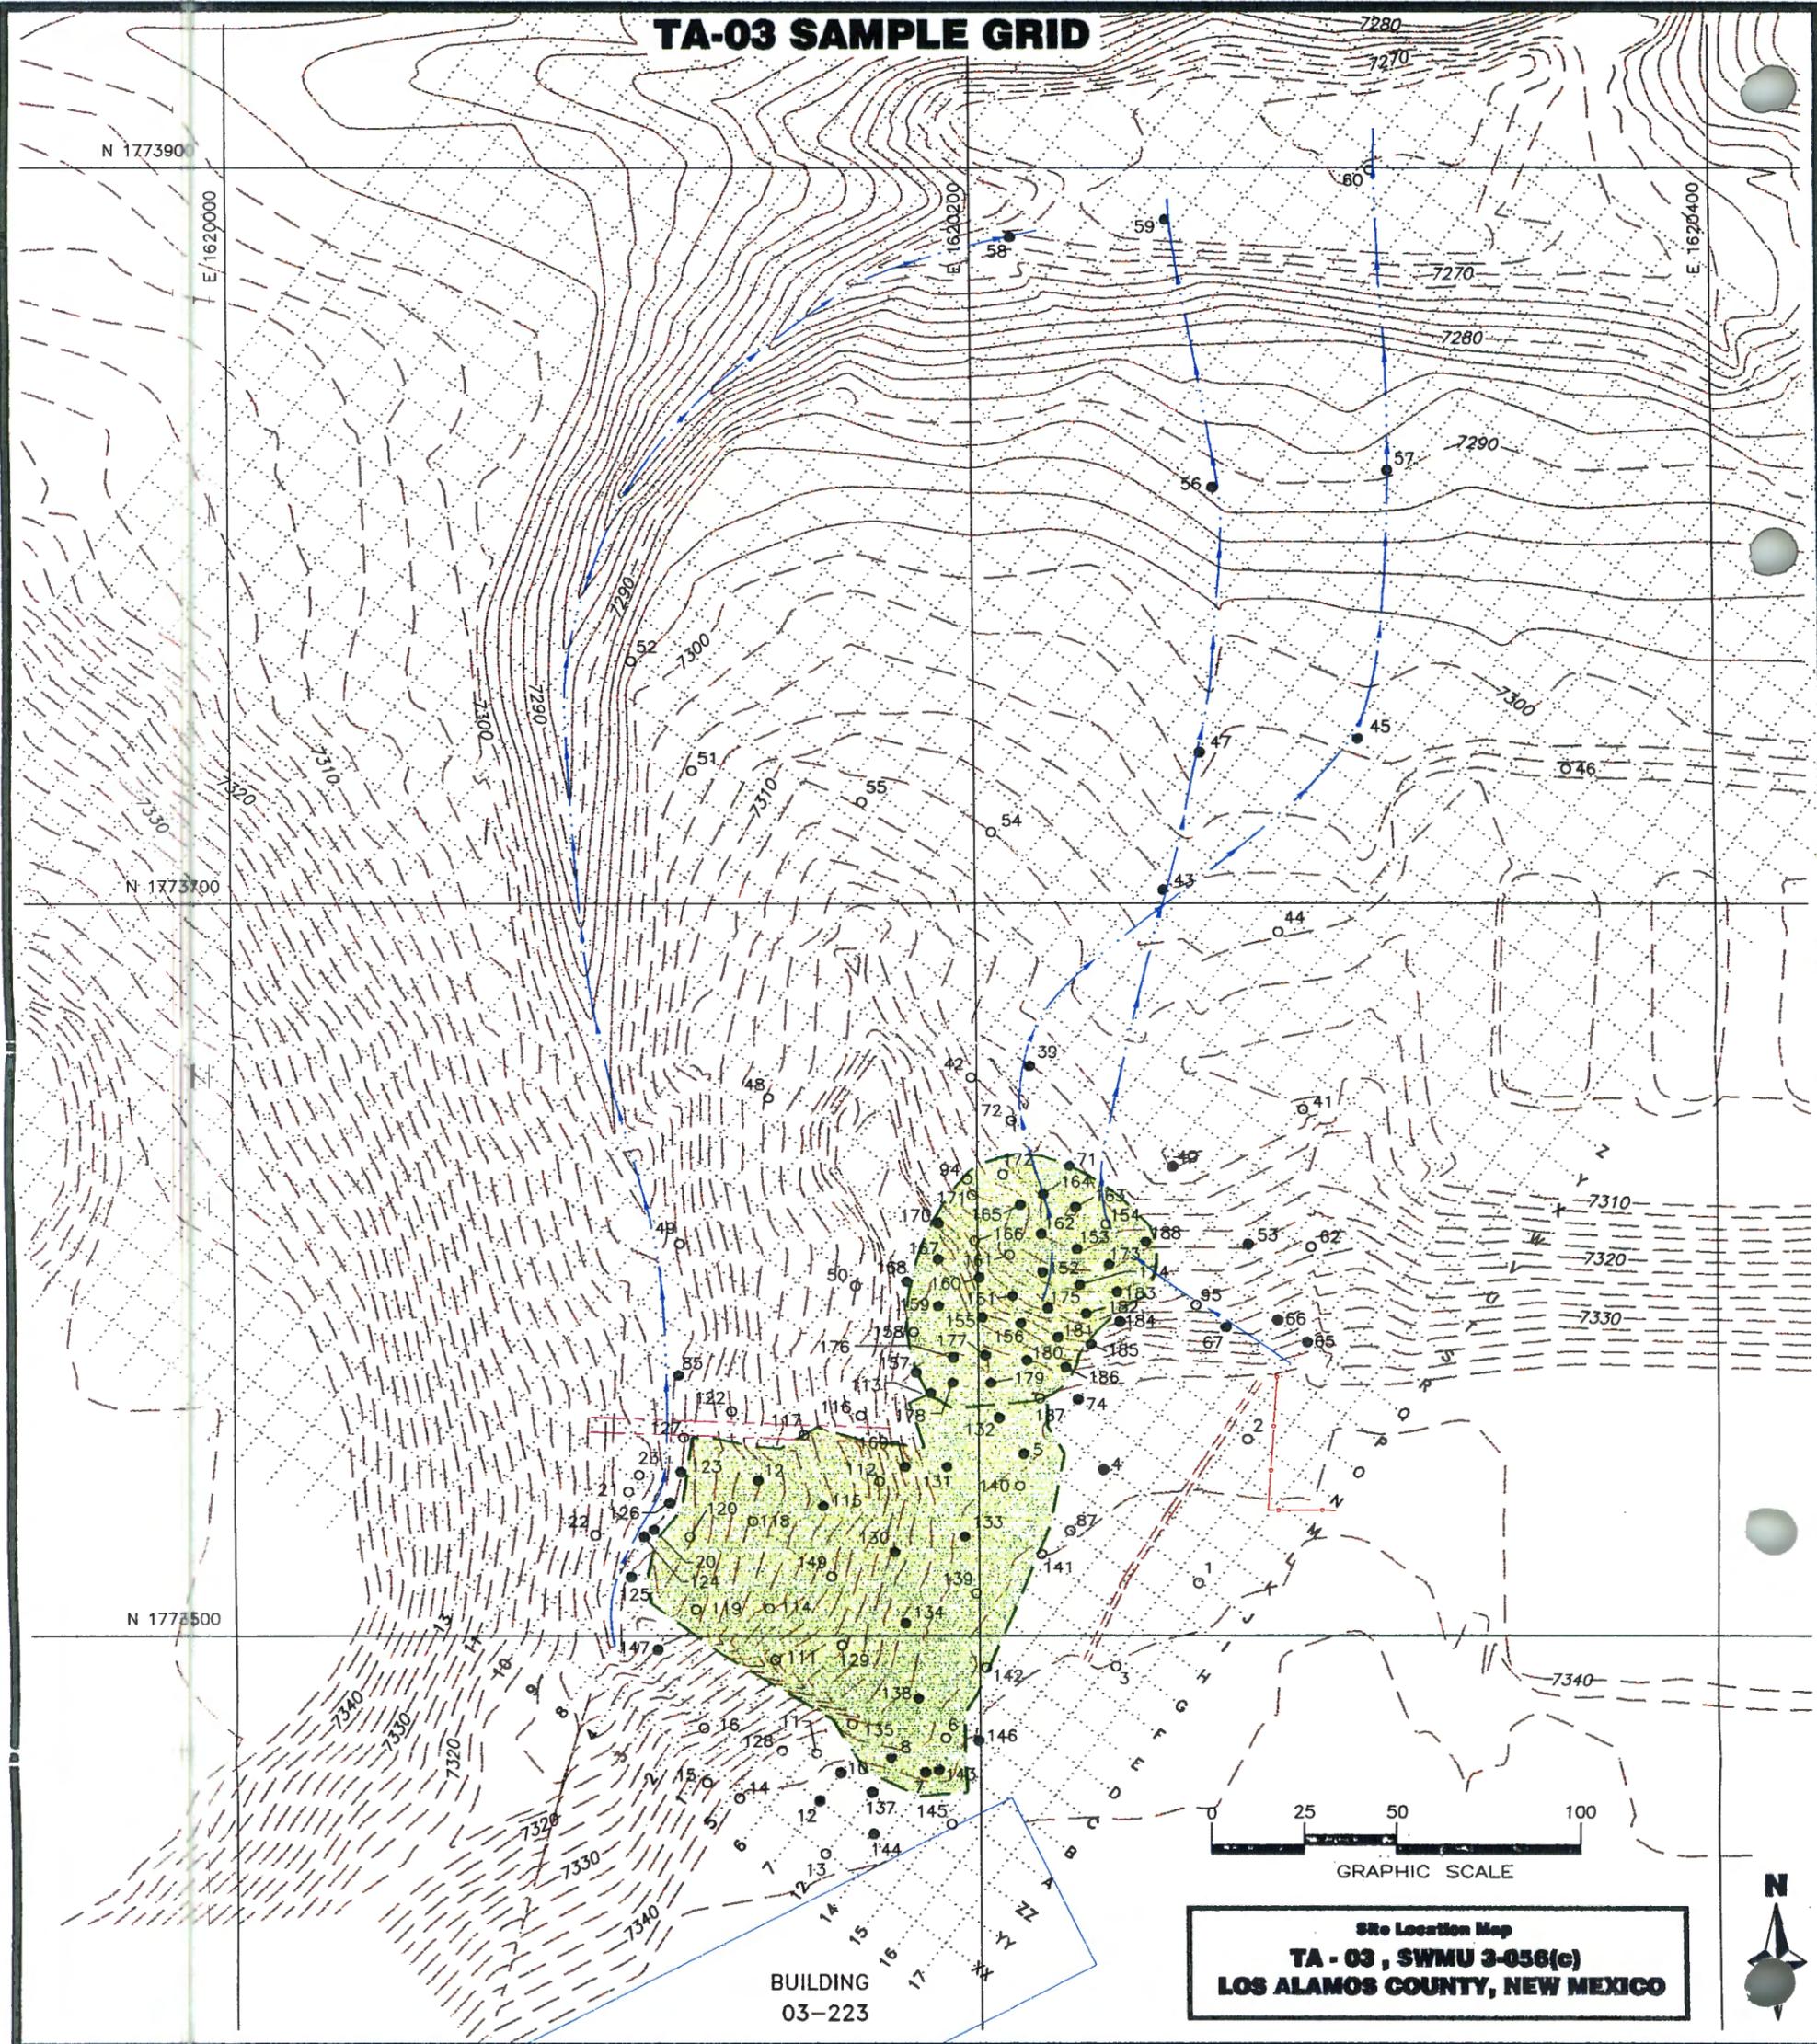
Figure B-1. PRS 3-056(c) Pre-Cleanup Site Map.

VCA Plan for PRS 3-056(c) (Attachment A). Table B-1 lists the sample locations, collection dates, analysis dates, and PCB concentrations remaining at the site following the 1995-96 corrective action cleanup activities and Figure B-1 depicts the corresponding sample locations of the data listed in Table B-1.

Table B-1 and Figure B-1 summarize the sampling information relevant to the initiation of the additional proposed corrective action cleanup activities. Contaminated areas are represented by sample locations with PCBs greater than 1 ppm, which are identified by solid circle symbols on Figure B-1. Additional samples are proposed prior to cleanup activities to further define extent of PCB contamination (PCBs greater than 1 ppm), as described in the VCA Plan for PRS 3-056(c), Section 4.2, Supplemental Sampling.
