From: Maestas, Ricardo, NMENV
Sent: Thursday, March 06, 2014 2:23 PM
To: Allen, Pam, NMENV
Subject: FW: Geotech brine monitoring system in Carlsbad
Attachments: for Susan.pdf

From: LucasKamat, Susan, NMENV
Sent: Thursday, February 20, 2014 9:49 AM
To: Griswold, Jim, EMNRD
Subject: Geotech brine monitoring system in Carlsbad

I was wondering if the monitoring system on the brine well at the Carlsbad Y was still operational? And if you have seen any anomalous incidents in the last 2 weeks.

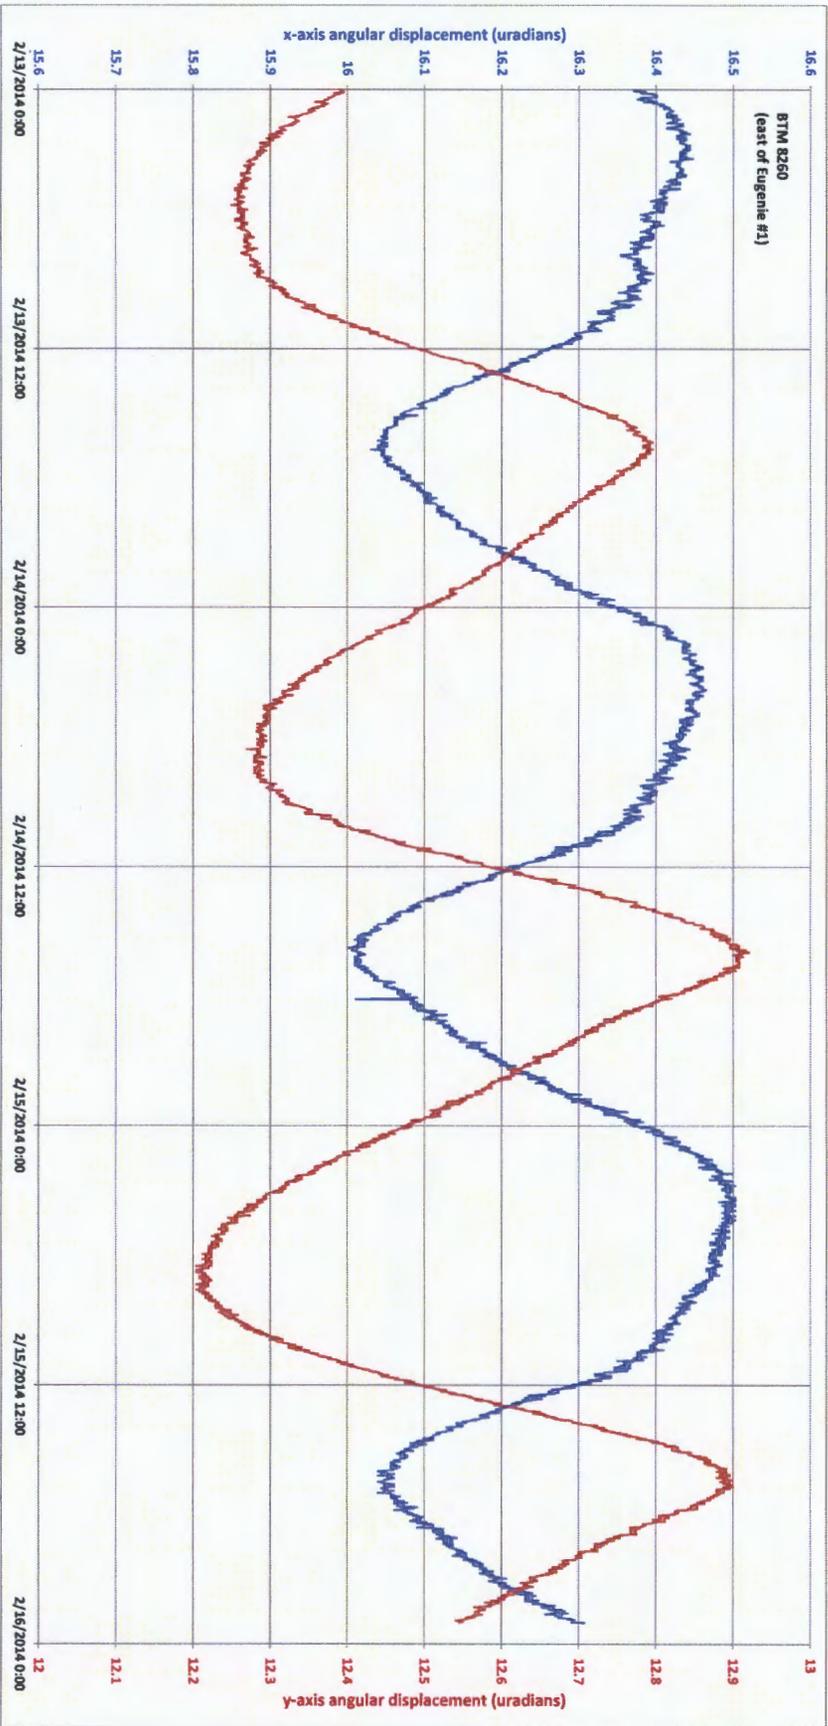
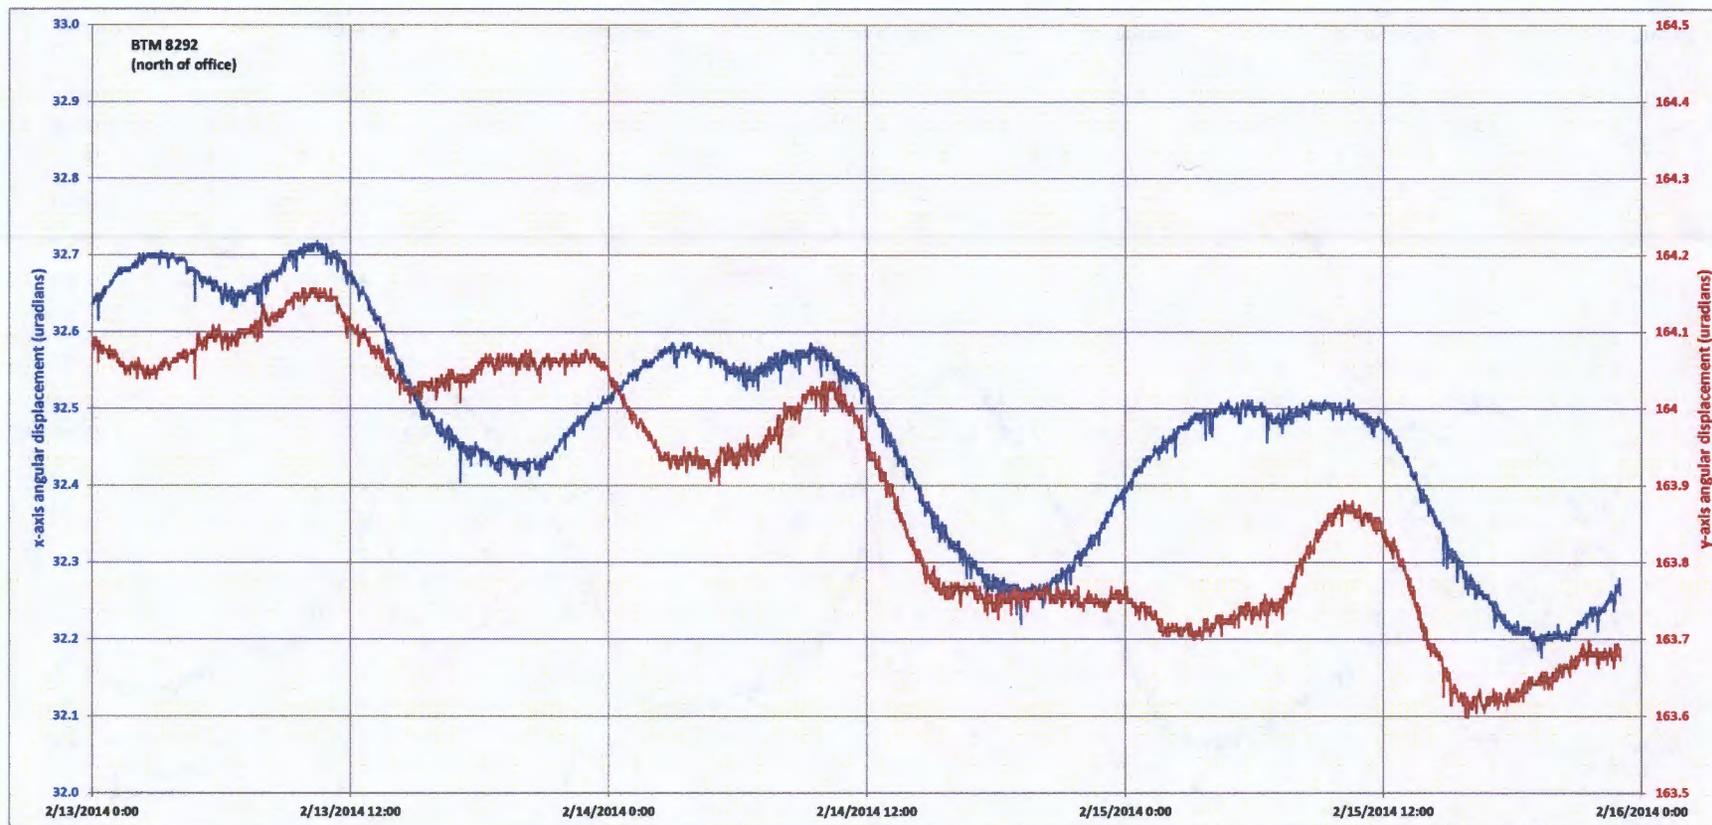
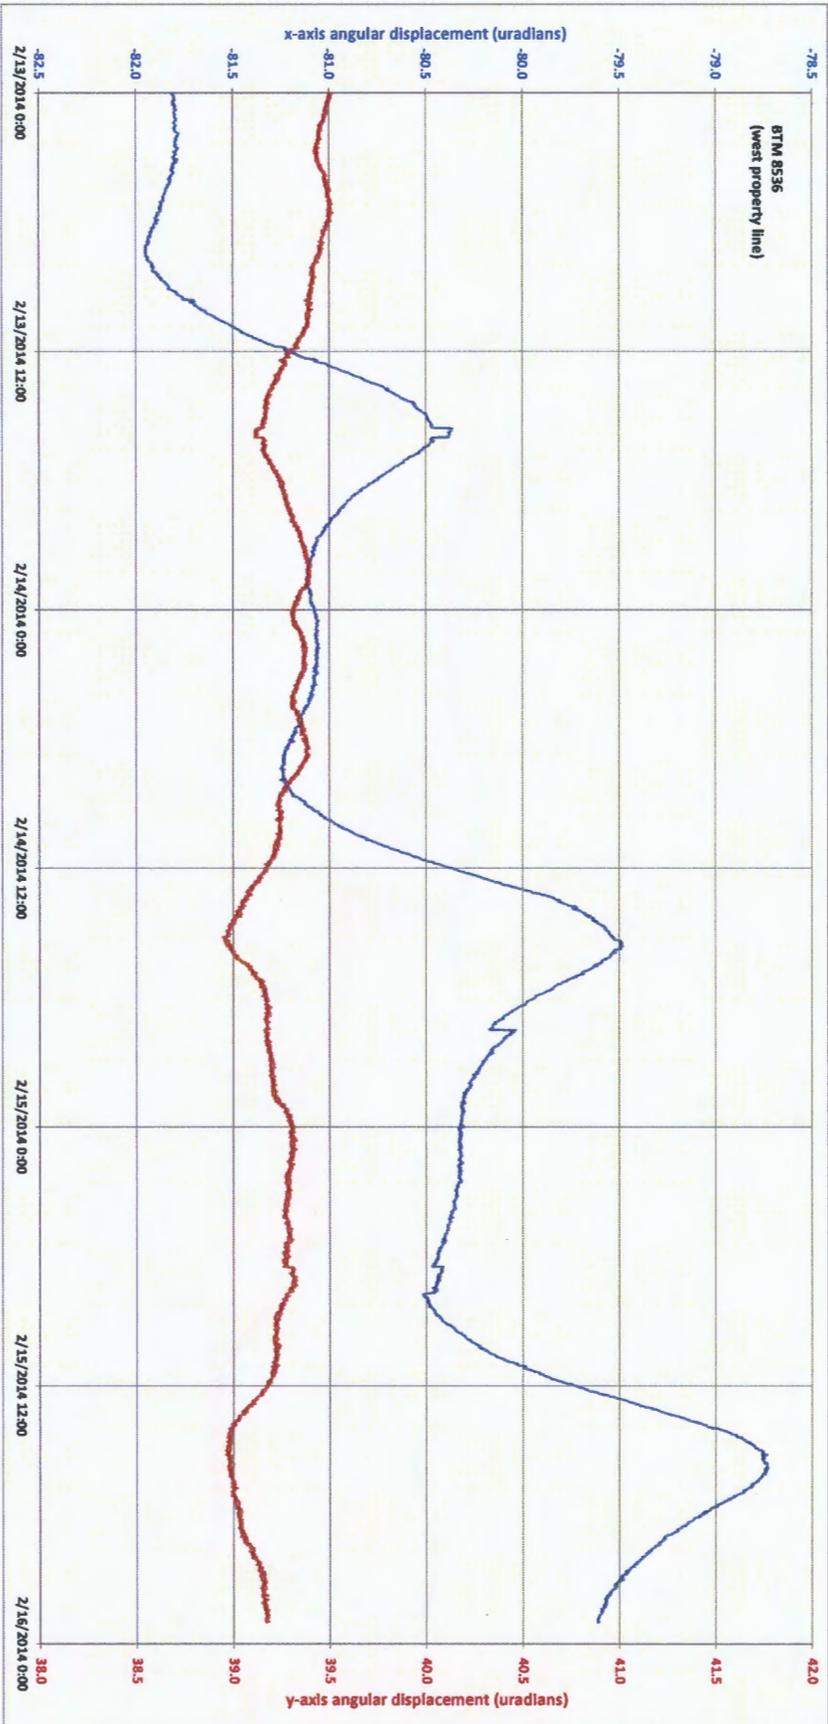
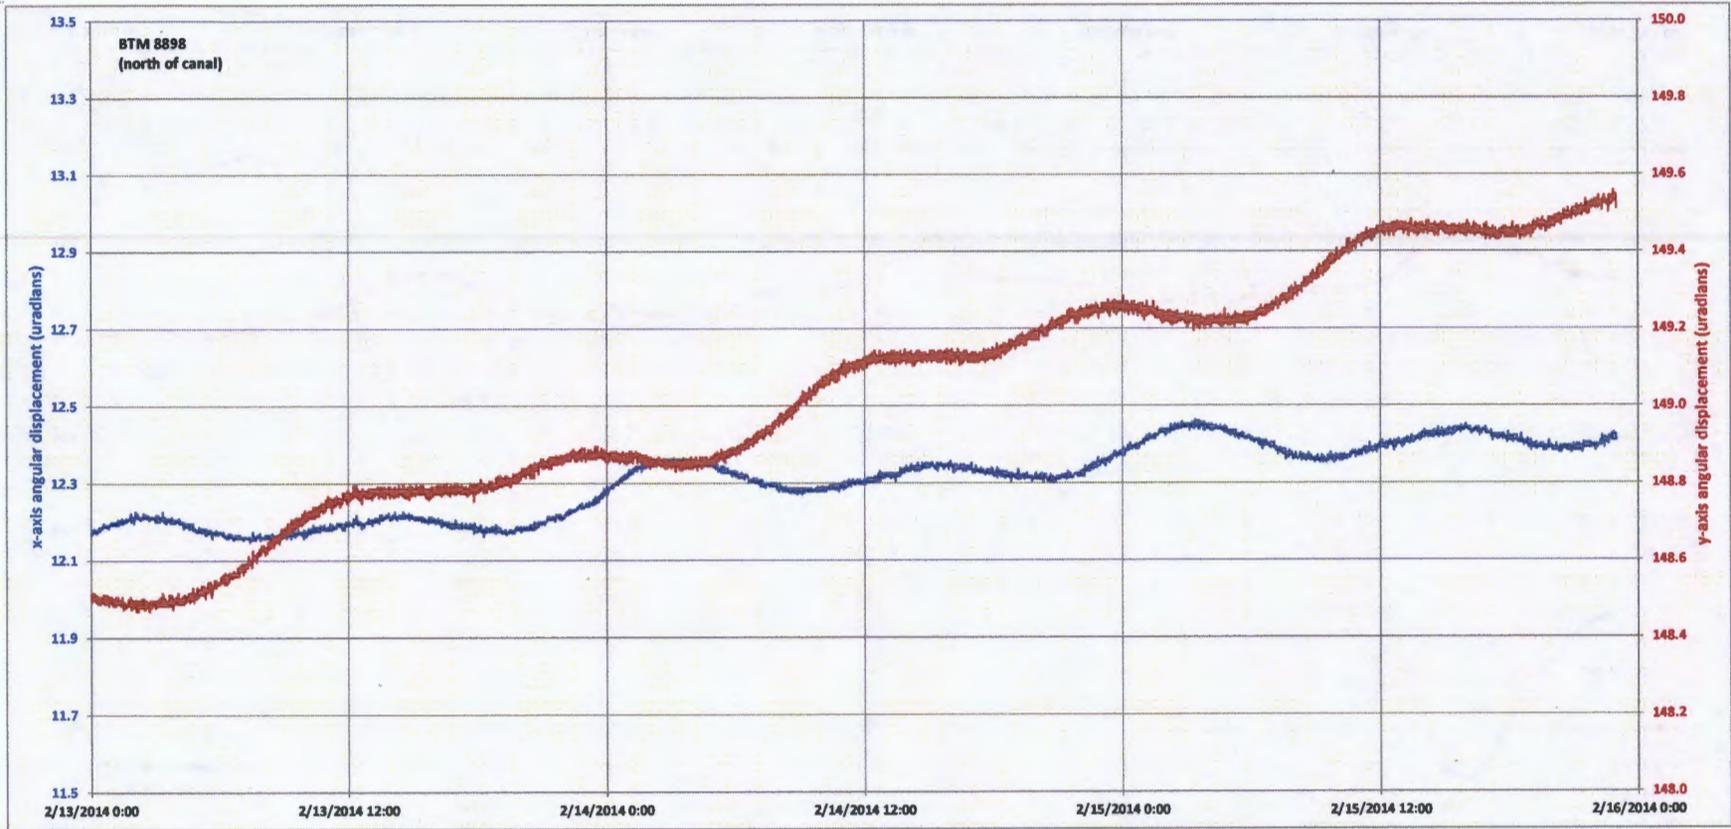
The Carlsbad brine well network didn't pick up any signal that would correspond to a roof collapse.

Sorry for the delay. See attached. I'm not seeing anything I would otherwise associate with a roof fall. The large oscillations are temperature-related and the high frequency hash is typically bit toggles within the logging system. Call if you need anything.
