**Subpart A Inspection Report  
in Response to the February 14, 2014 WIPP Incident**

**April 7 - 29, 2014**

**U. S. ENVIRONMENTAL PROTECTION AGENCY  
Office of Radiation and Indoor Air  
Center for Waste Management and Federal Regulation  
1200 Pennsylvania Avenue, NW  
Washington, DC 20460**

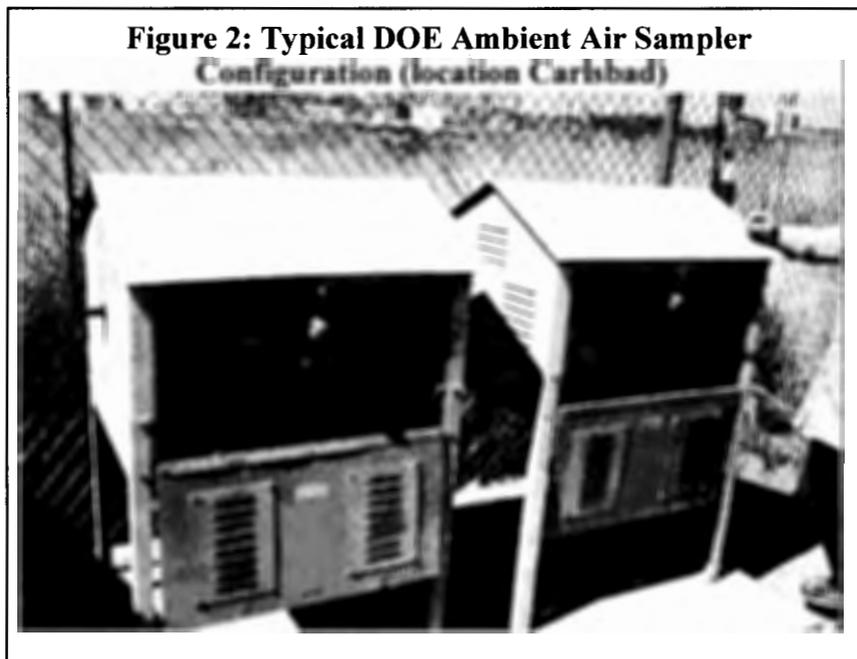
**Figure 2: Typical DOE Ambient Air Sampler Configuration (location Carlsbad)**

Many of the ambient air samplers were observed to be placed in appropriate, unobstructed areas, and the filter changes took place according to procedures. At the Carlsbad sampling location, however, inspectors observed that the samplers were placed in close proximity to an outbuilding, which could potentially restrict airflow to the sampler. Additionally, while Sampler 14889 showed 170.3 hours elapsed, its duplicate (9916) showed only 129 hours elapsed. According to DOE procedure, a sample can be accepted, with a notation, as long as at least 100 hours are shown for the weekly sample. Sampling staff expected that the discrepancy was caused either by a timer failure, or by overheating, which can cause the pump motor to shut off intermittently. A hand timer was used to verify the timer on sampler 9916. More than 8 minutes elapsed before the timer gave a reading of 0.1 hours, indicating timer failure. Sampling staff allowed the sampler to continue running, and stated that they would return to replace the timer later that day. It was not clear to EPA whether the resulting sample would be considered a duplicate. EPA staff inquired about how instrument failures and maintenance are recorded, and sampling staff stated that the both of these occurrences are noted on the sample sheets.

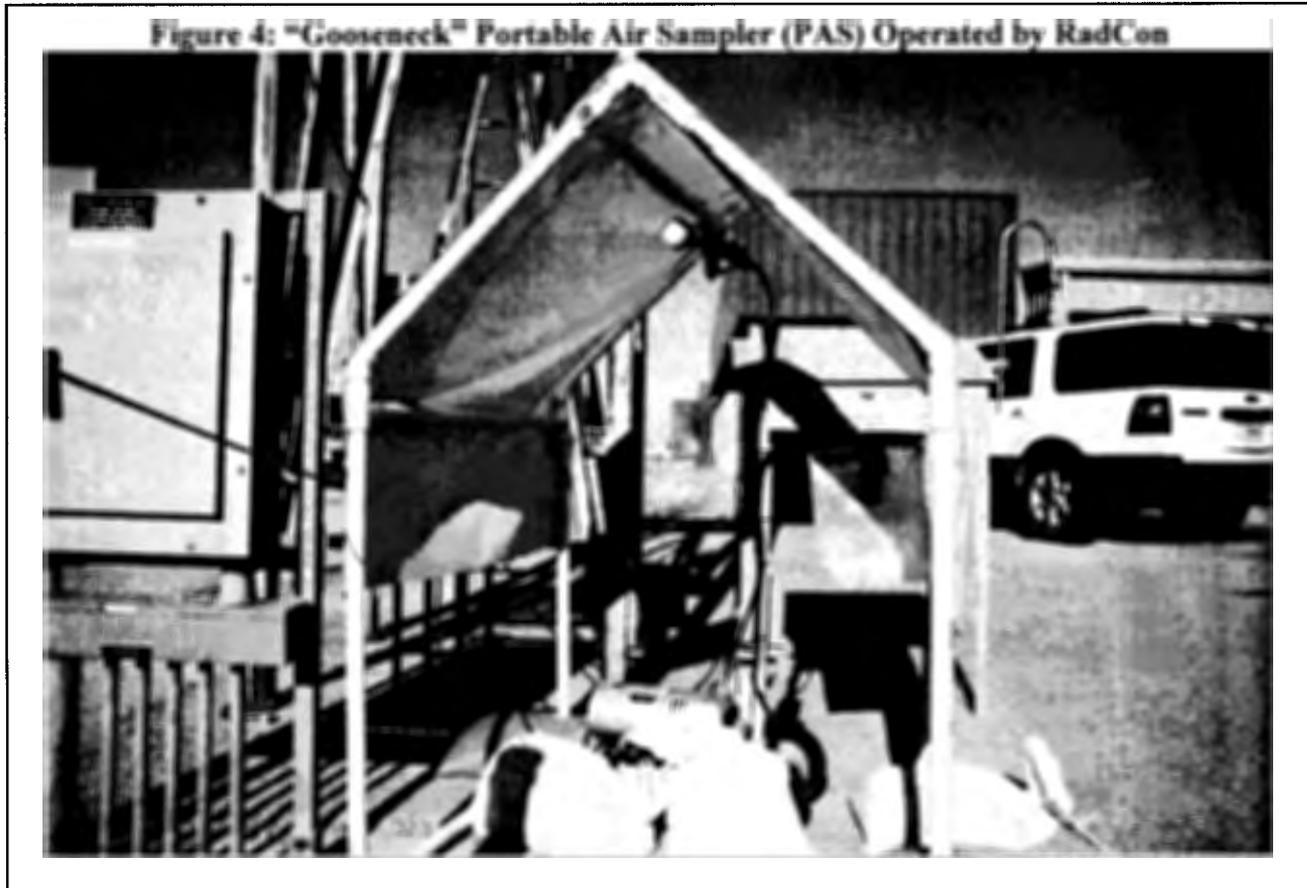
On Wednesday, April 9, the EPA team inspected the sampling equipment at the Salt Handling and Air Intake Shafts. Because of the underground contamination, the aboveground physical structure (shaft collar) and area surrounding each shaft has been restricted as a Radiological Buffer Area (RBA). The EPA team walked the exterior of the salt shaft, up to the RBA boundary. Brattice cloth, used in mine operations to restrict air flow, had been placed over and around the structure of the shaft collar, making it impossible to view the continuous air monitor at that location without entering the RBA. Four Hi-Q “gooseneck” portable air samplers (PASs) were observed: 240-R1-000-0861, 240-R1-000-1101, 240-R1-000-0062, and 240-R1-000-1610. These instruments are free-standing, low-volume air samplers that do not have any external housing. The sample heads are at waist height and parallel to the ground surface (see Figure 4). Units 0861 and 1101 were outside the boundary of the RBA. Analog flow rate meters in line with the filter head indicated that each was operating at 2 cfm. Although some of the

calibration labels were weathered due to the harsh environment at the WIPP, the instrument calibrations are maintained by RadCon, and those that were legible had been recently calibrated. Samples are collected from the PASs and counted for radioactive contamination using procedure WP 12-HP3500. The frequency of filter changes on PASs is daily, although it was 4-8 hours during the initial response. During the initial response, RadCon air samples were all sent for isotopic analysis.

At the air intake shaft, Hi-Q PAS 240-R1-000-1612 was observed to be operating within the RBA. A Staplex kinetic impactor, which can be used to sample selectively for alpha- and beta-emitting transuranics without collecting lighter radon decay products, was present but not operating. As at the salt shaft, brattice cloth was placed around the shaft collar. At each location, brattice cloth would be pulled over the shaft opening if ventilation was secured (i.e., the ventilation fans turned off). This action would be taken to prevent contamination from escaping the shaft, which could occur if the ambient temperature dropped and warmer air began to rise from the underground.

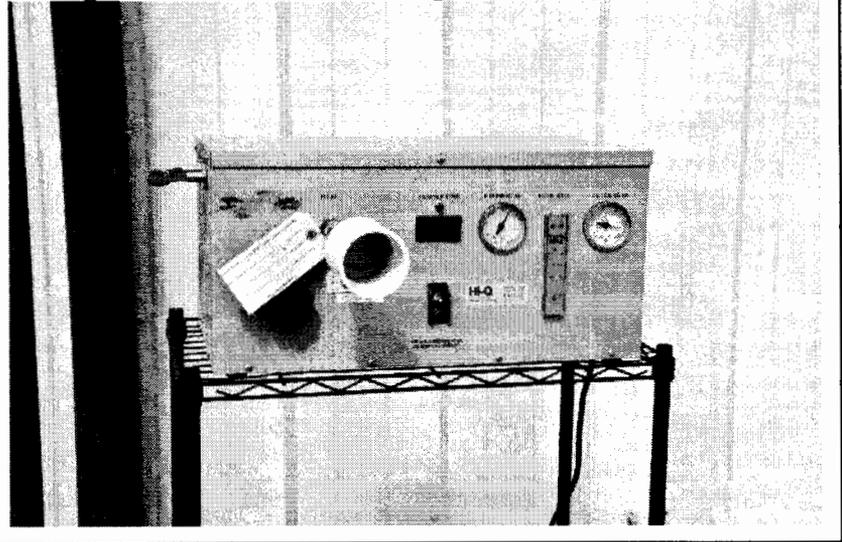
**Figure 5: Ambient Air Sampler, Loving Fire Station**

The physical positioning of several ambient air samplers needs to be improved for the samplers to function properly. The ambient air samplers located at the Carlsbad location were partially obstructed by a large outdoor shed and closely parked maintenance trucks, potentially preventing air flow from the desired 270 degree sampling area or even the 180 degree minimum sampling area. The presence of vehicles could also provide bias from vehicle emissions, which may interfere with collection efficiency. The newly established ambient air samplers located at Artesia, Loving, Hobbs and Eunice were all closely located to structures more than three times the height of the samplers (Figure 5). Each of these samplers should be moved to attempt to get a 270 degree sampling area away from buildings. In addition, samplers in Artesia and Eunice station were located next to regularly plowed farm land, which could reduce the collection efficiency of gathering the targeted radionuclides due to early loading of the sample filters with soil particulates. Lastly, the sampler in Artesia was placed under an exhaust vent for the adjacent fire station. Particulate exhaust from this vent may reduce collection efficiency.

This sampler should be moved away from this exhaust. These observations are made in consideration of 40 CFR Part 58, Appendix E, Probe and Monitoring Path Siting Criteria for Ambient Air Quality Monitoring. The samplers sited at WIPP Far Field, WIPP East, WIPP South, Mills Ranch, Smith Ranch, Southeast Control, Met Tower, Salt Hoist, Training Building and the WIPP Guard & Security Building were placed in excellent locations for sample collection.

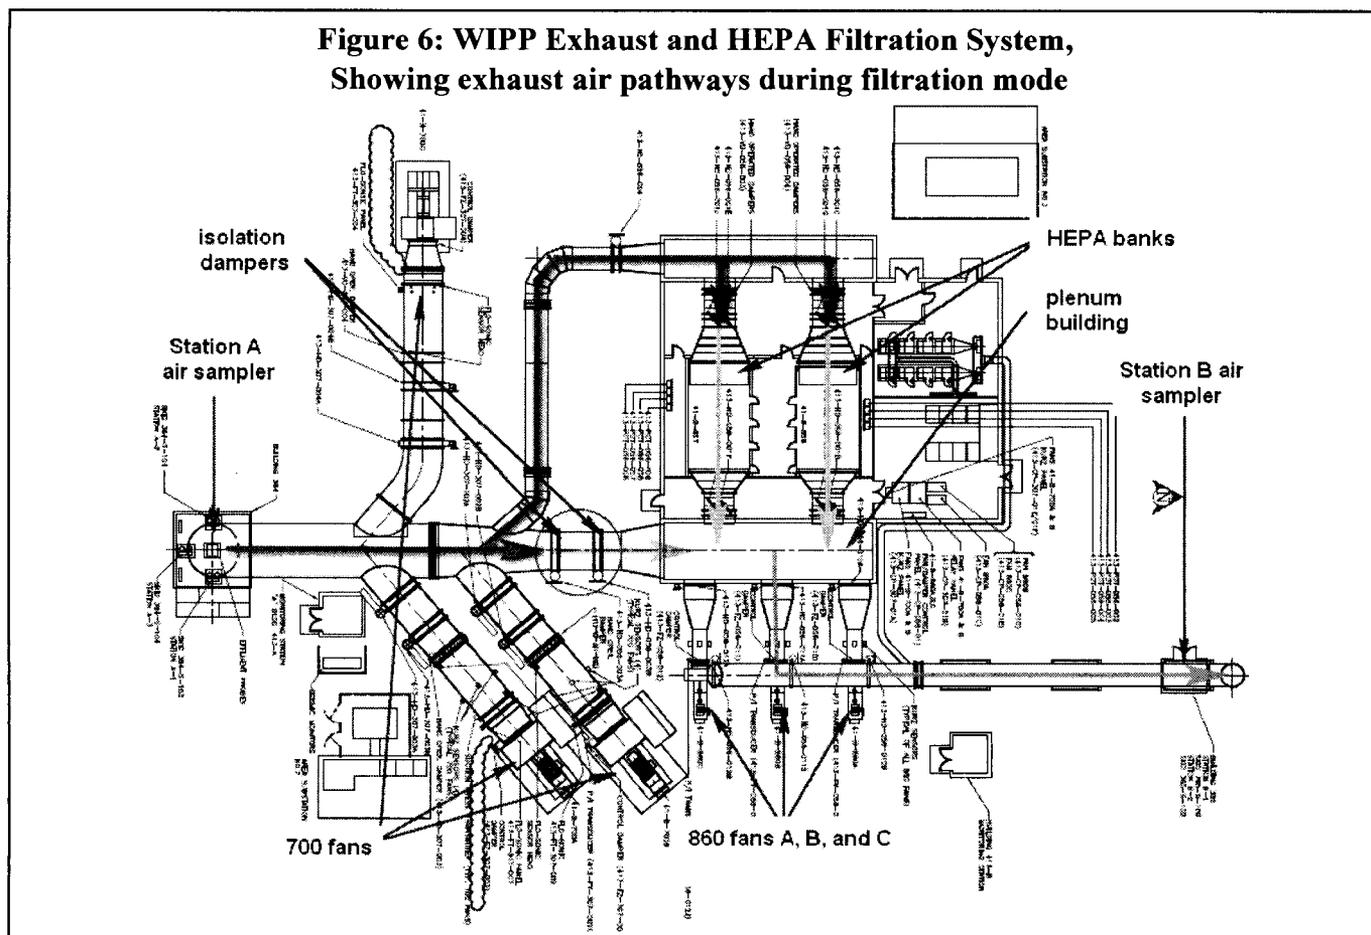
The exhaust system can be operated in several configurations. If the facility is not in filtration mode and one or more of the three “860” fans is being operated, exhaust air passes through the open dampers into the plenum building, and is then exhausted at Station B. In filtration mode, a single 860 fan is operated and the dampers are closed, forcing air through the HEPA filtration banks. Because the plenum building remains under negative pressure, some unfiltered air passed through the dampers and was exhausted without being filtered, prior to the sealing of this leak pathway. However, because all of this air is exhausted through the same pathway, air samples taken at Station B capture all radioactive material that enters the environment. In Figure 6, the red arrows denote the path of unfiltered mine exhaust, the green arrows show the path of filtered air, and the orange arrow shows the mixture that is exhausted from the plenum building. There are similar sets of dampers on each of the three “700” fans (the typical exhaust points for high ventilation configurations) that are likewise closed when the facility enters filtration mode. However, these dampers are under constant negative pressure, so any leakage at those locations would pull exterior air into the effluent stream.

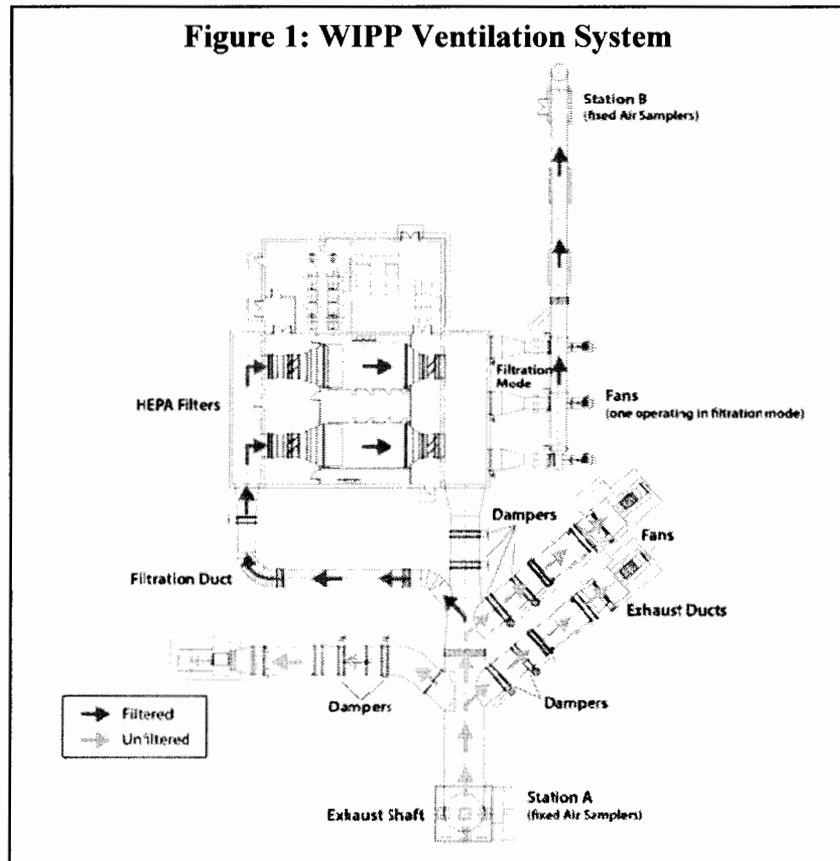
DOE demonstrates compliance with EPA's public dose standards during the operational period of the facility by continuously sampling the effluent (exhaust) leaving the underground. This sampling has routinely been performed at the unfiltered exit to the air exhaust shaft (Station A), which is the primary release point, and at the waste handling building (Station C). The measured values are then fed into models approved by EPA to calculate doses to the public. Since the February 14 incident, sampling at the exhaust shaft has taken place at Station B, after the exhaust has passed through the high-efficiency filters. Air leaving the waste handling building has always been filtered. A graphic showing the WIPP exhaust system can be found in Figure 1.
