2012 Update to the Site Discharge Pollution Prevention Plan, Revision 1

Los Alamos National Laboratory
NPDES Permit No. NM0030759
LA-UR-13-21503 • May 1, 2013

Water/Cañon de Valle Watershed

Volume 4

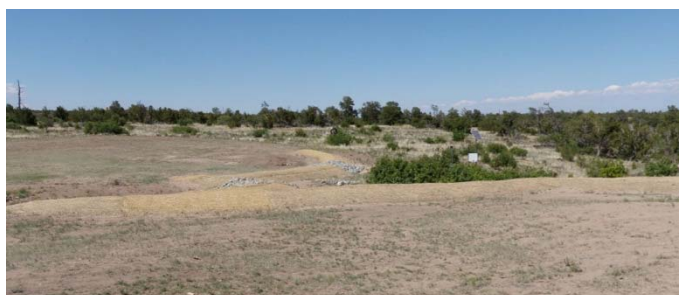
F-SMA-2, Earthen Berm, F00103010015 (photo ID 23503-5)

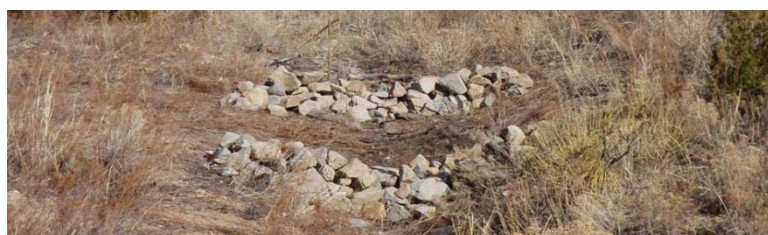
PT-SMA-1.7, Rock Check Dam, I00306010010 (photo ID 12975-1r)

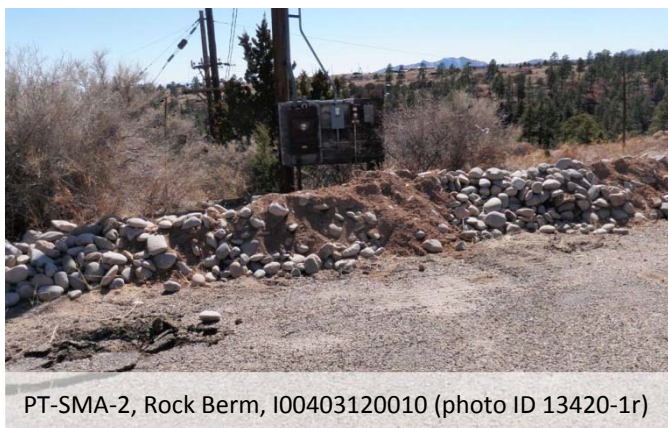
PT-SMA-2, Rock Berm, I00403120010 (photo ID 13420-1r)
