**Subject: Submittal of the 2011 Annual Inspection Report for Los Alamos County
Airport Landfill, Solid Waste Management Units 73-001(a) and 73-001(d),
Technical Area 73**

LA-UR-12-0671
February 2012
EP2012-0018

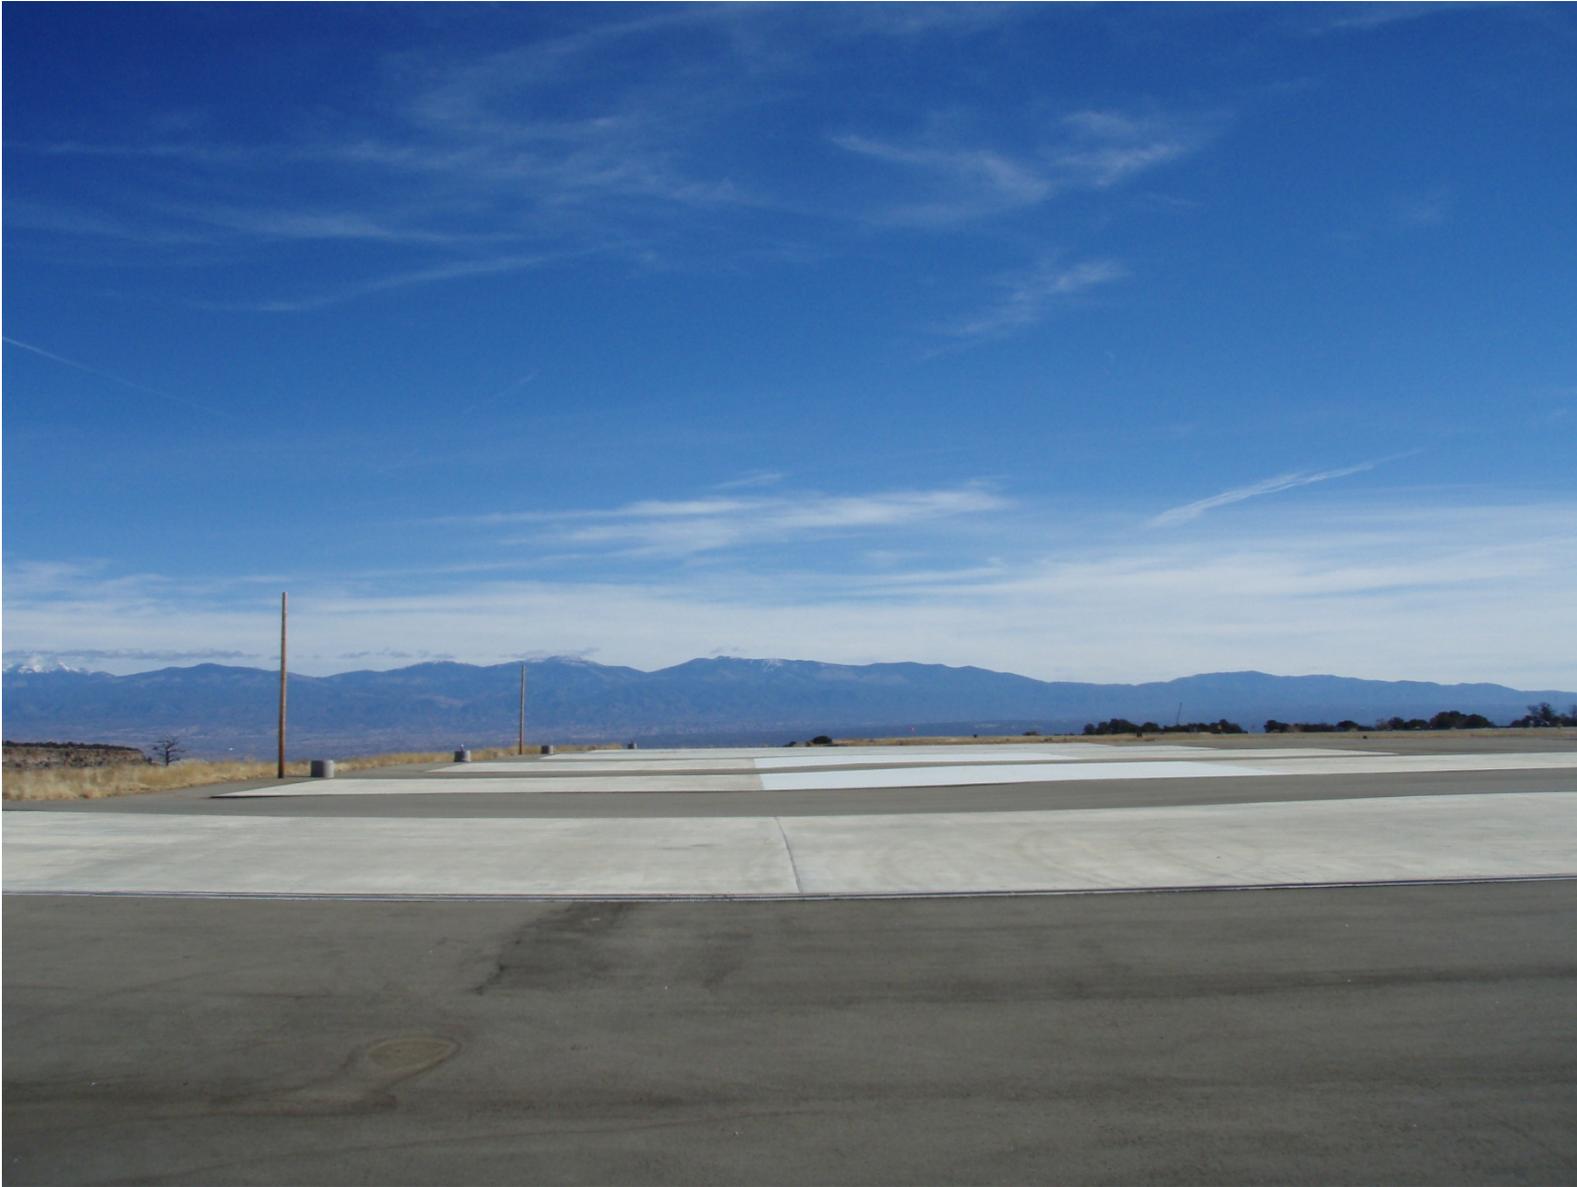
Monthly inspection surveys of the MatCon asphalt pavement were conducted by walking transects along the western, eastern, and southern areas of the pavement and between each hangar pad shown in Figures 3 and 4. The survey looked for evidence of cracking, subsidence, or separation of the pavement.

Figure 4 View to the east; note uneven appearance of pads and MatCon pavement

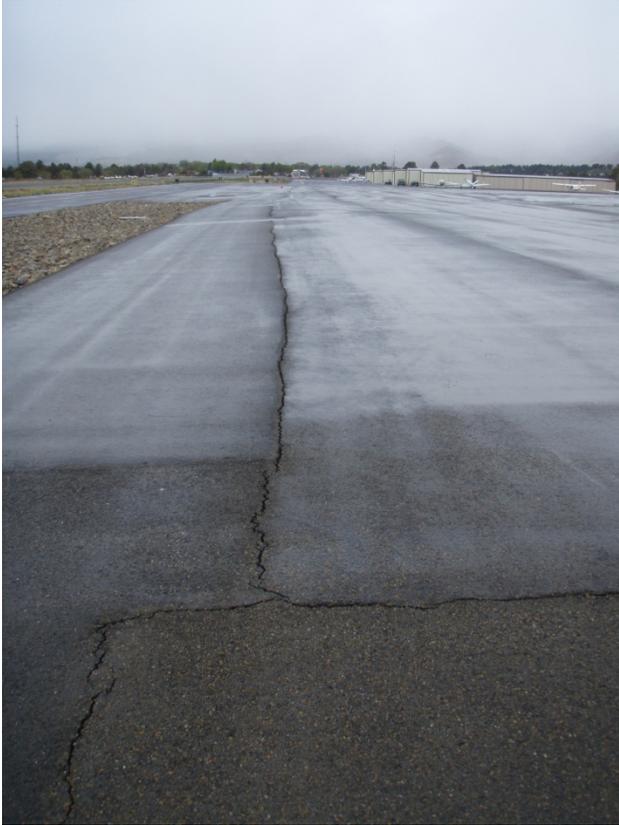
During the surveys, visible cracking or separation was observed in various locations of the MatCon pavement. The cracks occurred mainly along the contact seam between paving lanes as shown in Figure 5. Cracks ranged from a few feet to over 100 ft in length and were up to 0.5 in. wide and approximately 3 in. deep. In several locations, weeds were growing through the cracks.

Figure 5 Typical crack in MatCon pavement;
view to the west

In October 2011, cracks in the MatCon pavement and joints between the pavement and the concrete hanger pads were hot sealed as shown in Figures 6 and 7. The MatCon pavement was repaired under an existing warranty by MatCon representatives. Joints between the pavement and the concrete hanger pads were hot sealed under a separate nonwarranty subcontract by the same representatives.

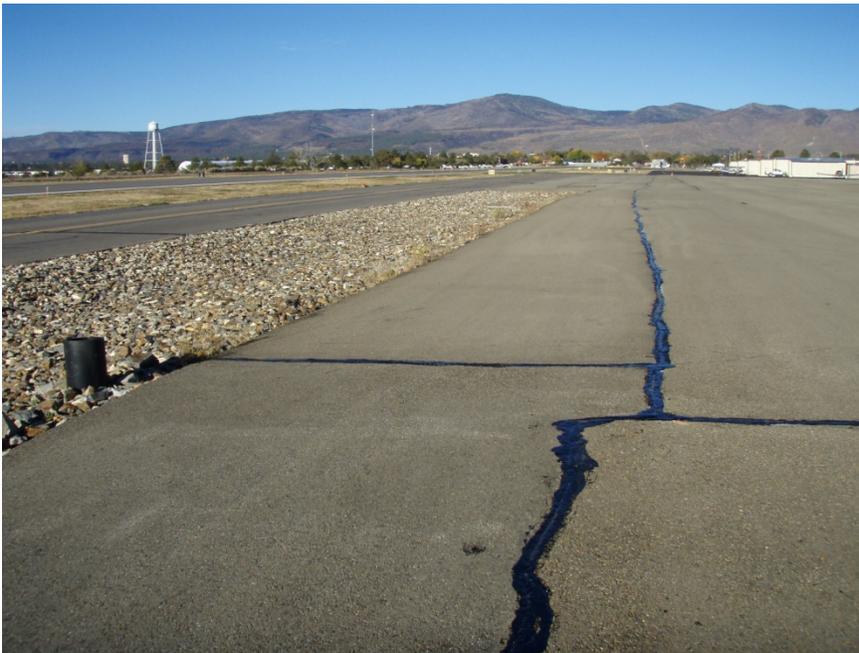
Figure 6 MatCon pavement hot seal; view to the west

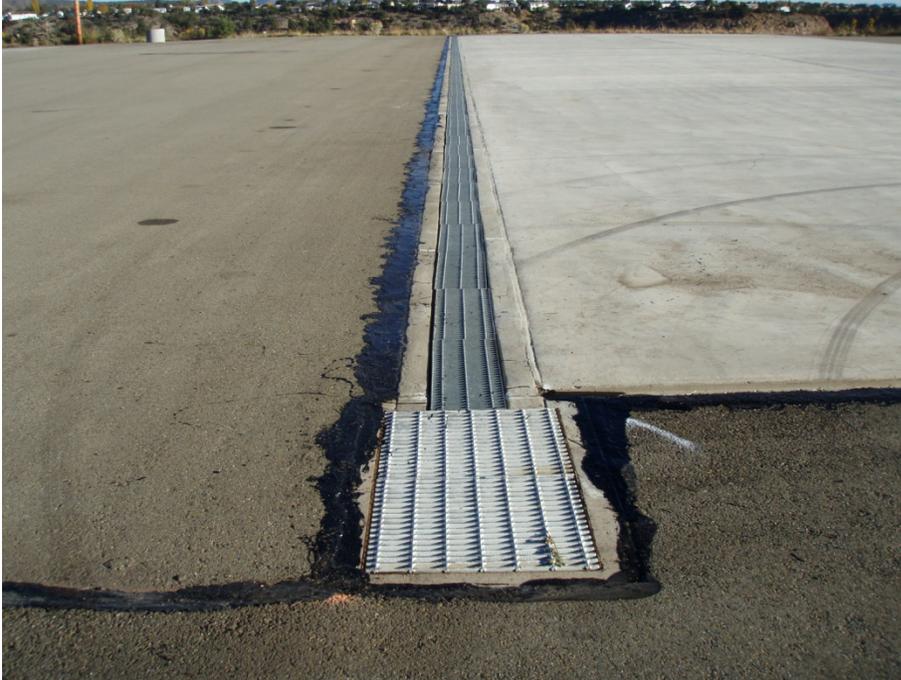
Figure 7 MatCon pavement hot seal along trench drain and pad

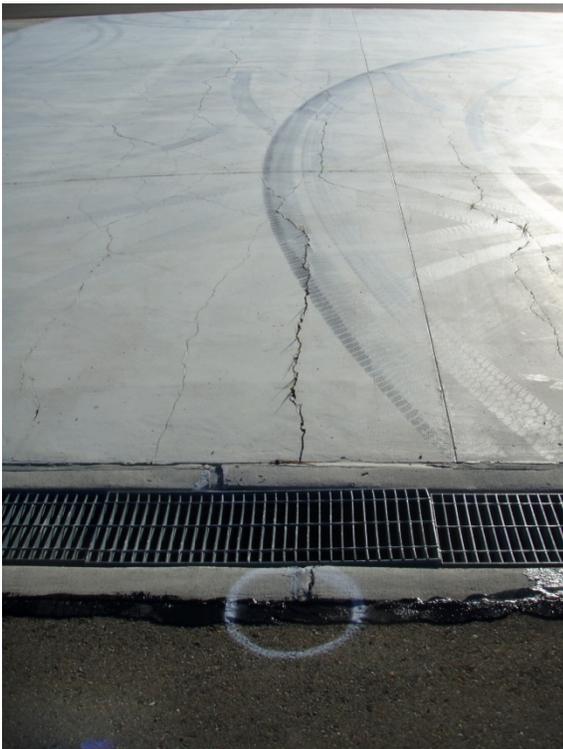
Visible subsidence was noted on the northern half of hangar pads 2 and 3. Subsidence was also found on the northwest quarter of hangar pads 1 and 4, but to a lesser degree than on pads 2 and 3. Cracking associated with the subsidence of the pads was also observed throughout the central portion of each pad. Typical cracking observed at pad 3 is shown in Figure 8. Cracks in pads 2 and 3 had been treated in 2009 using polyurethane sealants; some of the treated cracks have expanded and grown in length and width. Separation of the expansion joints was observed at all the pads, with the exception of pad 5.

Figure 8 Typical hangar pad cracking;
view to the east

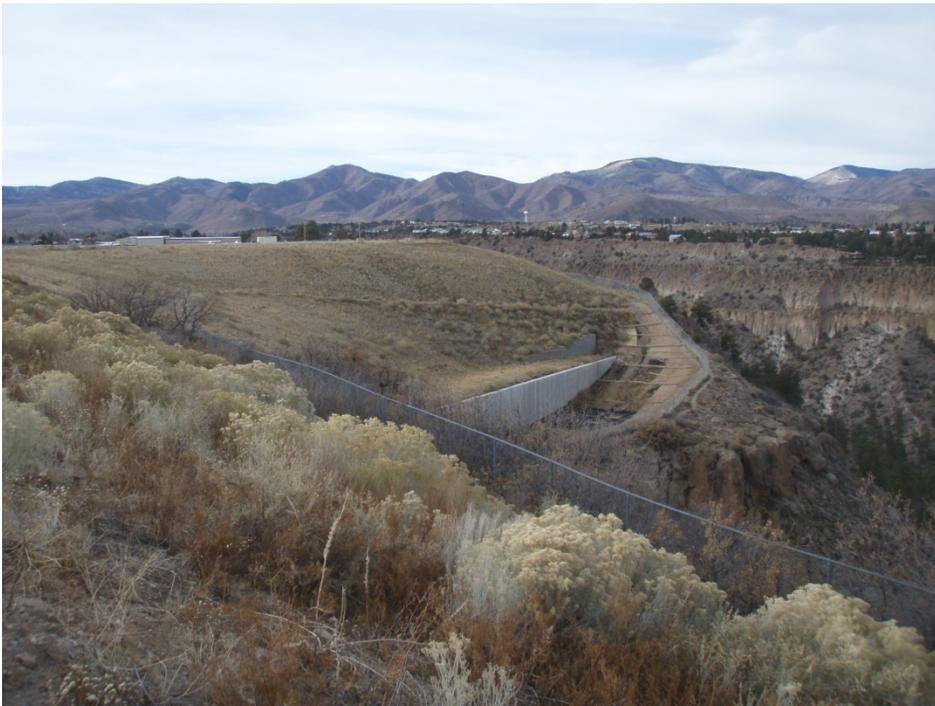
The vegetated areas are well populated with various grasses, some shrubs, and seasonal weeds, as shown in Figures 9 and 10. A few areas have sparse vegetation but are covered with TRM. No animal burrows were noted. During the inspection, erosion caused by stormwater runoff was observed in one area. Rills are forming along the northeast margin of the vegetated slope and the straw wattle area. In September 2011, wattles were replaced and additional wattles were installed along the access area to the retaining walls as shown in Figure 10.

Figure 10 Northwest view of vegetated slope, wattle area, and retaining wall

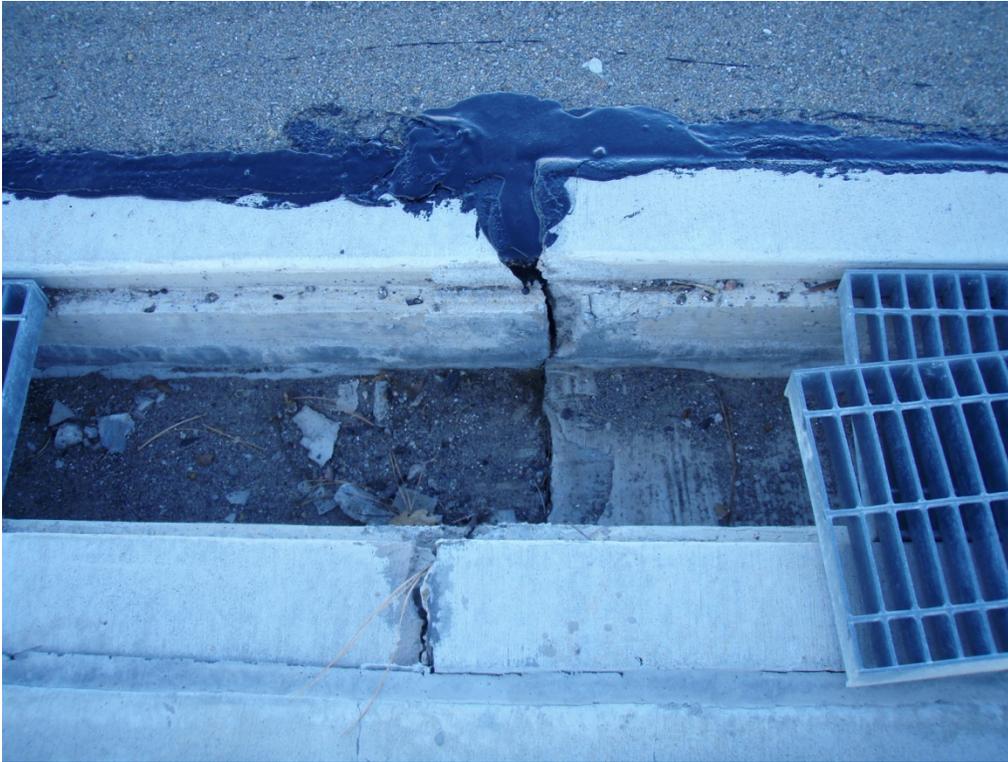
General cracking was observed along the concrete channels of the five trench drains next to the hangar pads. Larger cracks (approximately 0.25 to 0.5 in. in width), as shown in Figure 11, and displacement of the concrete channels associated with hangar pad subsidence were noted in the trench drains next to hangar pads 1, 2, 3, and 4. Standing water was observed in the northern half of trench drains associated with pads 2, 3, 4, and 5, and ponding was observed at the northern ends of pads 2 and 3, as shown in Figure 12. Cracks in the trench drains next to pads 2 and 3 had been previously repaired with grout. Drain inlets associated with pads 1, 2, and 3 are cracking or flaking and contain standing water. The remaining 10 drain inlets, manhole, and outfall appear to be in good working order.

Figure 11 Crack across trench drain

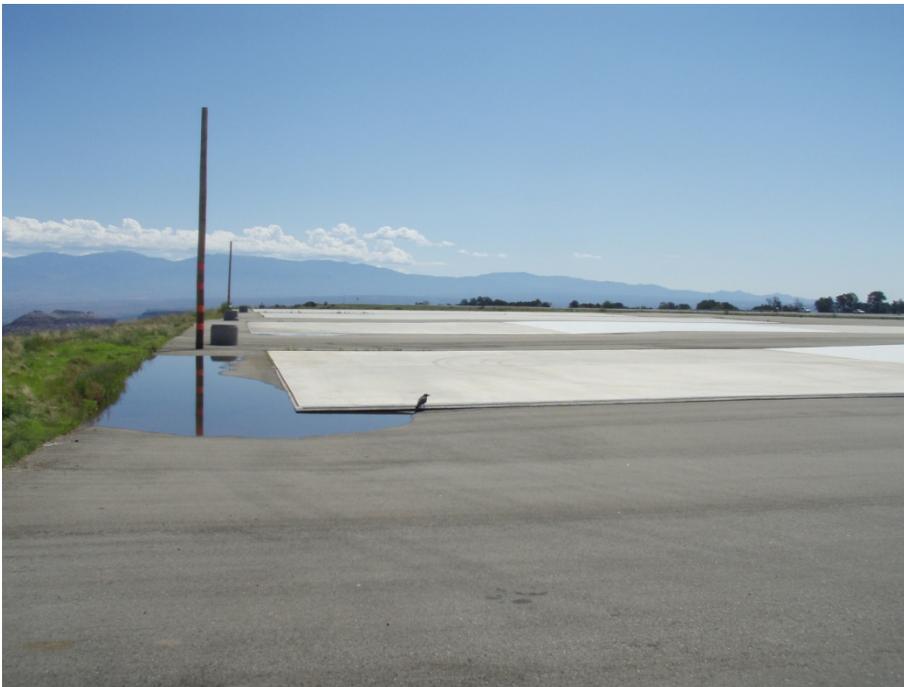
Figure 12 Puddle at northwest corner of hangar pad 2

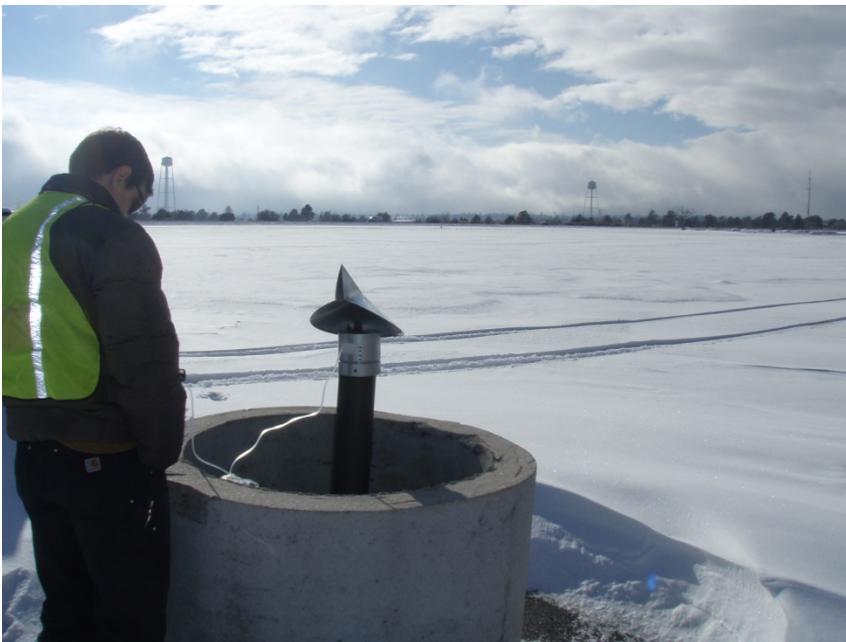
During fourth quarter monitoring, elevated combustible gases were detected at PS-04 and PS-06, and the monitoring instrument alarmed indicating a gas concentration greater than or equal to 20% of the LEL. The oxygen concentration was 11.3% at PS-04 and 15% at PS-06. Monitoring could only be completed at the vent risers; all other monitoring locations were not accessible because of snow accumulation, as seen in Figure 14. Fourth quarter gas-monitoring results are presented in Table 4.

Figure 14 Gas vent riser monitoring

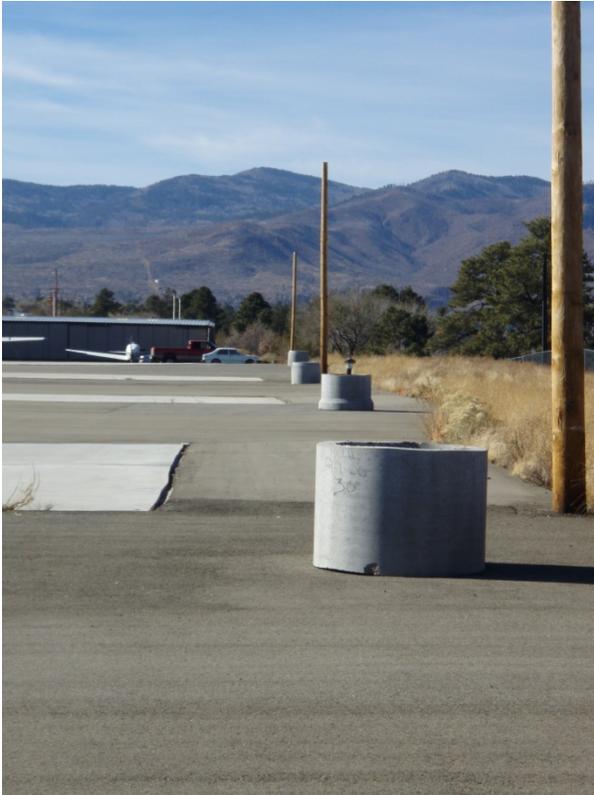
Figure 15 Gas vent locations; note missing risers and spinners

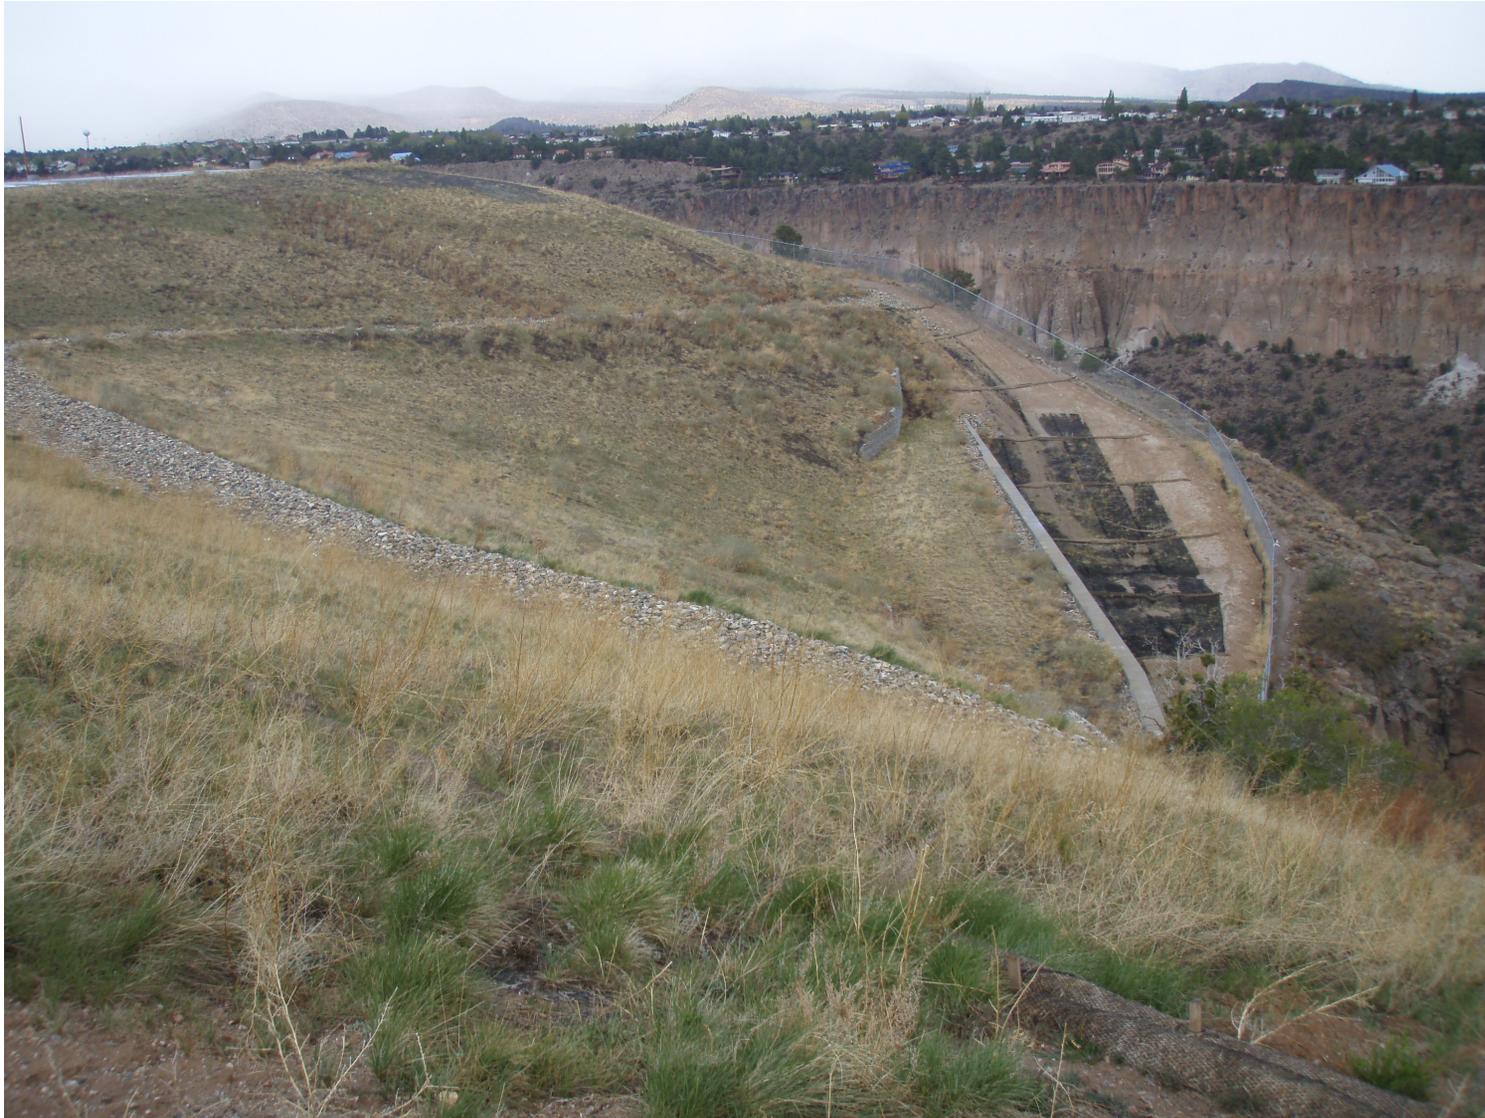
Looking NW at soil cap area. Note rill erosion and sediment movement in the straw wattle area near the boundary fence.

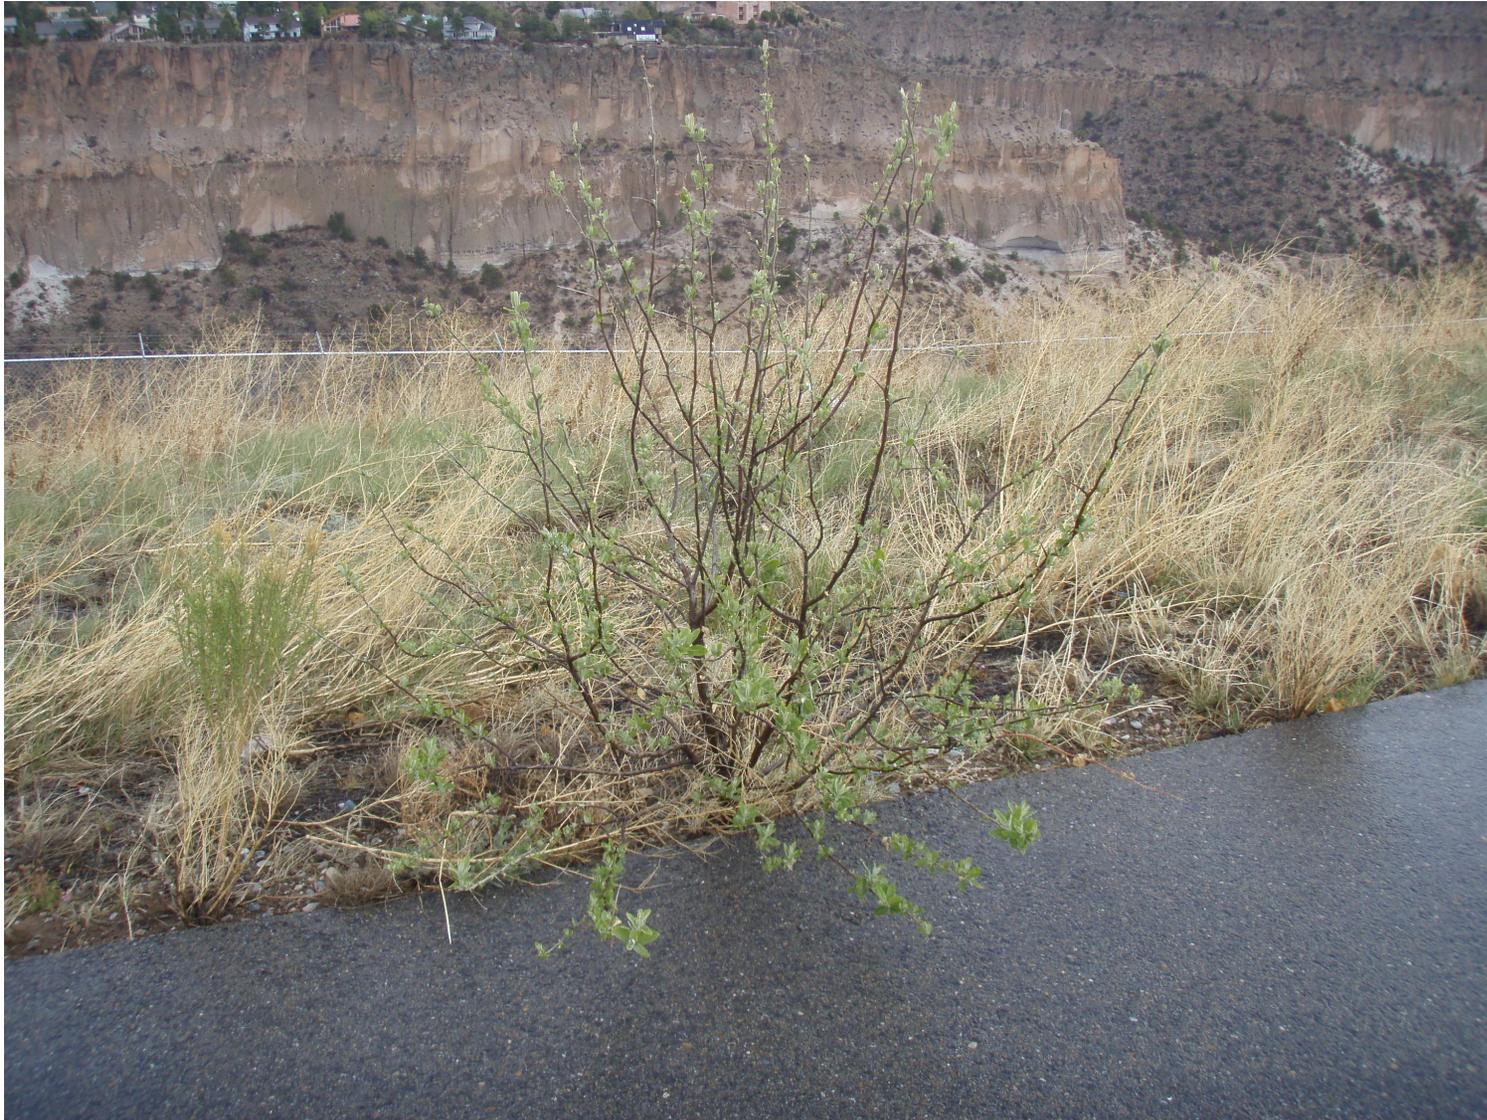
Tree growing along northern edge of MATCON pavement near pad #3. Will need to be removed.

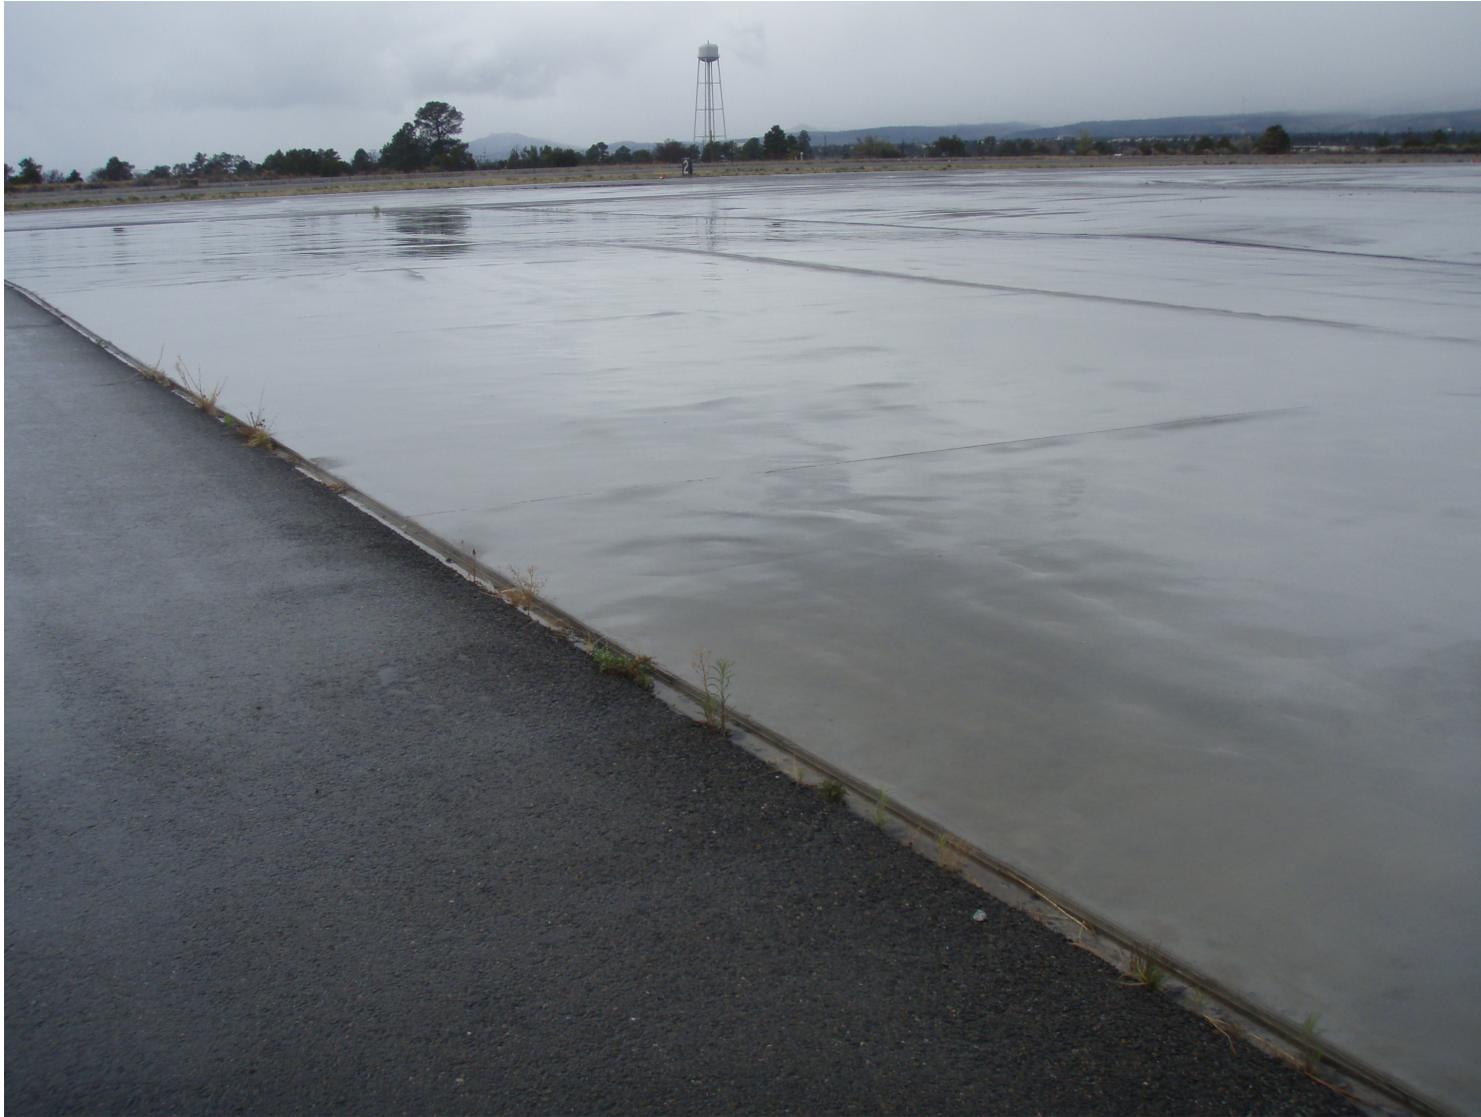
Vegetation along edge of pad and MATCON pavement

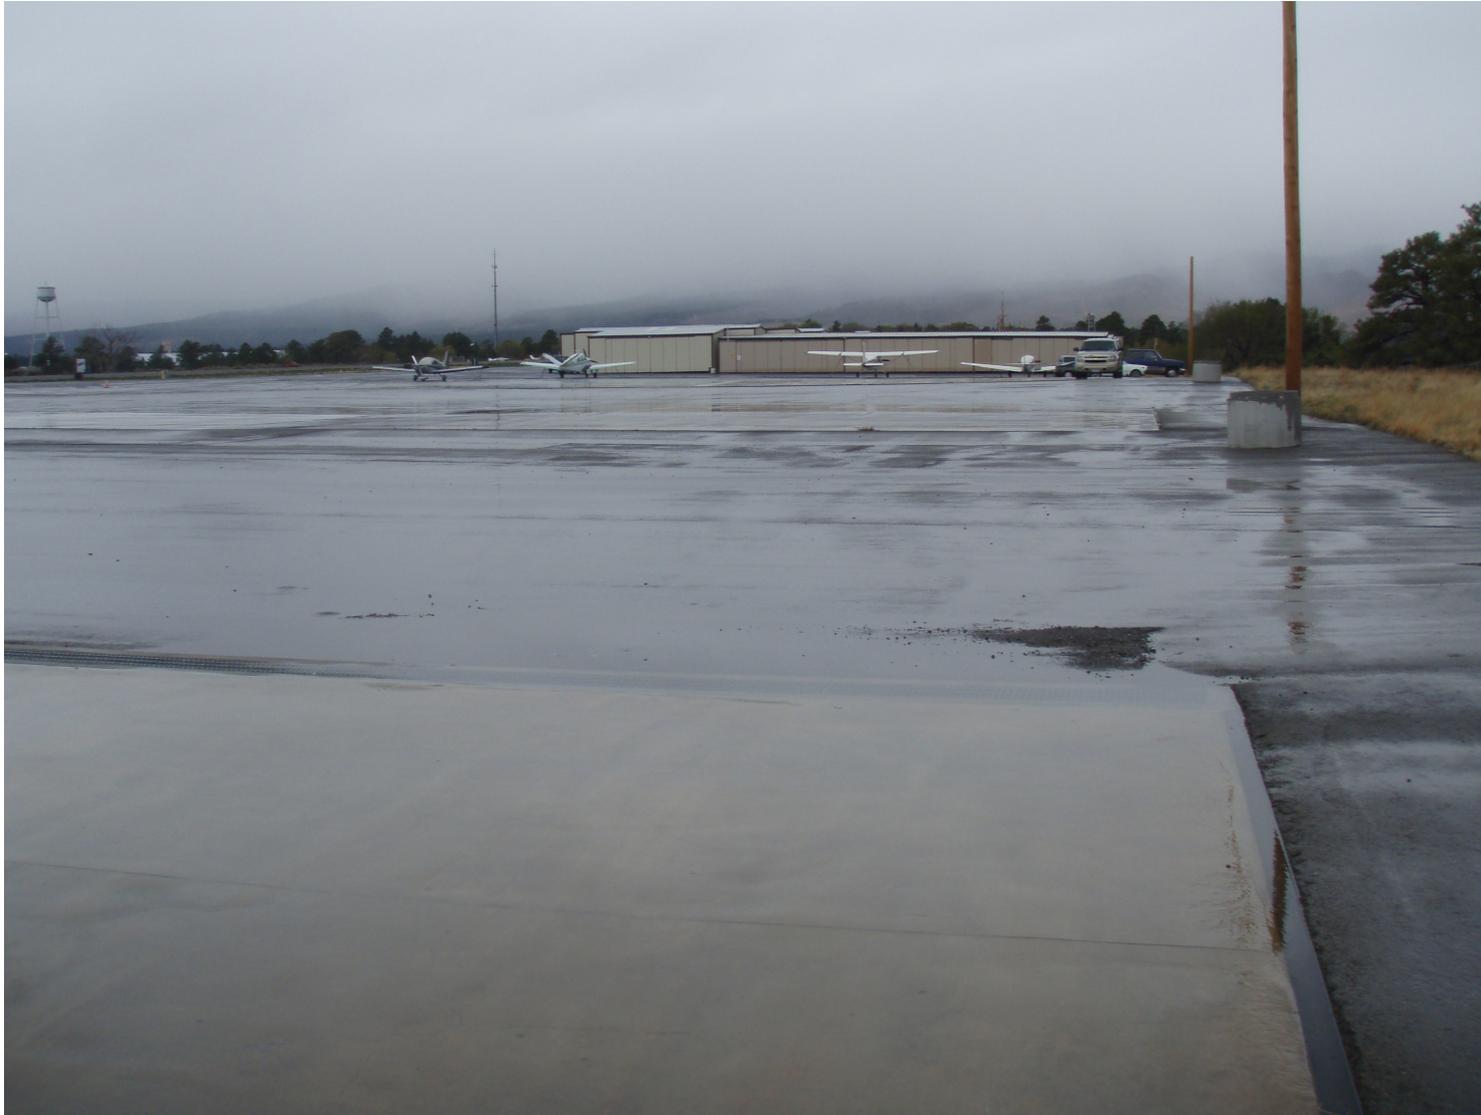
Looking west at NW corner of Pad #3, note large puddle. Subsidence does not allow for water to drain correctly in the trench drain.

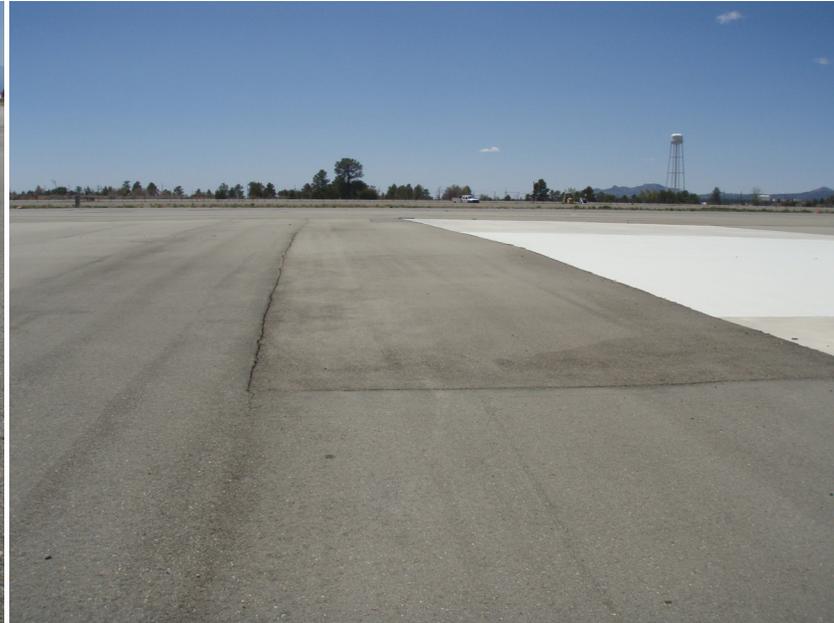
Photo # 2

Cracking in MATCON pavement. Cracks have been note up to 1 inch wide, 5 inches deep and over 100 feet in length.

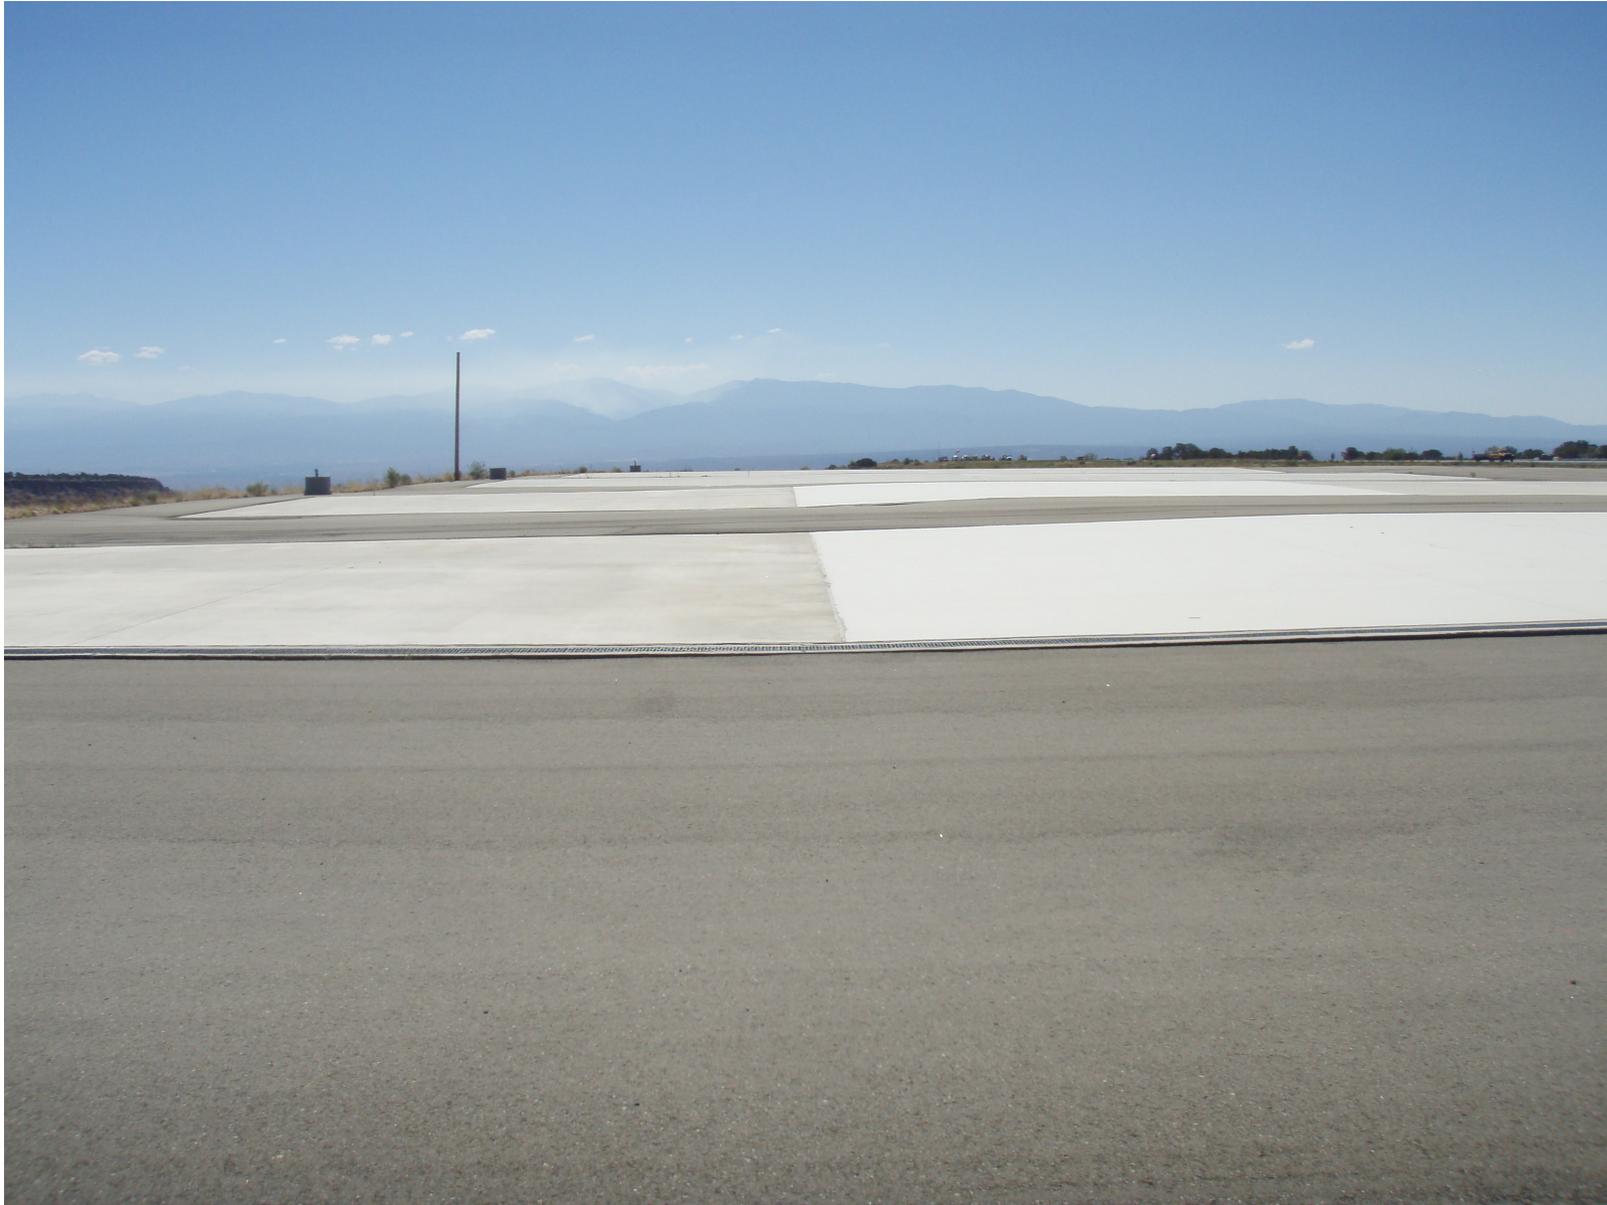
Photo 1: Looking east at pads 2-5, note uneven nature of pads and Matcon asphalt.

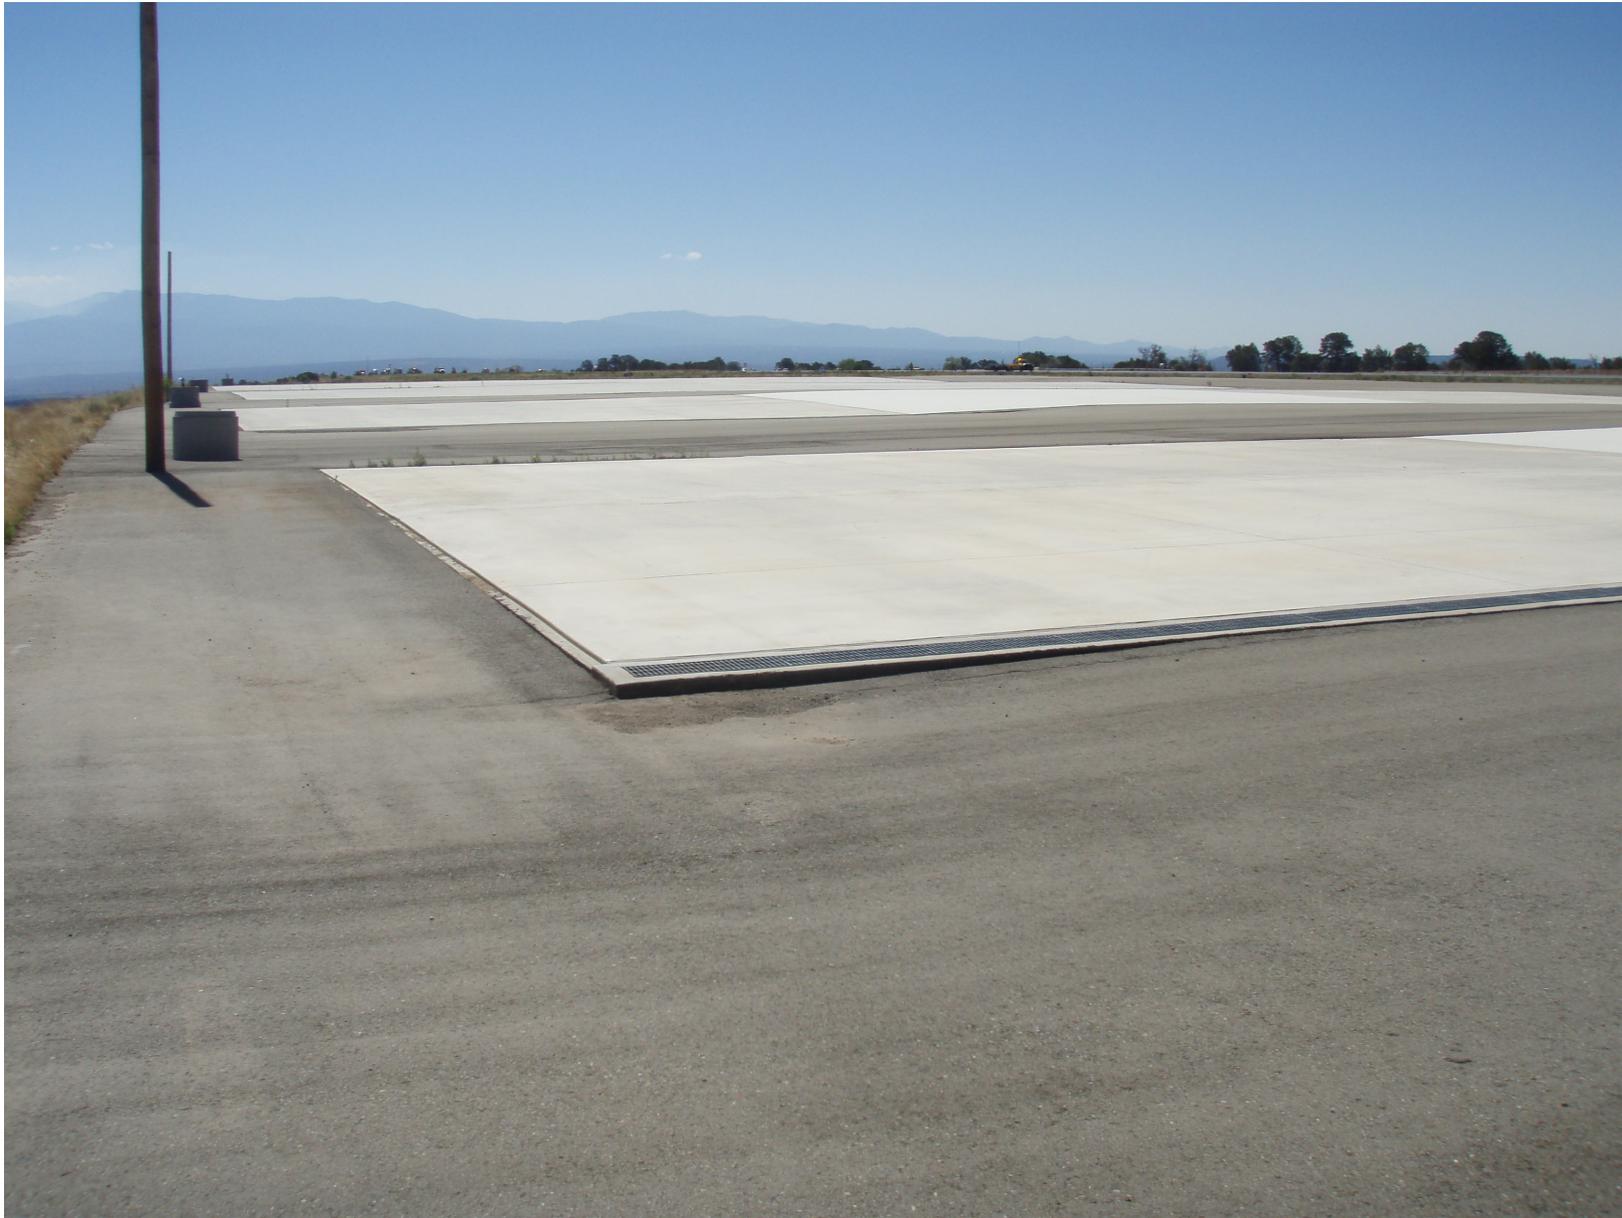
Photo 2: NW corner of pad 2, note subsidence of Matcon and drainage problems.

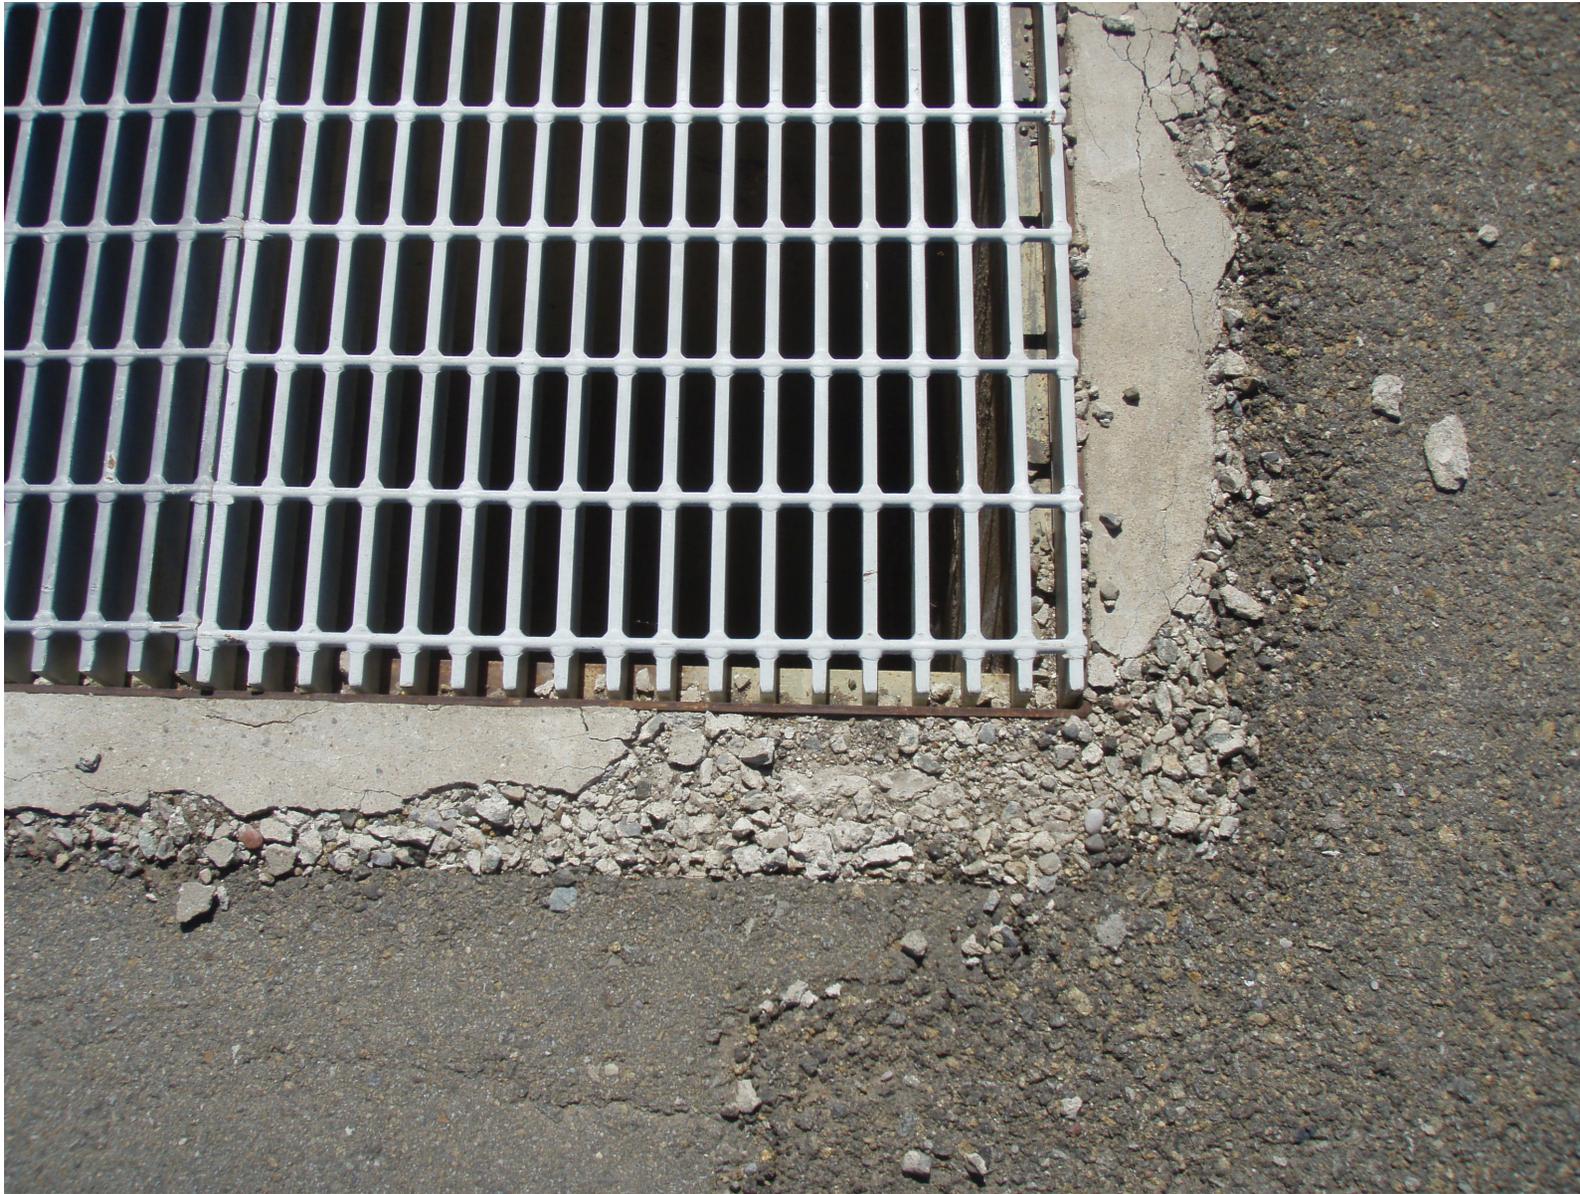
Photo 14: Concrete at drop inlet
