**Subject: Submittal of the 2011 Annual Inspection Report for Los Alamos County
Airport Landfill, Solid Waste Management Units 73-001(a) and 73-001(d),
Technical Area 73**

LA-UR-12-0671
February 2012
EP2012-0018

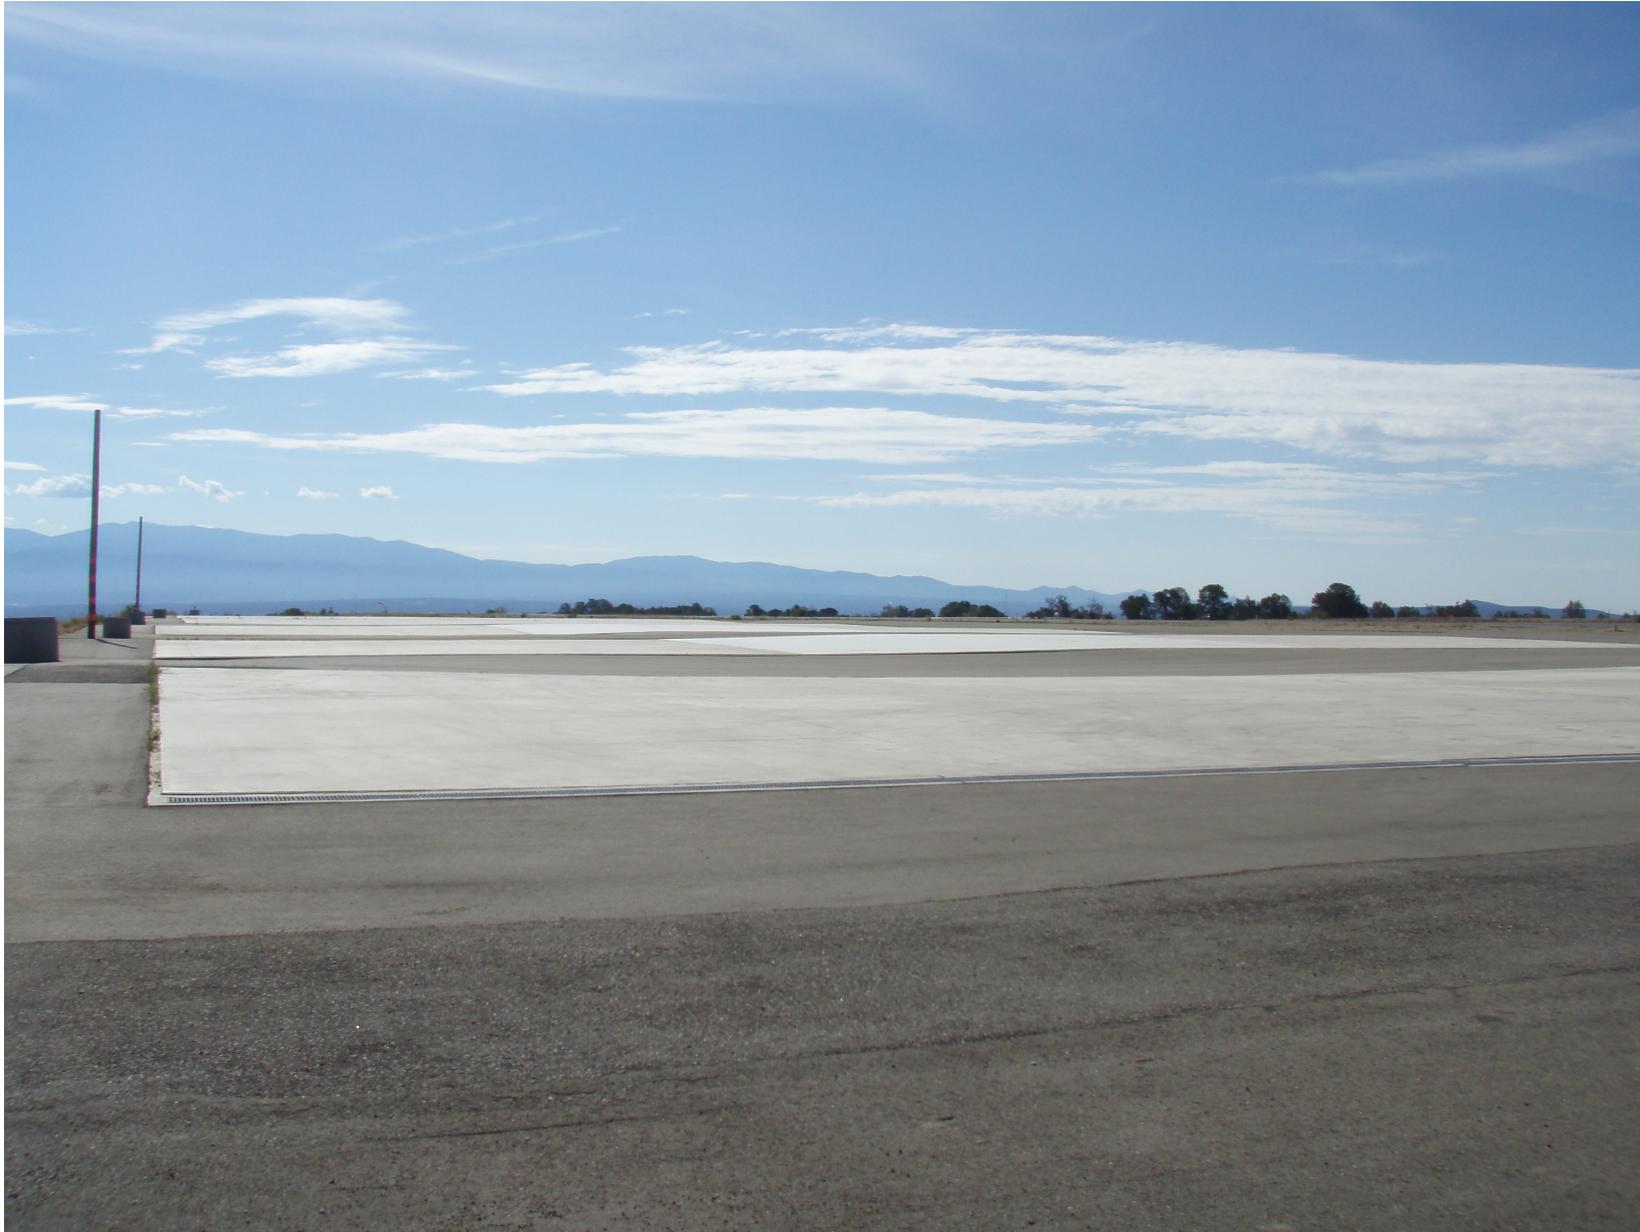
Photo 1: Southeast view of concrete hanger pads. Note wavy nature of MatCon and pads.

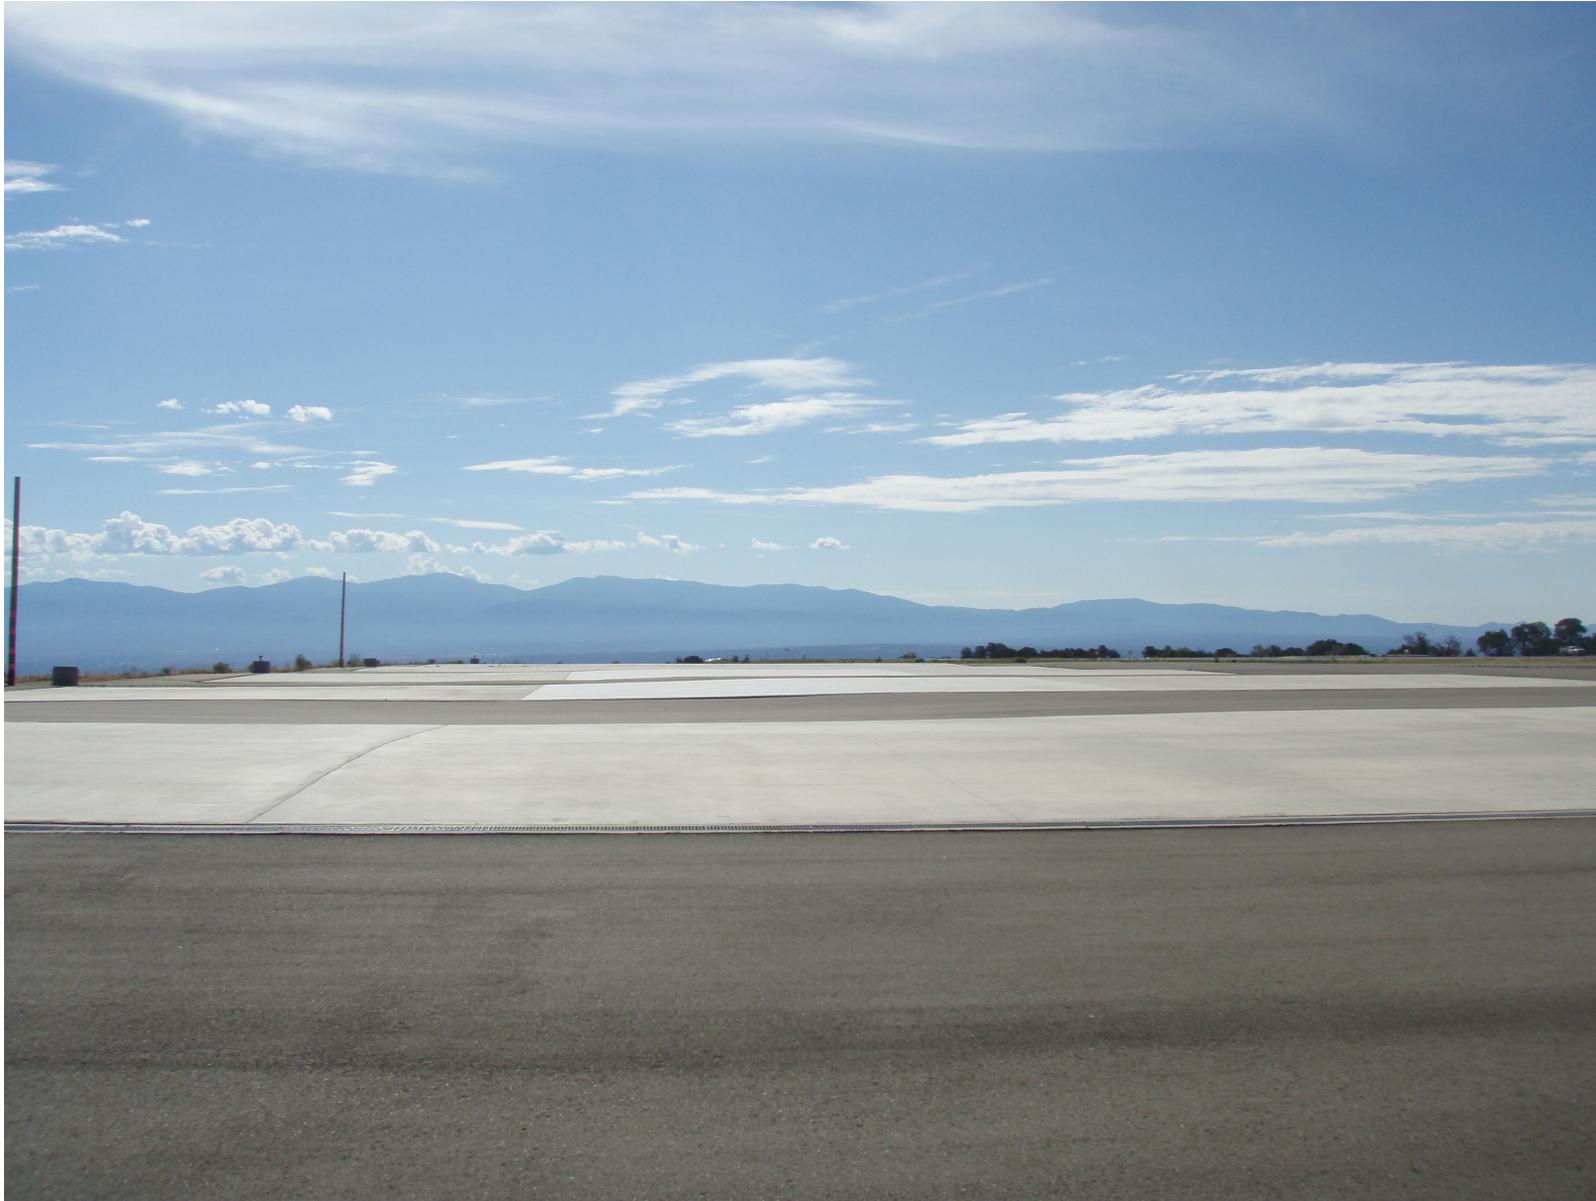
Photo 2: East view of pads.

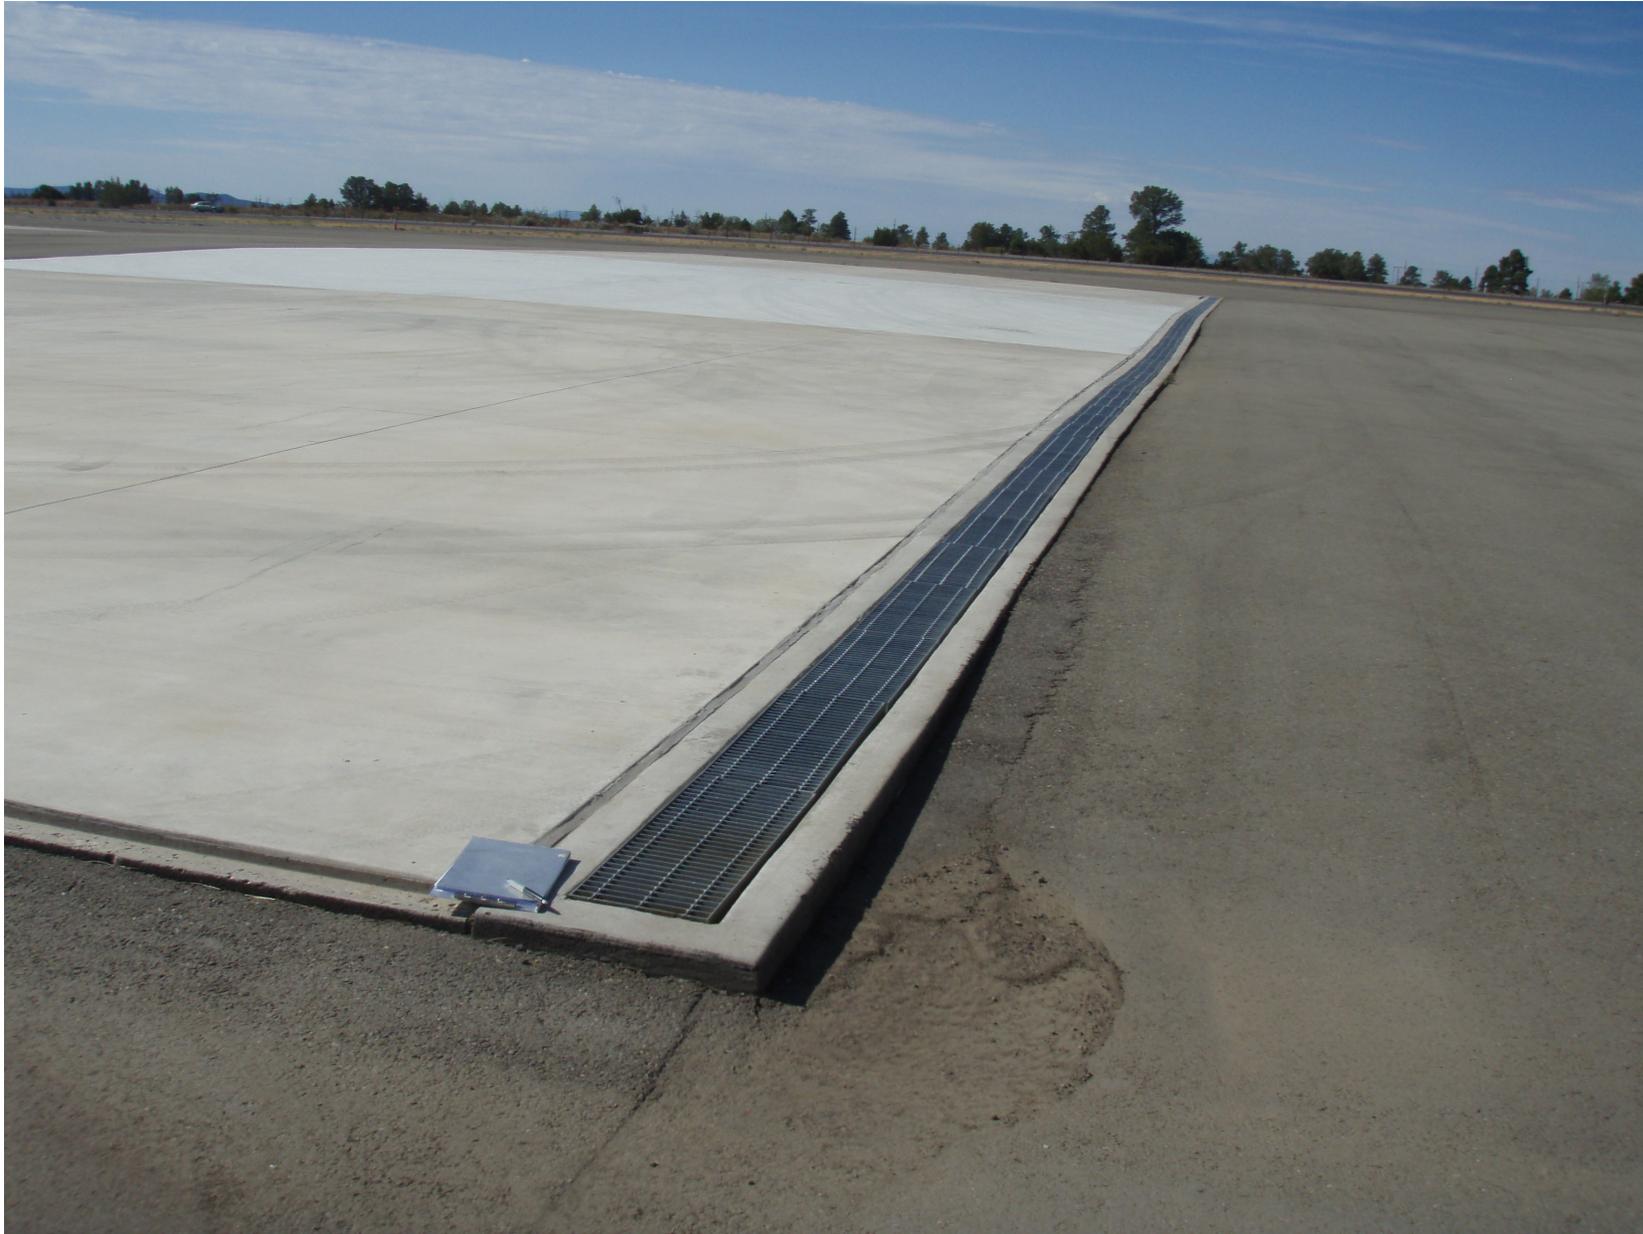
Photo 6: Northeast corner of pad #2.

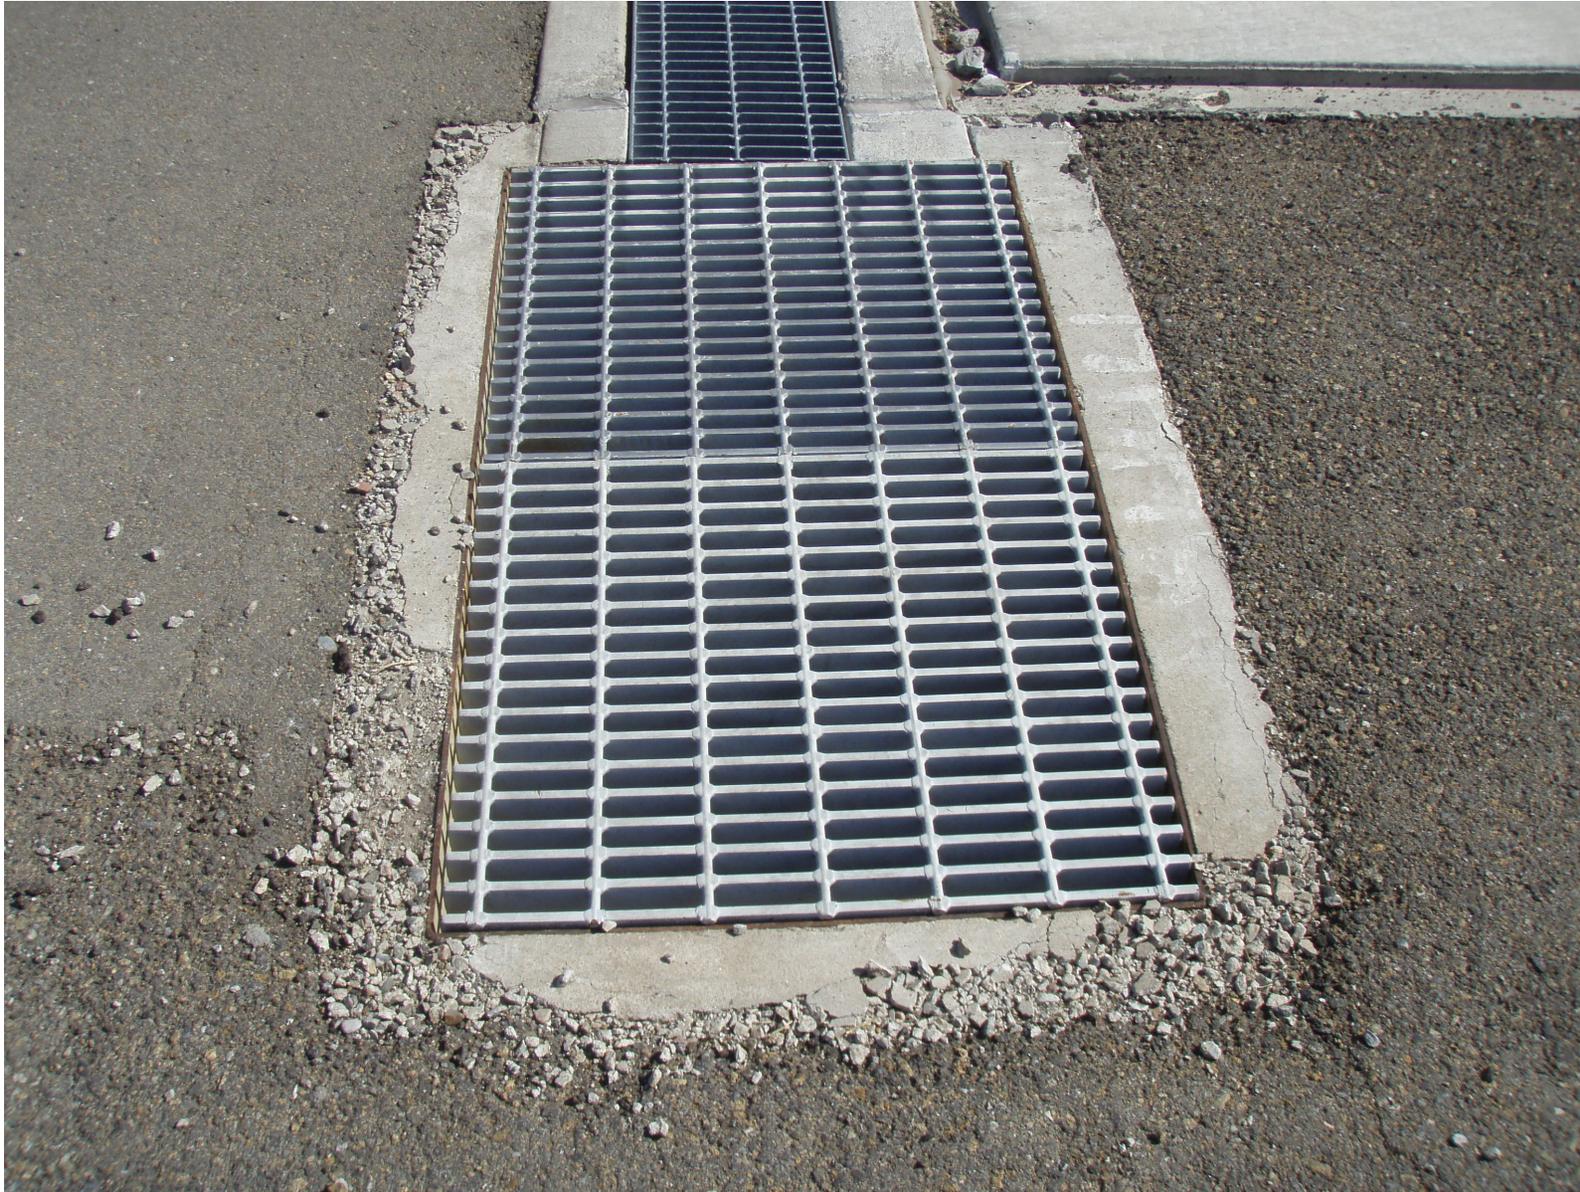
Photo 8: Drop inlet at Southwest corner of pad #3.

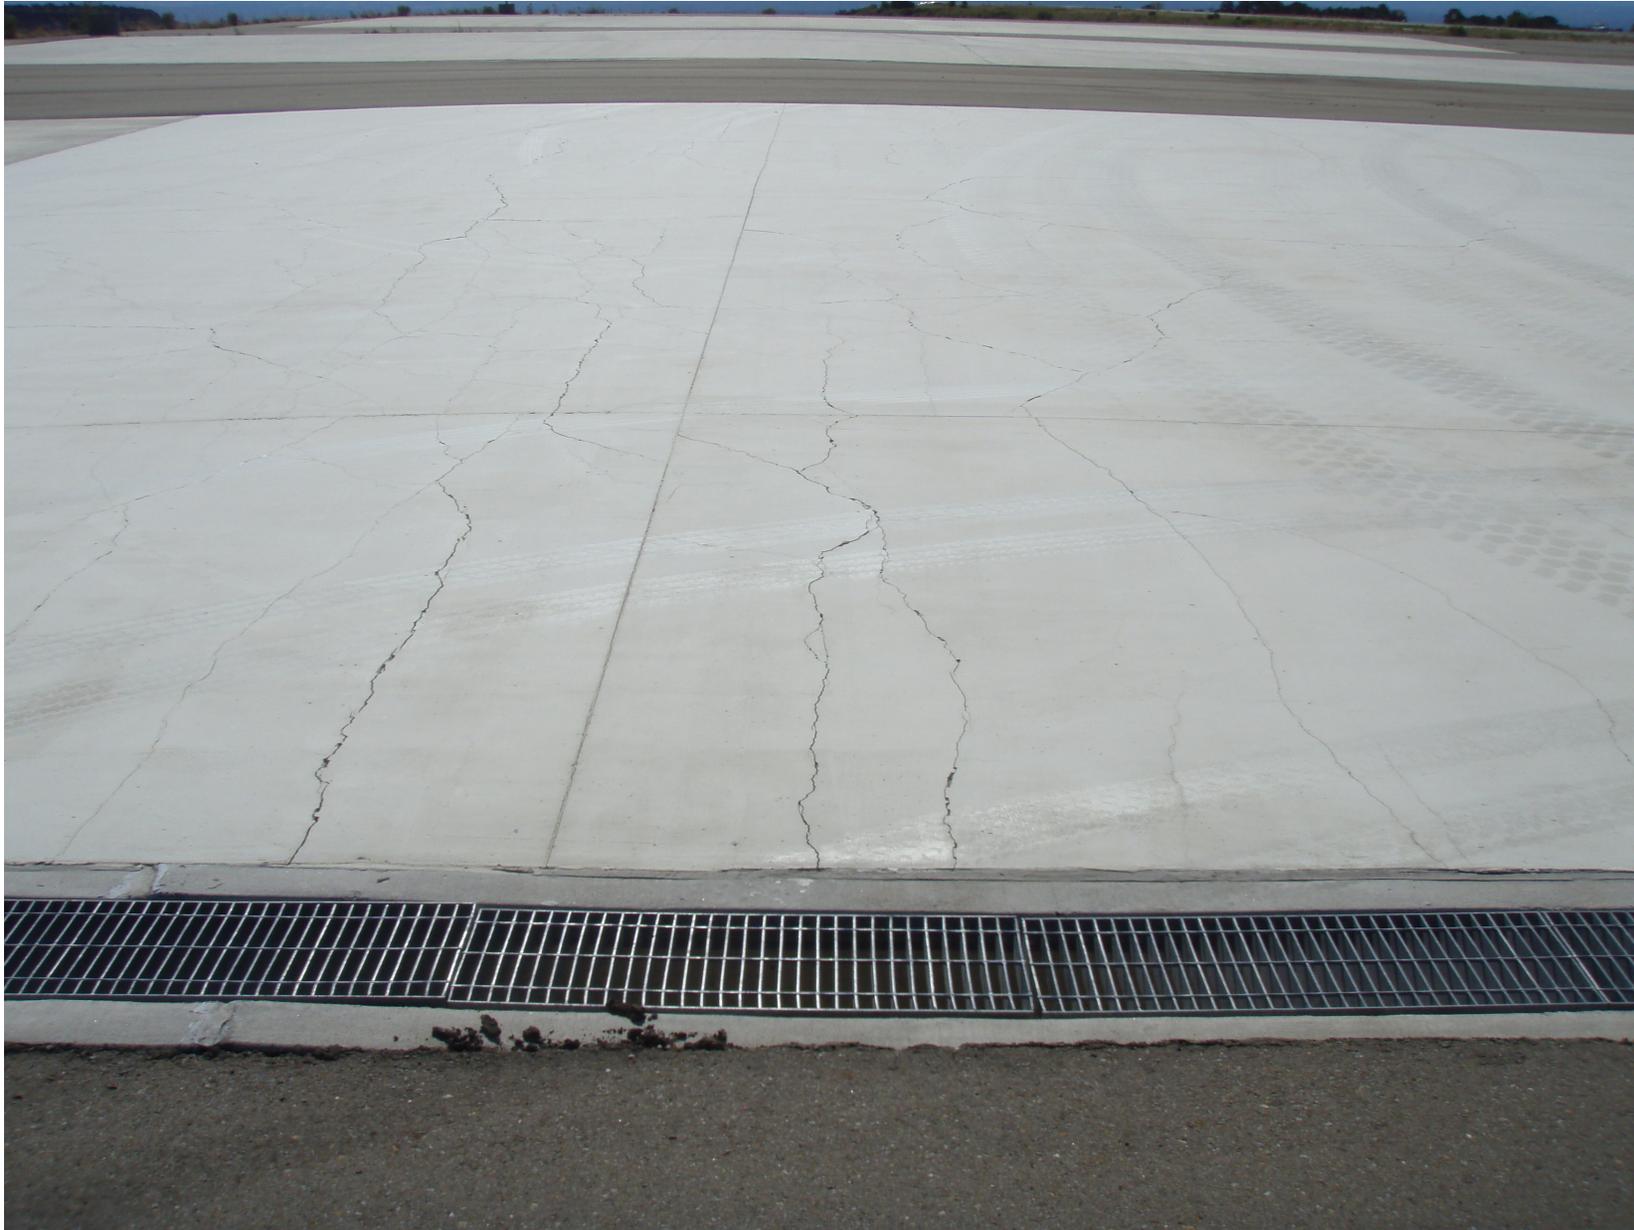
Photo 9: East view of pad #3.

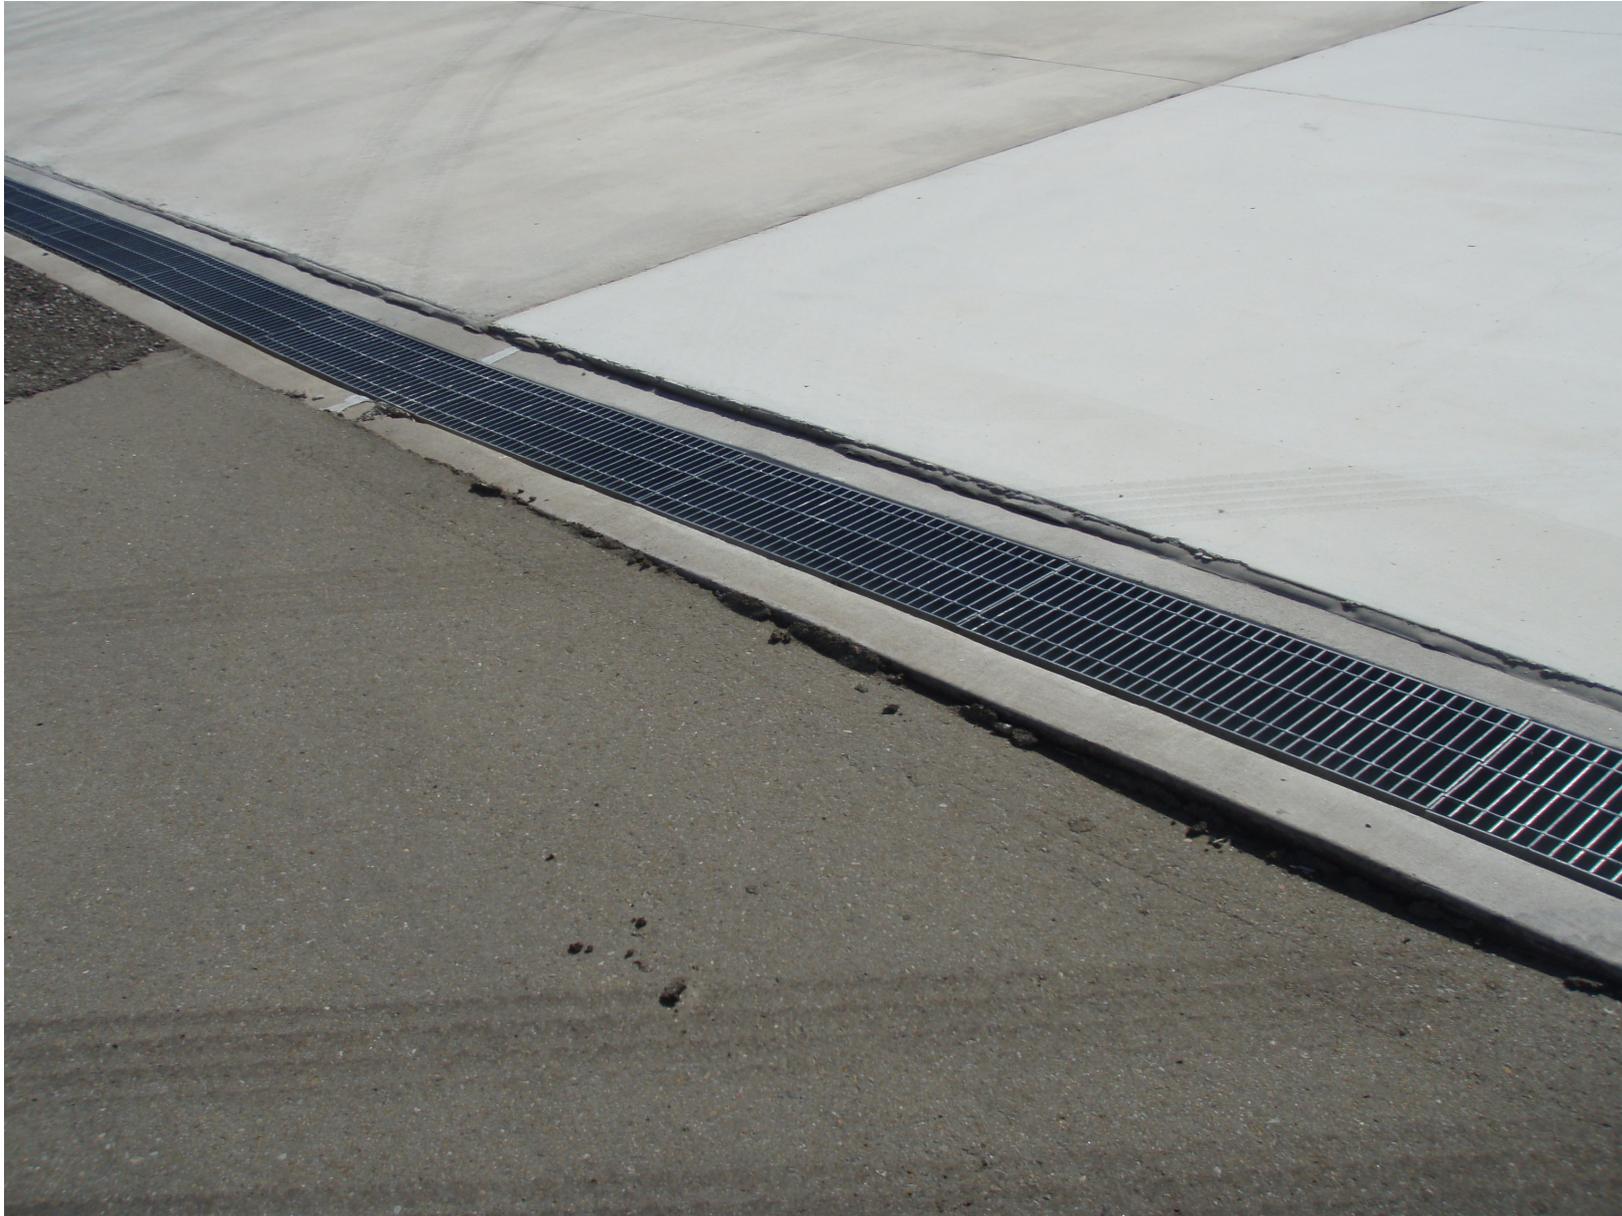
Photo 10: Trench drain at pad #3, note rising and subsidence.

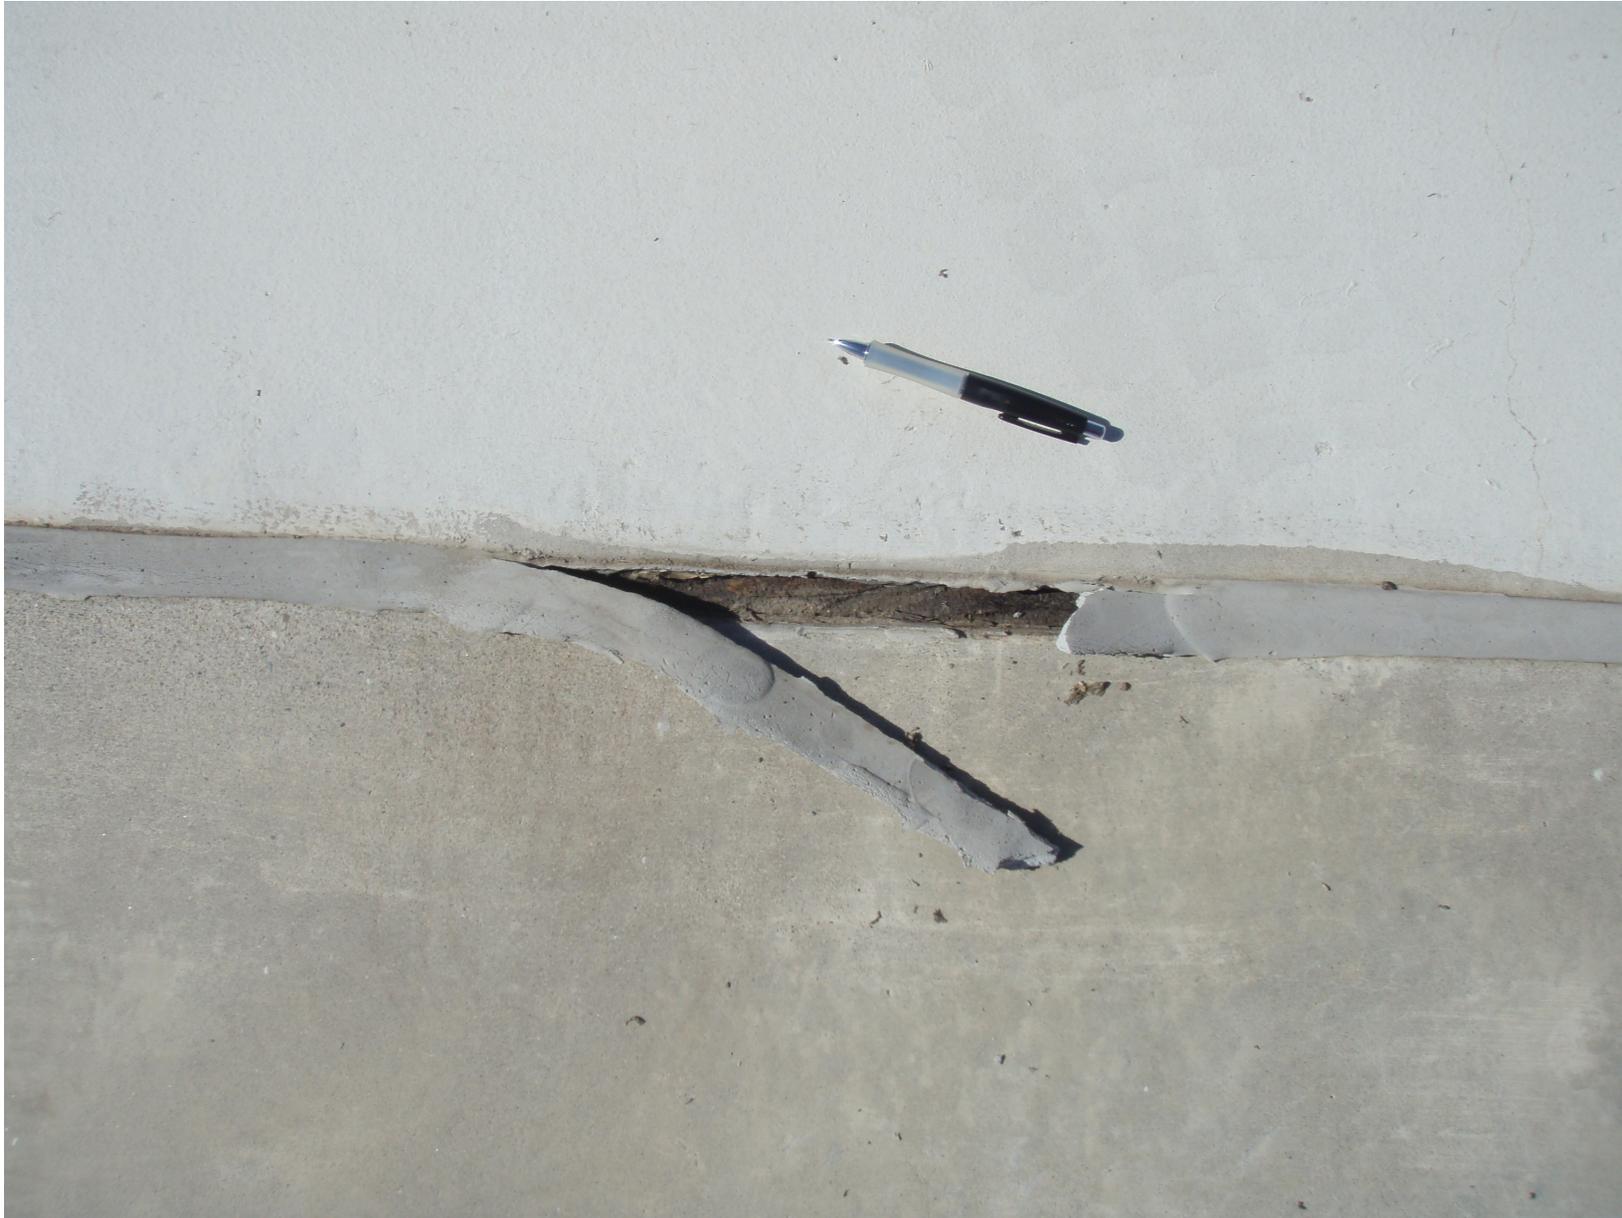
Photo 11: Seal in pad #3.

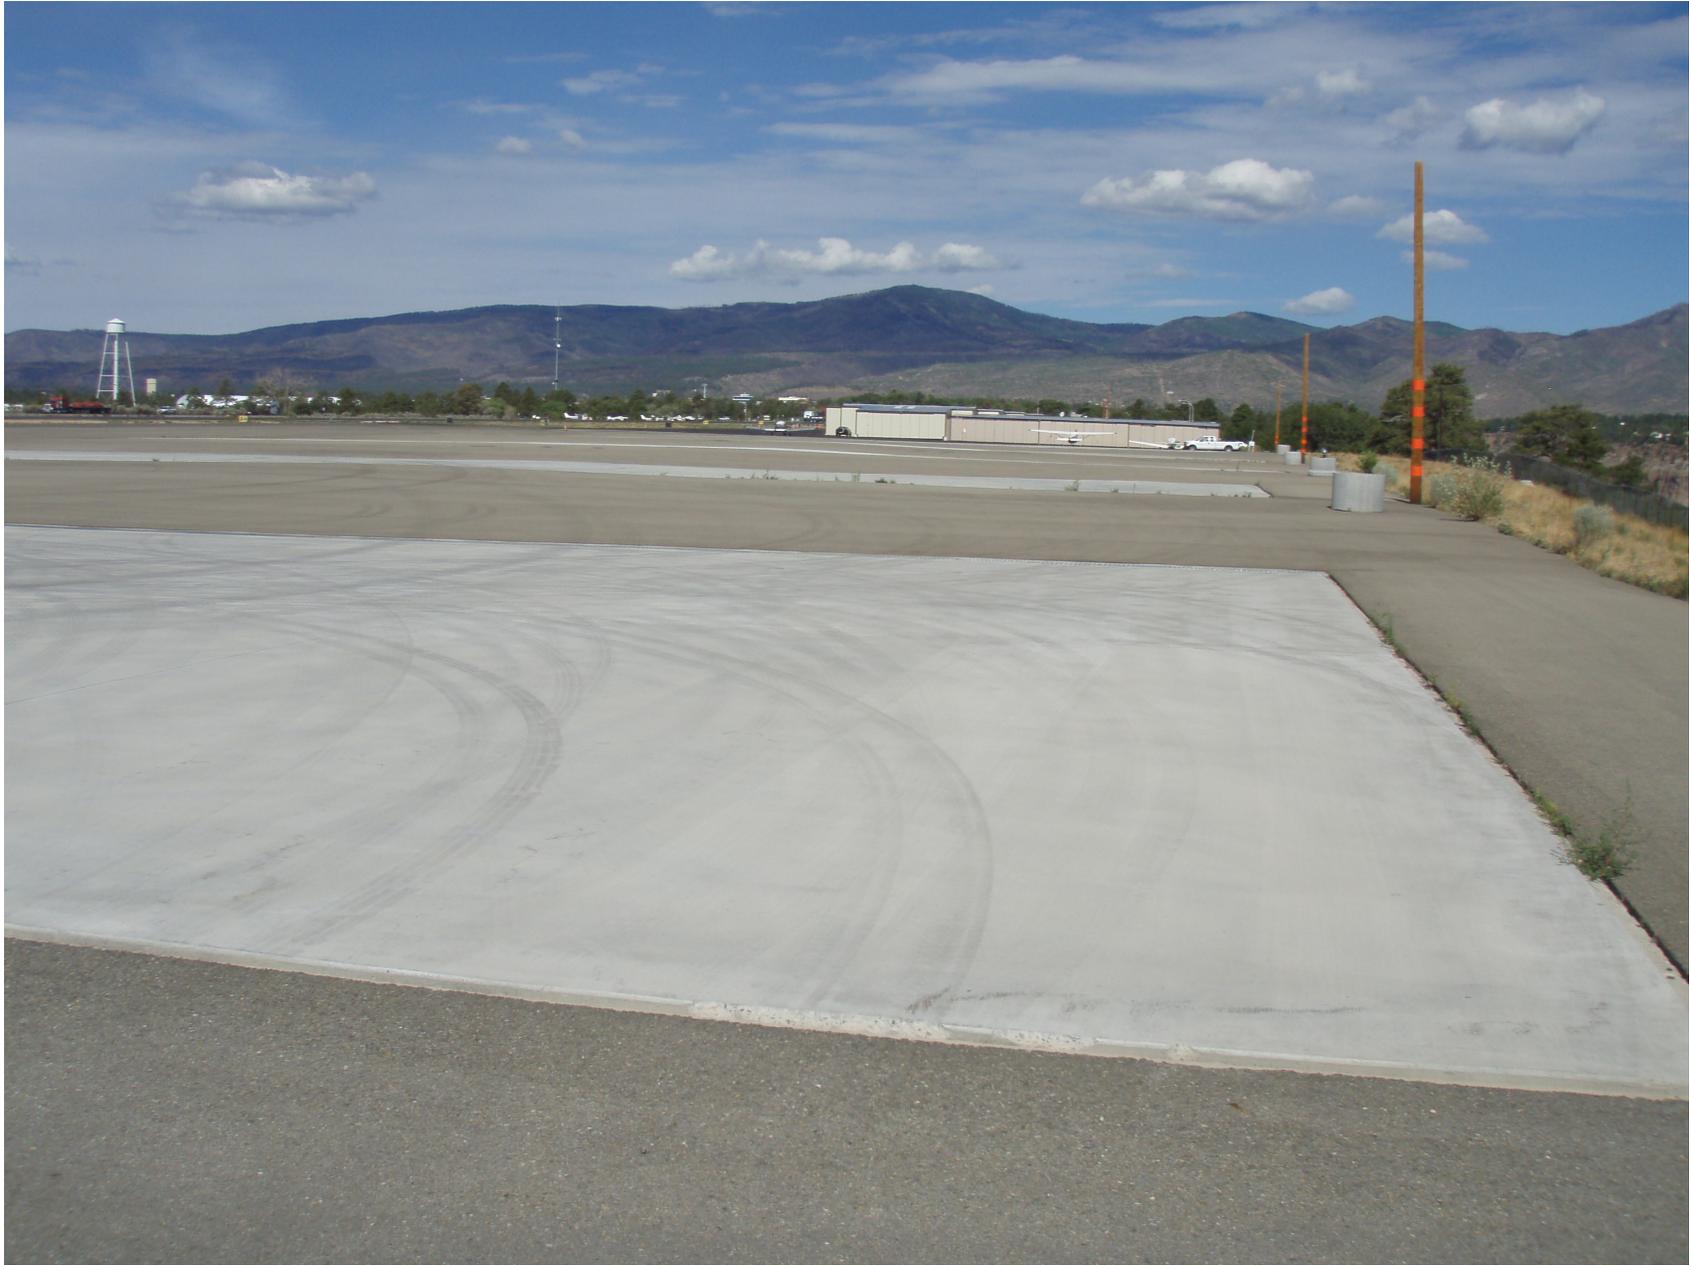
Photo 16: West view from pad #5.

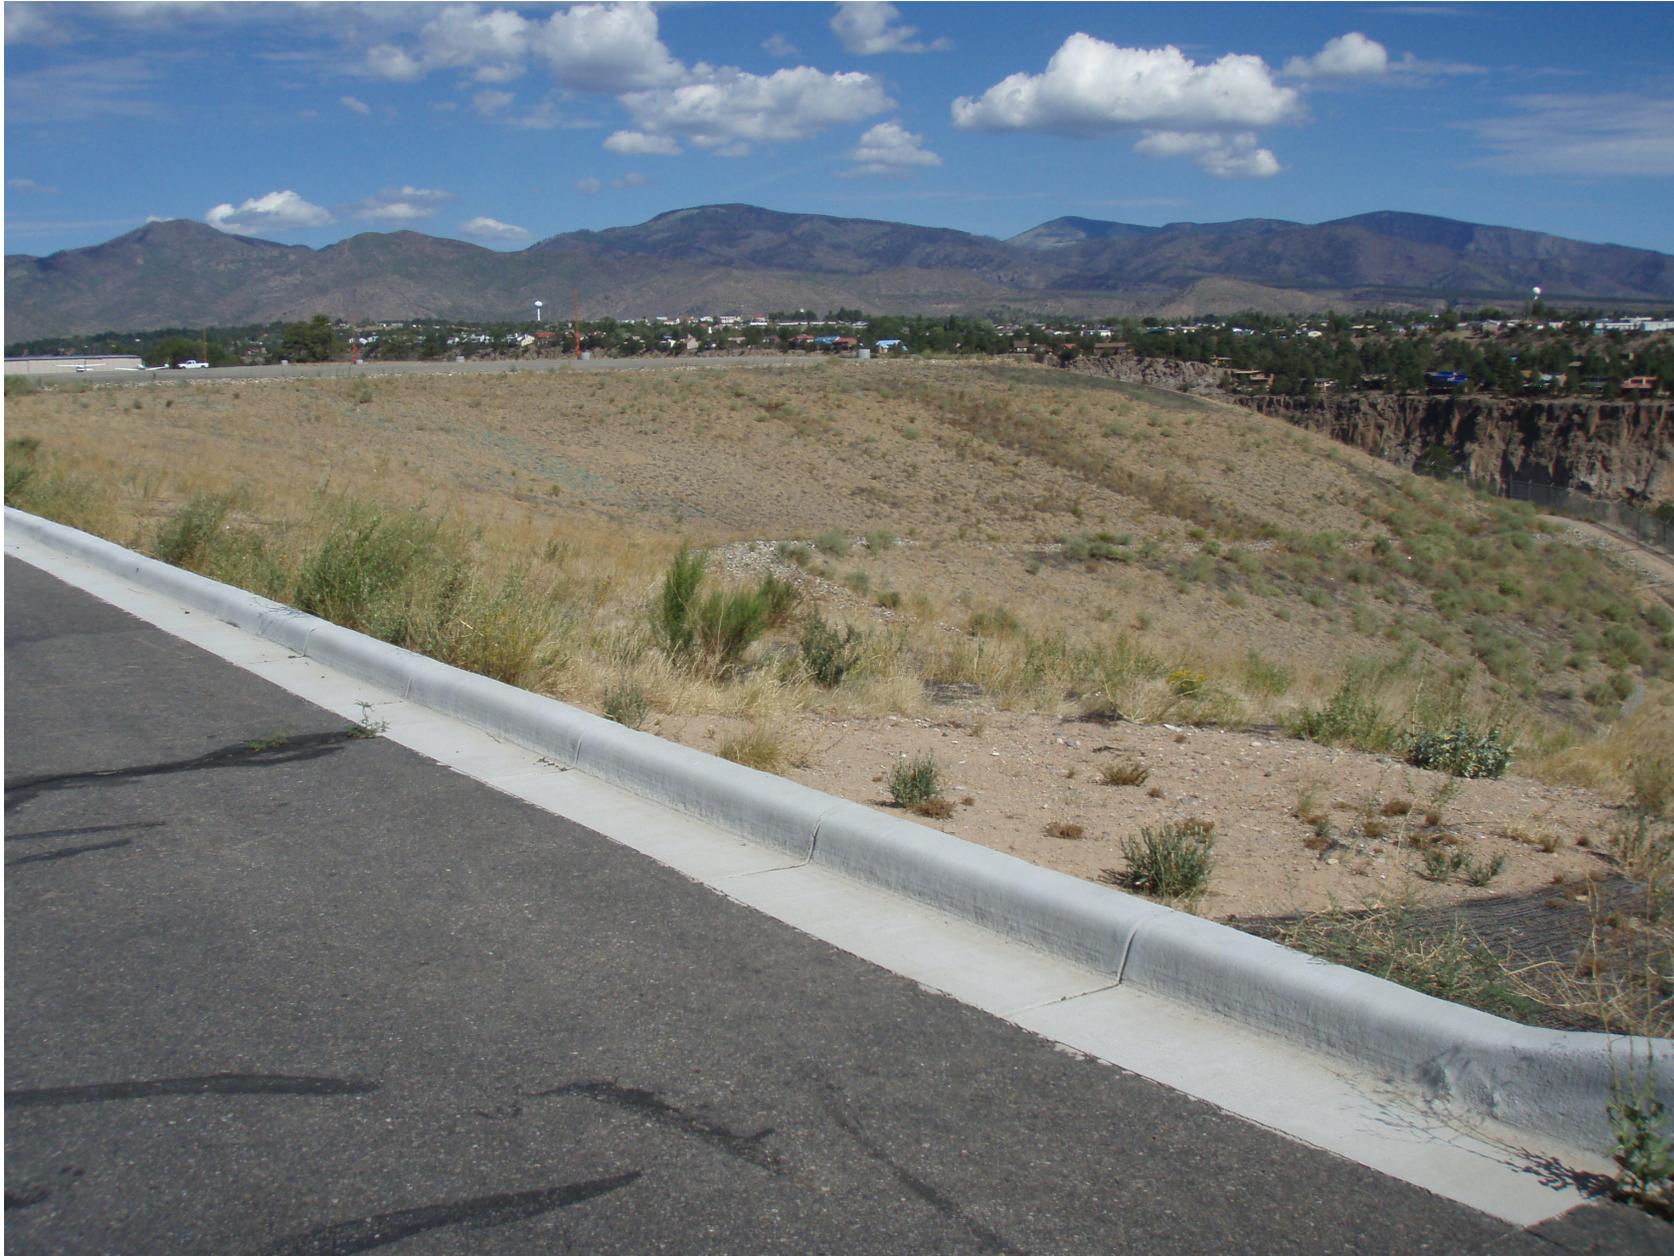
Photo 17: View of vegetative cap, no significant precipitation for over 90 days.

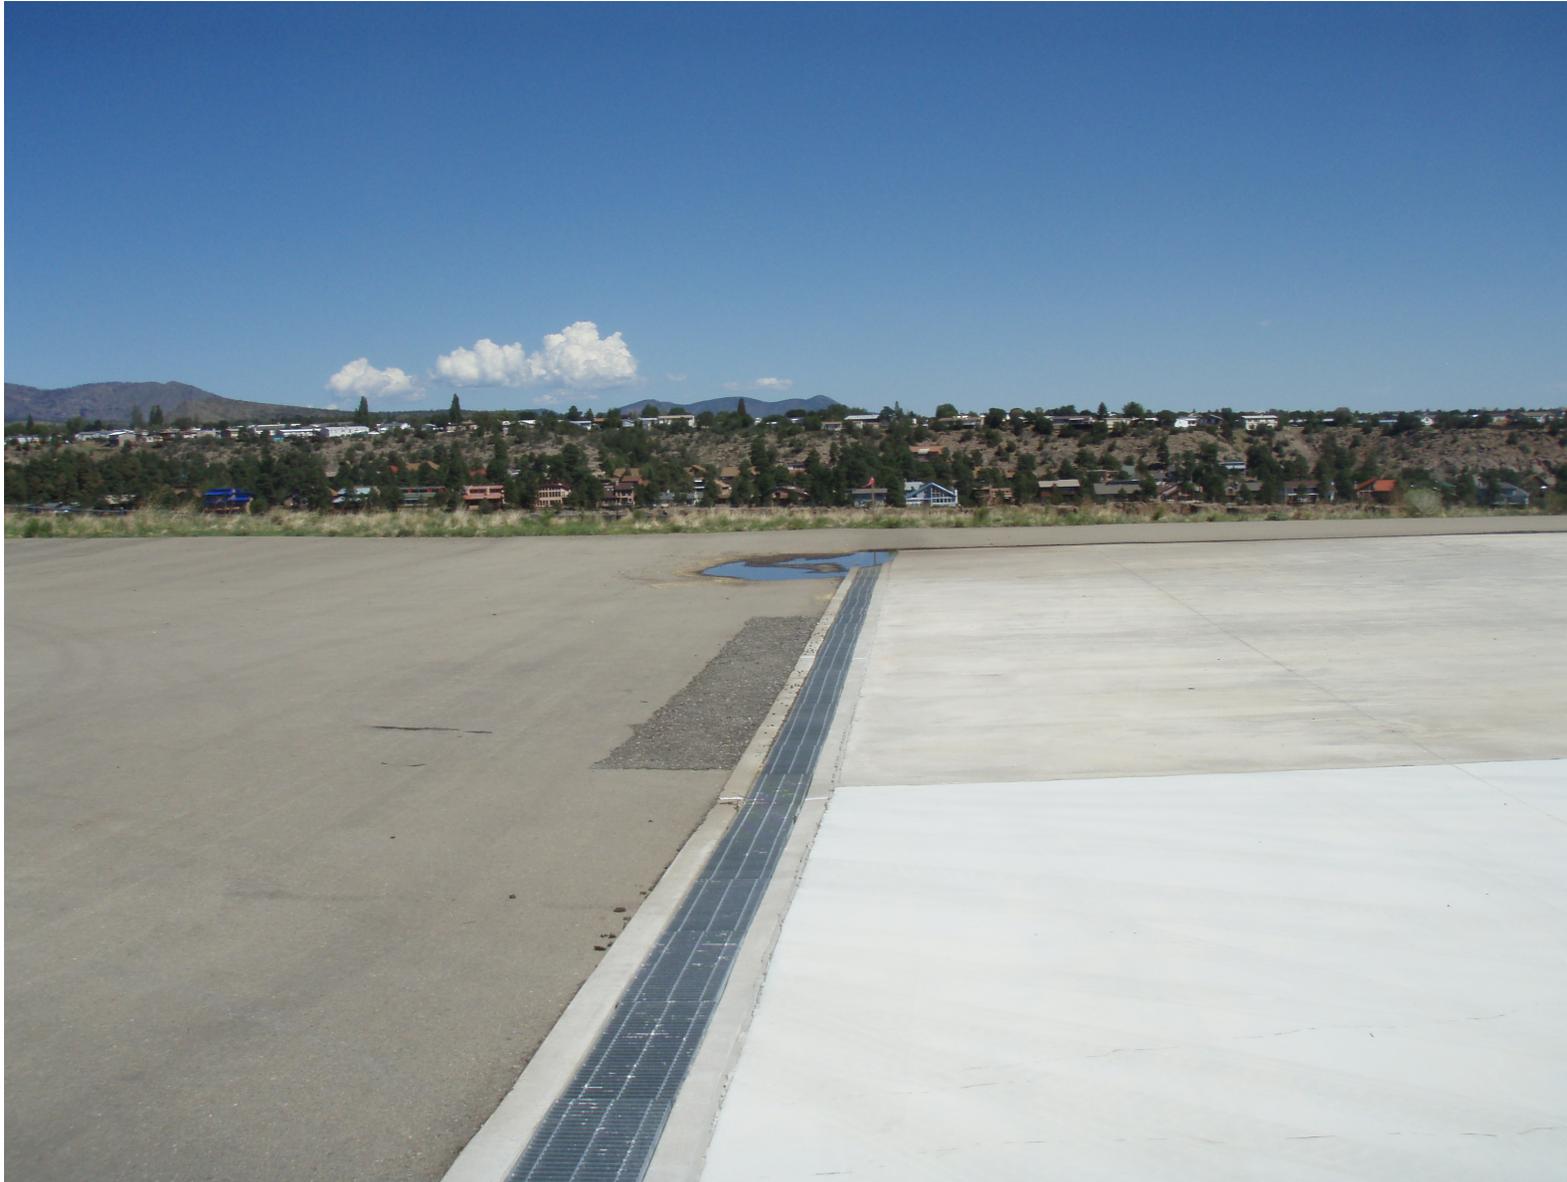
Photo # 1: North view of pad #3. Note Matcon patch, subsidence and puddle at end of trench drain.

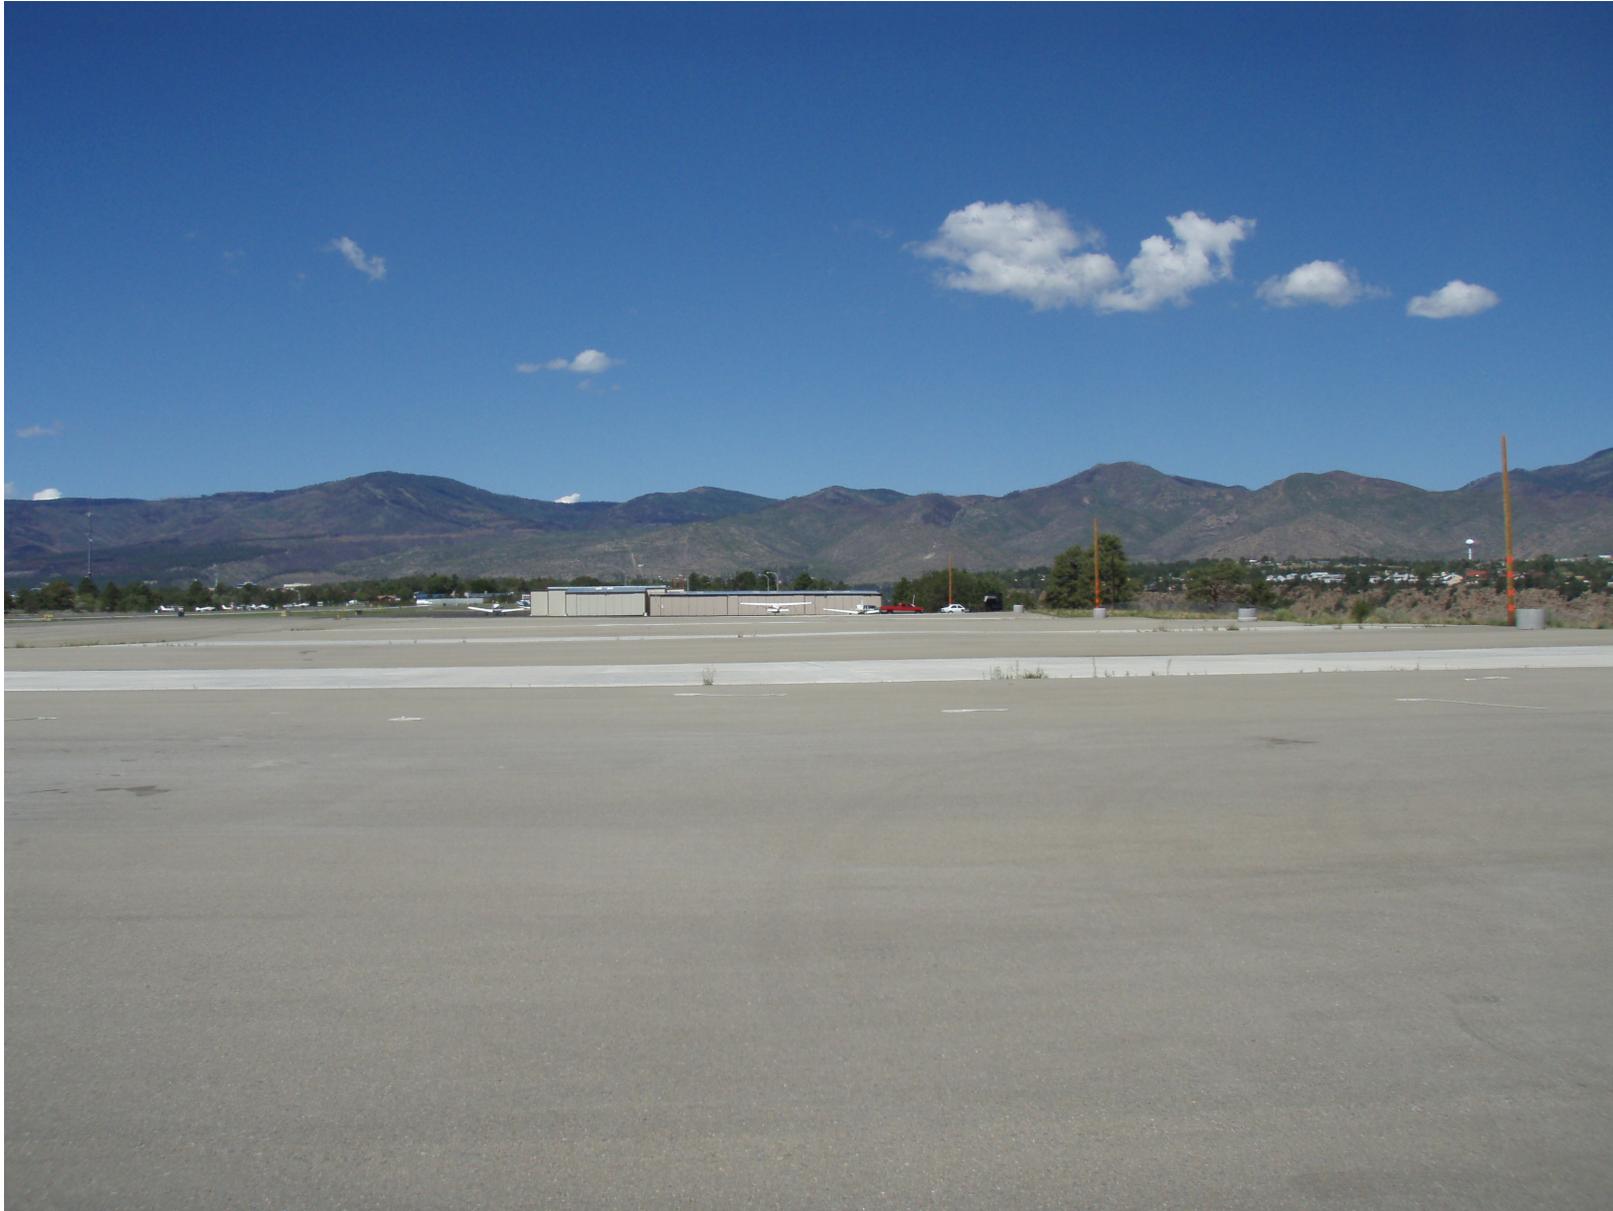
Photo # 3: View west of hanger pad and Matcon.
