**Subject: Submittal of the 2011 Annual Inspection Report for Los Alamos County
Airport Landfill, Solid Waste Management Units 73-001(a) and 73-001(d),
Technical Area 73**

LA-UR-12-0671
February 2012
EP2012-0018

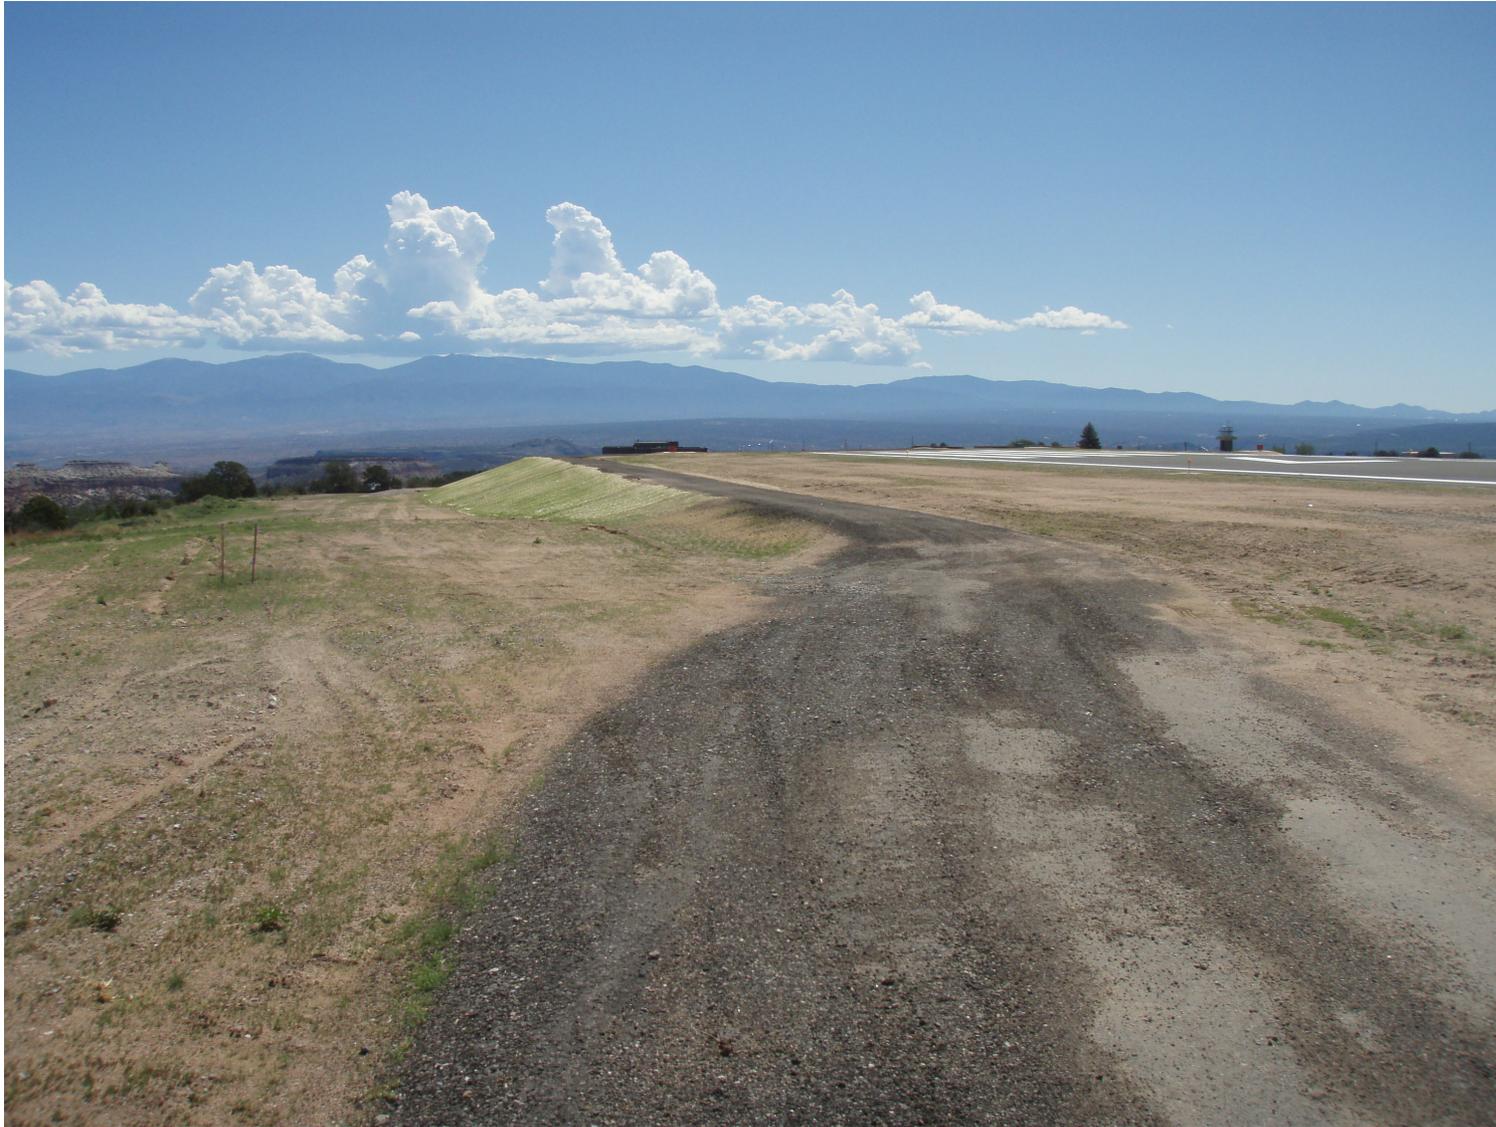
Photo # 4: East view of the Debris disposal area with the runway extension over top.

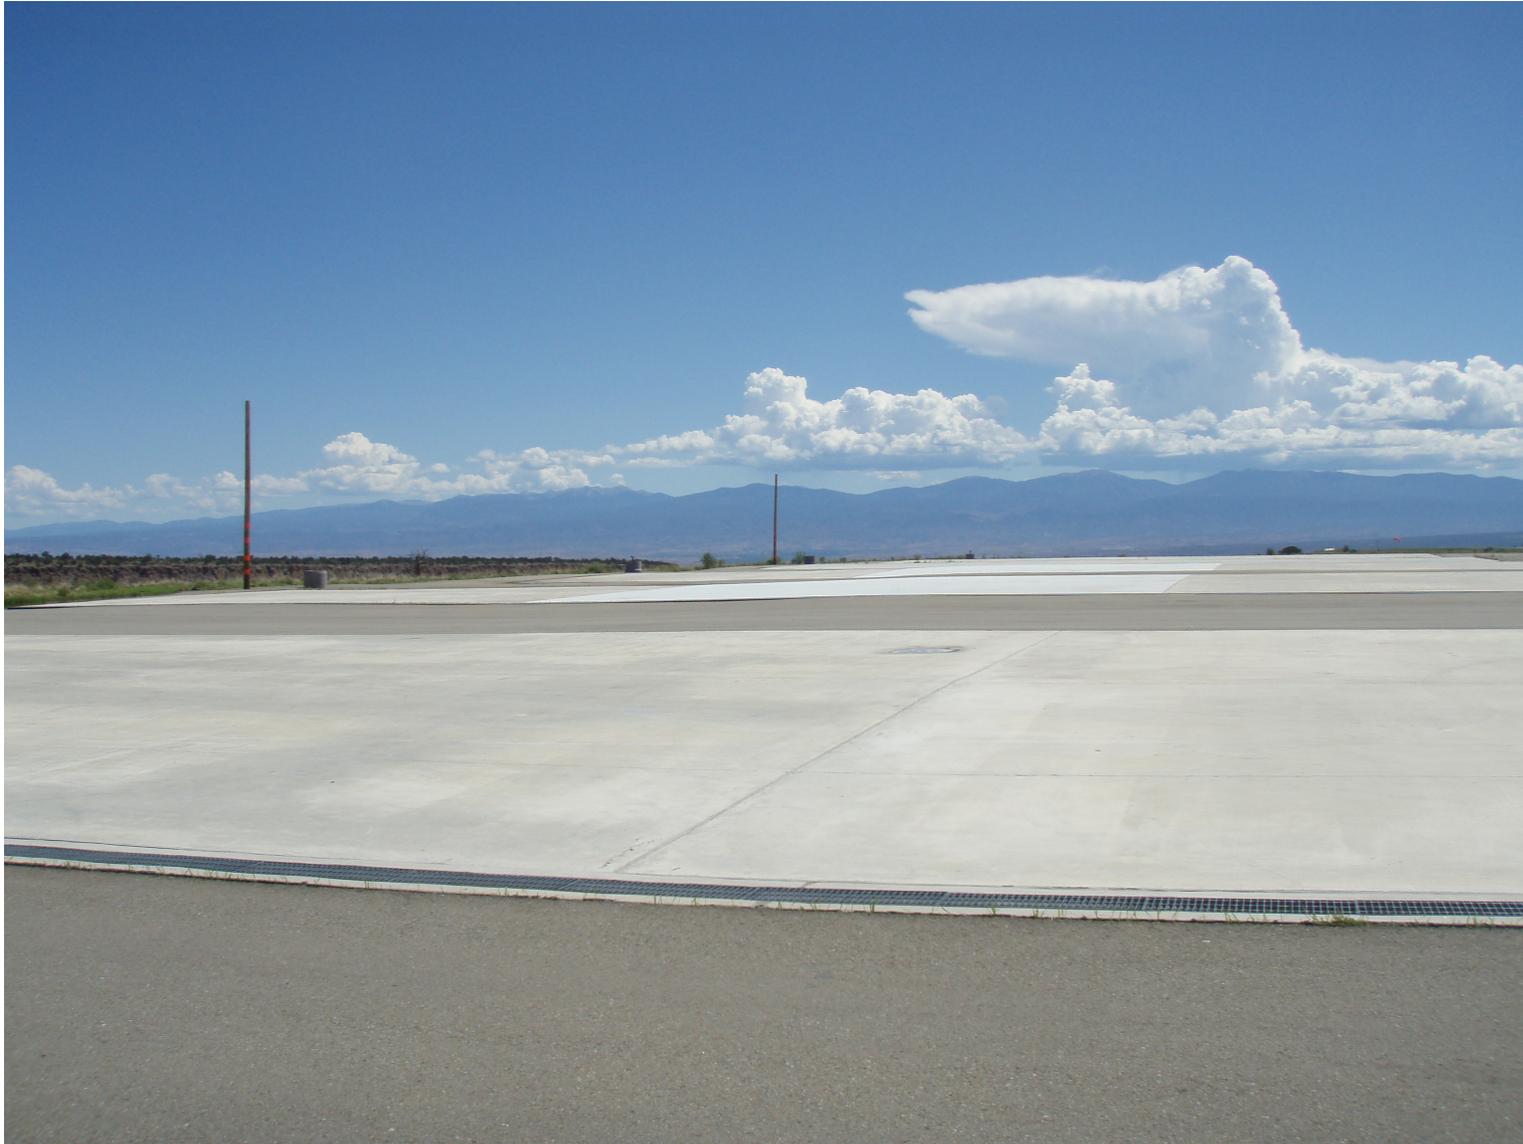
Photo # 5: NE view from pad # 1.

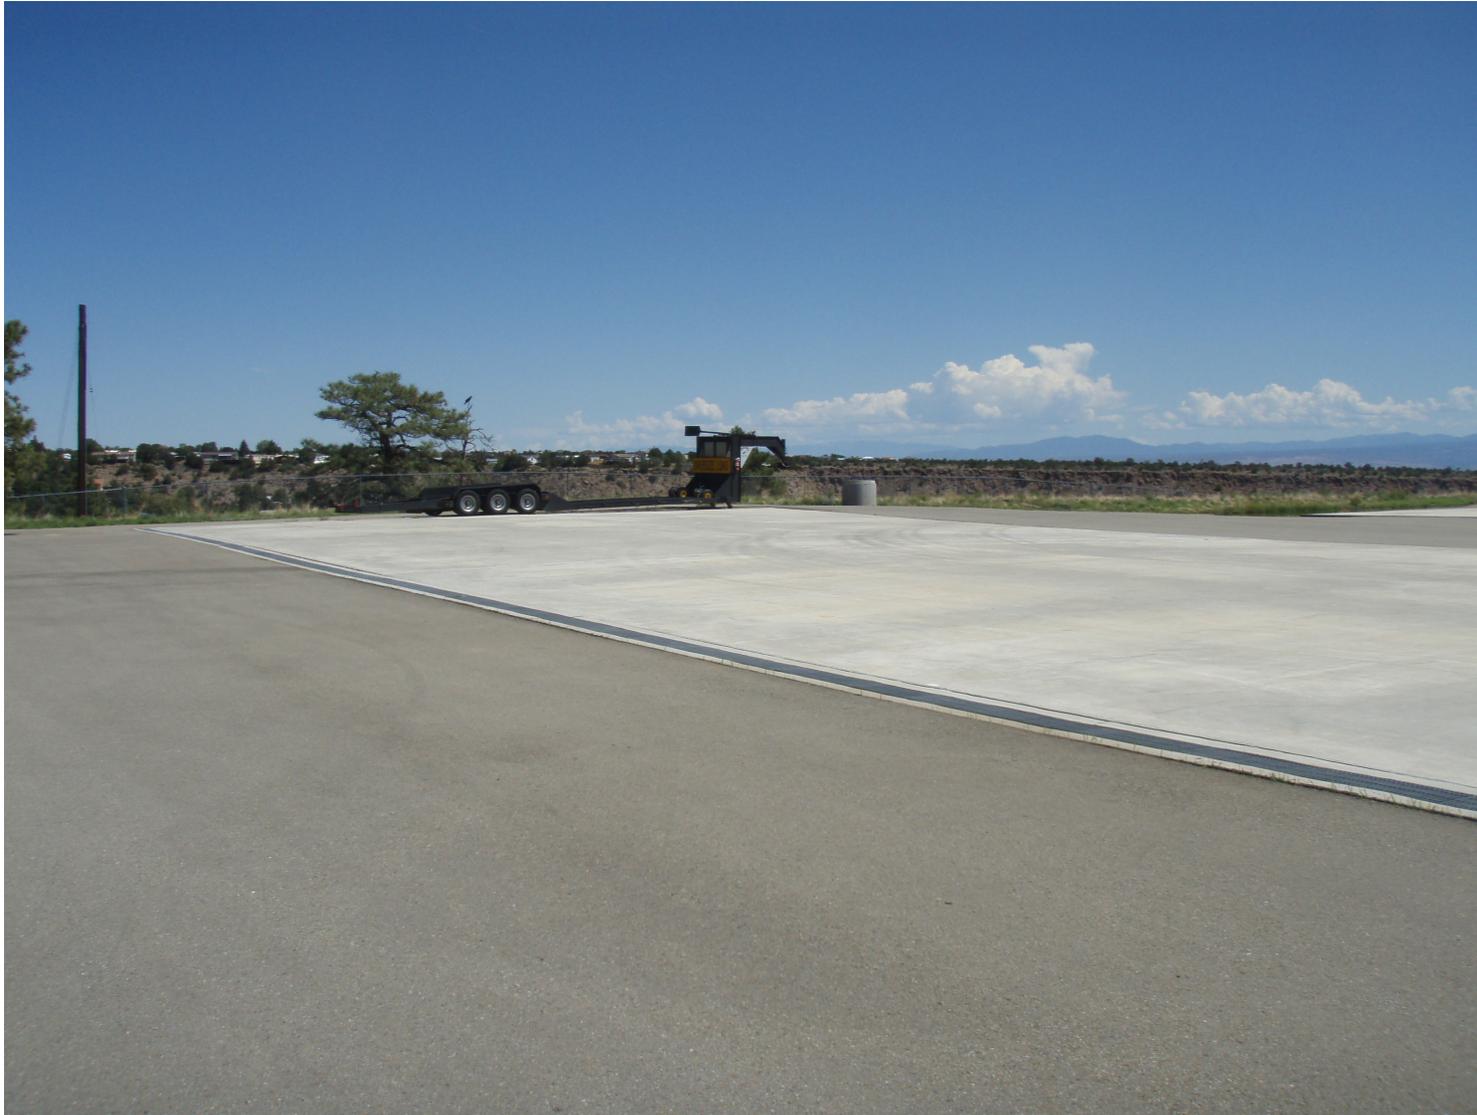
Photo # 6: North end of pad # 1.

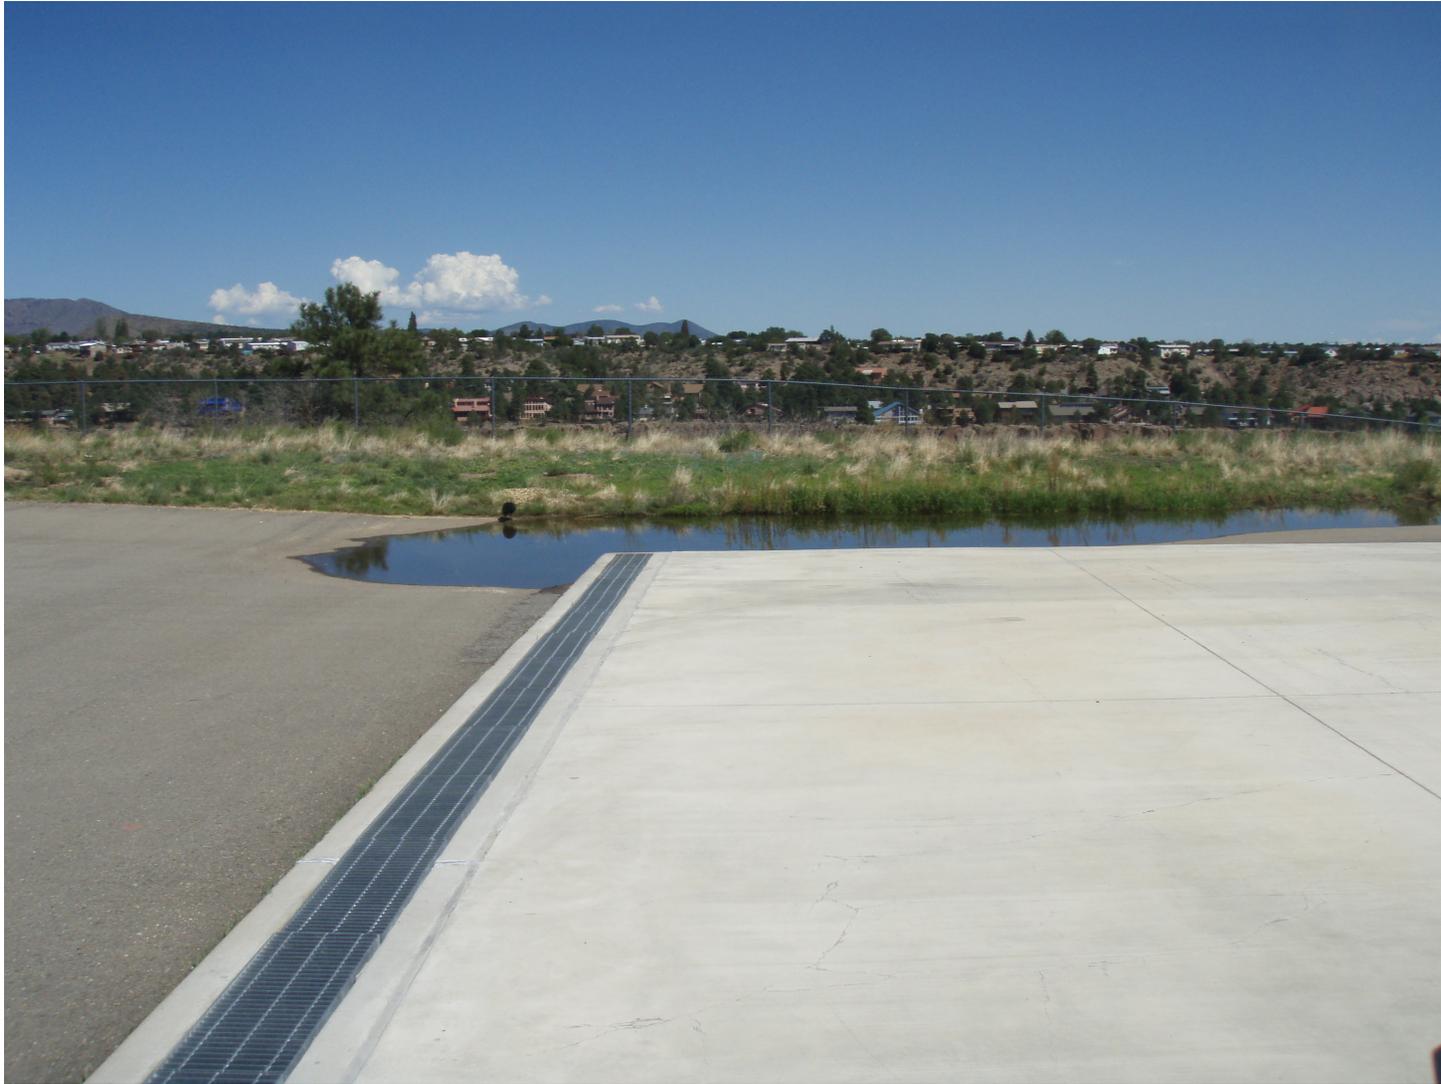
Photo # 7: North view of pad #2. Note Matcon patch, subsidence and puddle at end of trench drain.

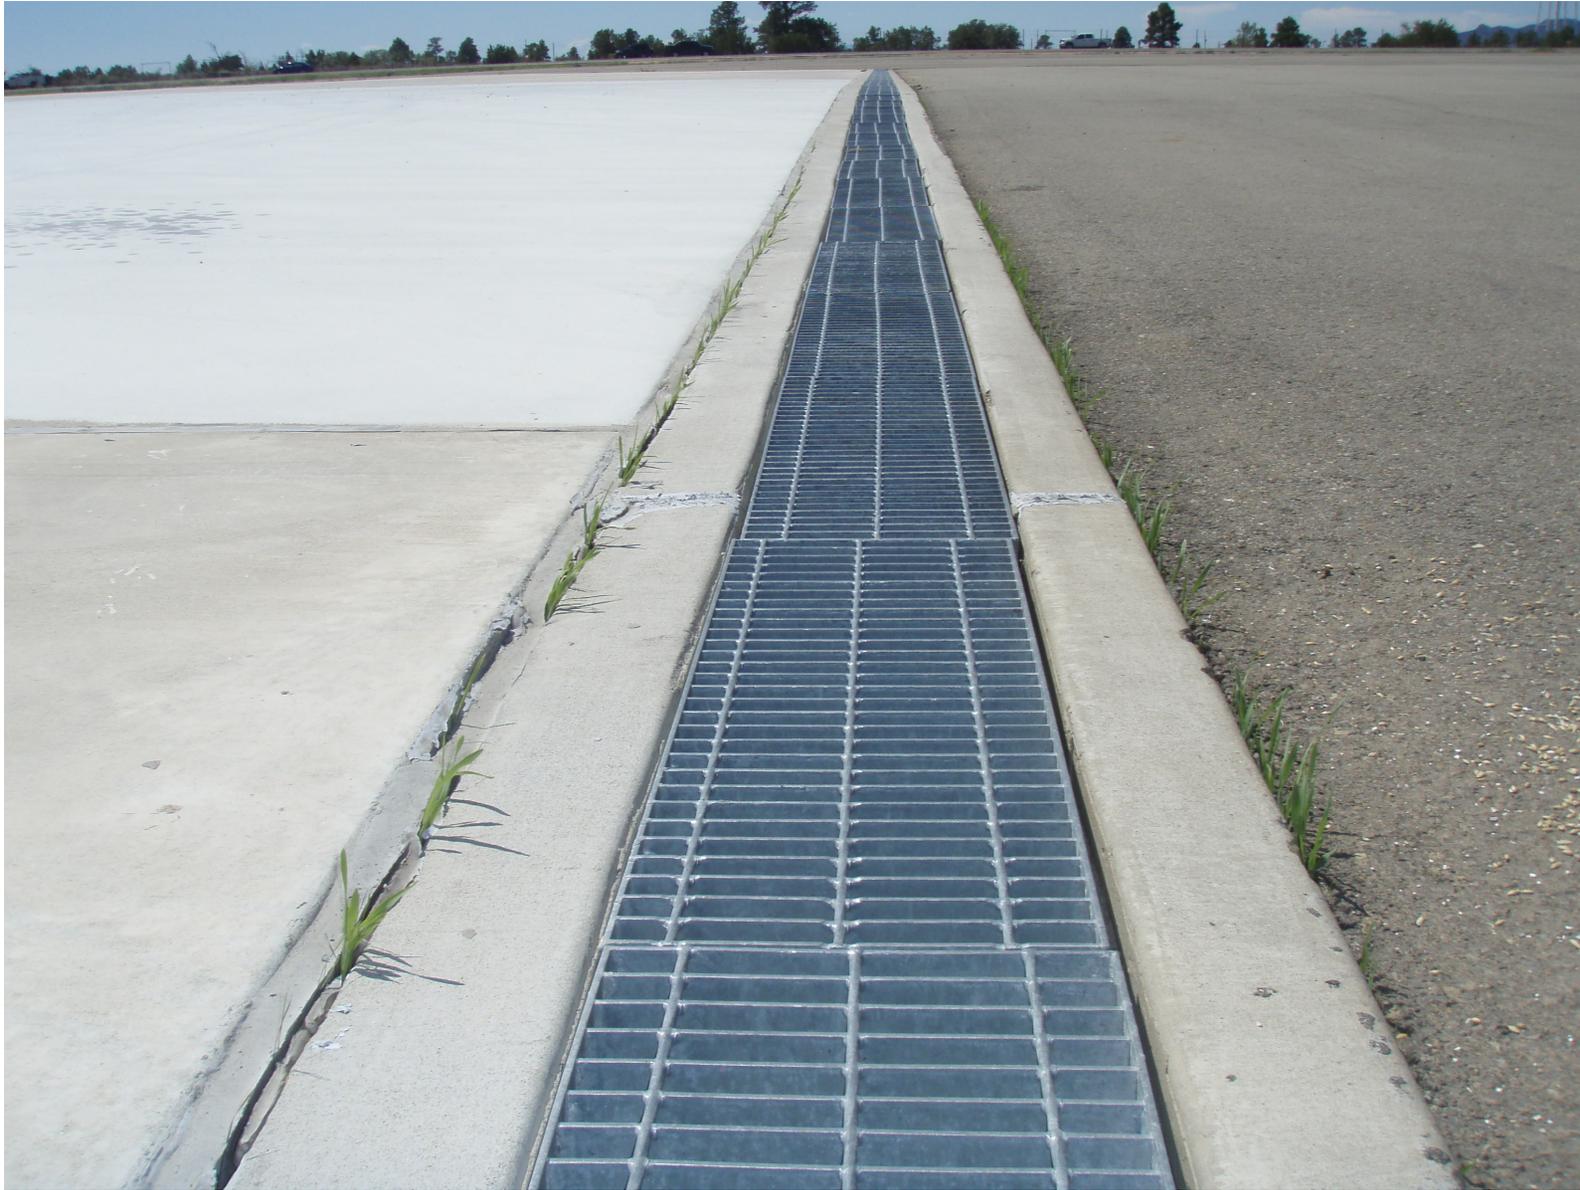
Photo # 8: Grasses growing along trench drain at pad # 3.

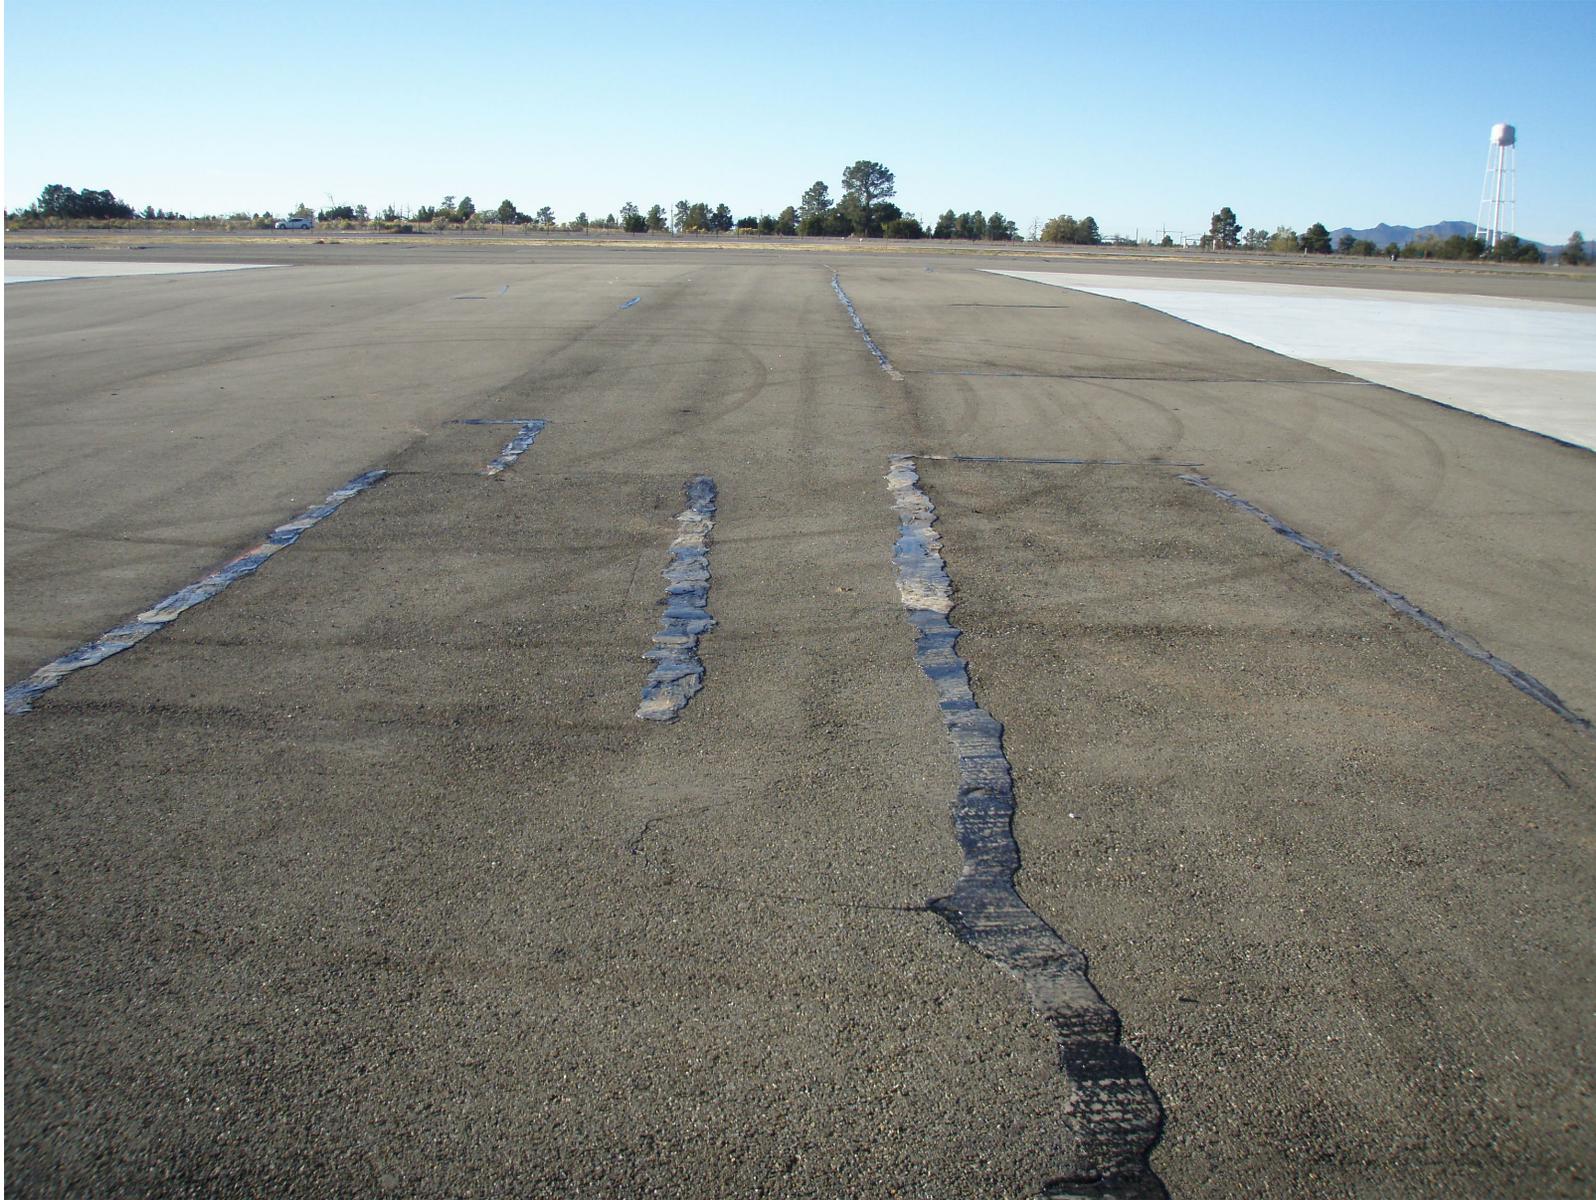
Photo2: Crack repair in MatCon

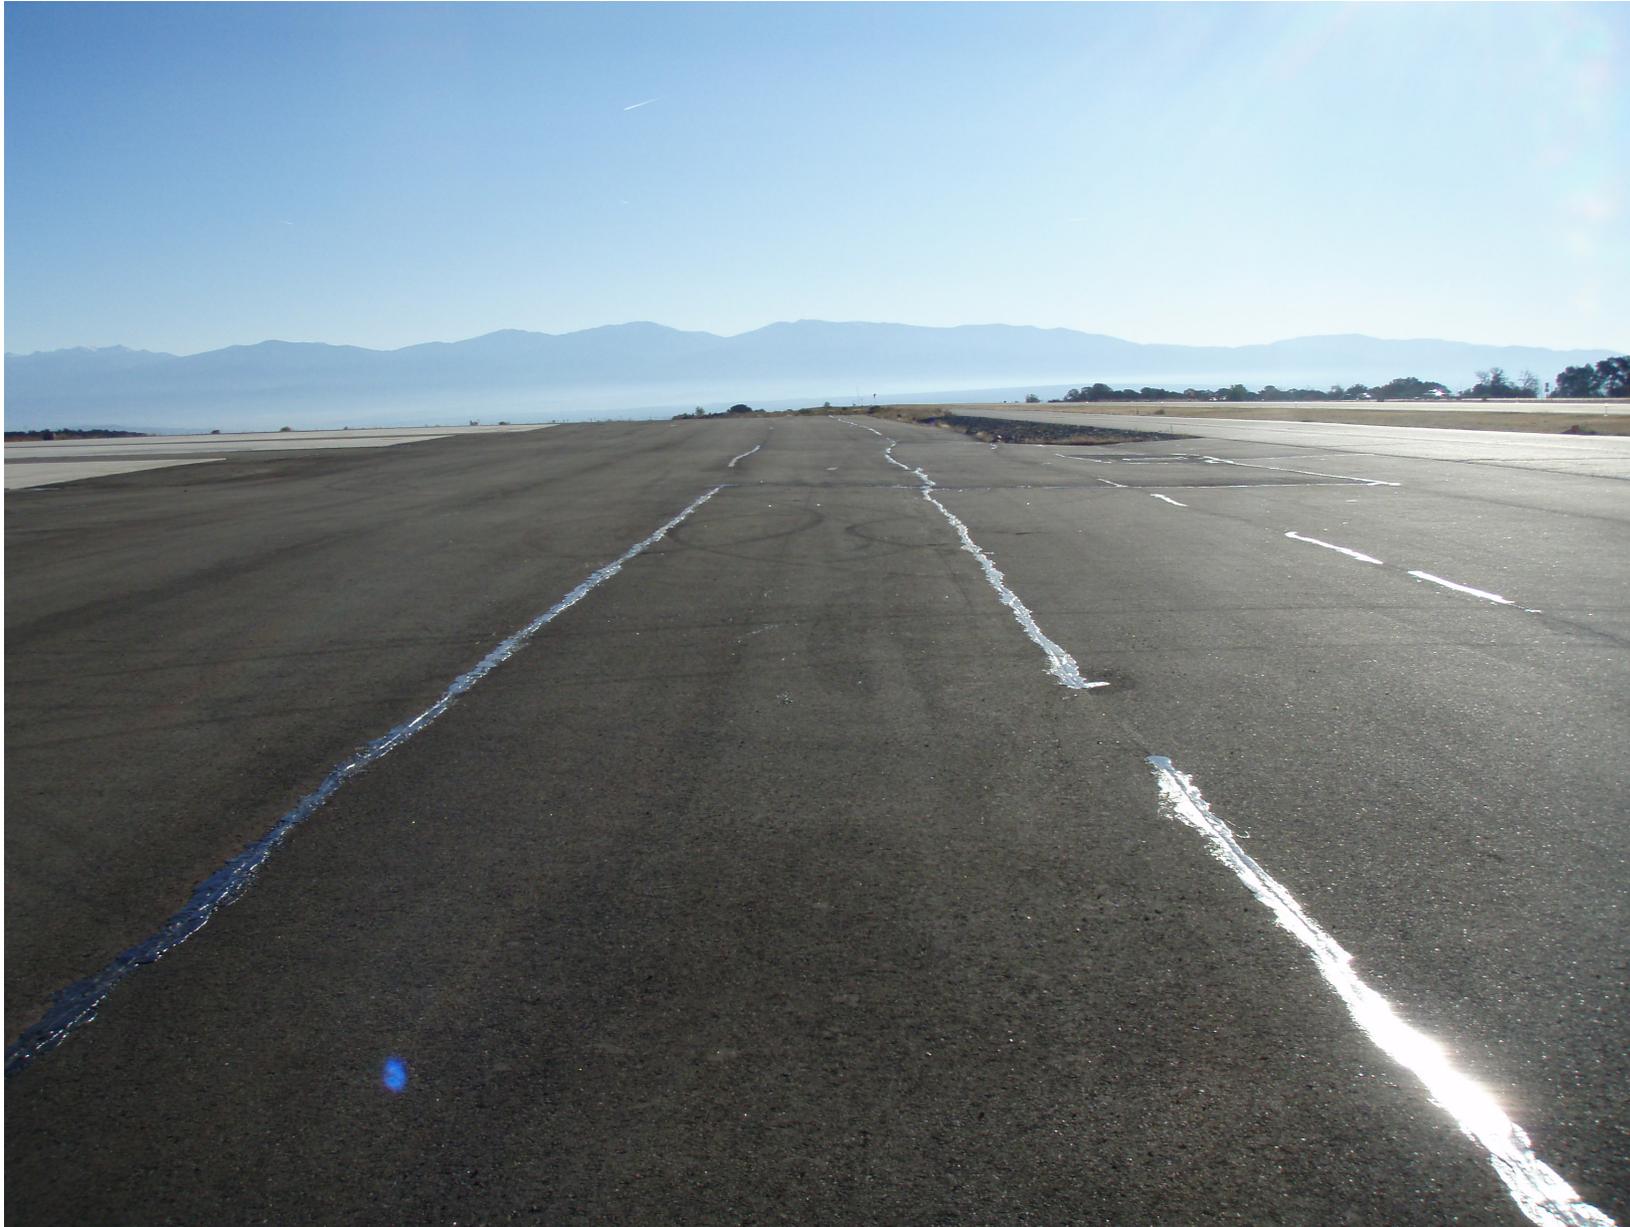
Photo3: Crack repair in MatCon

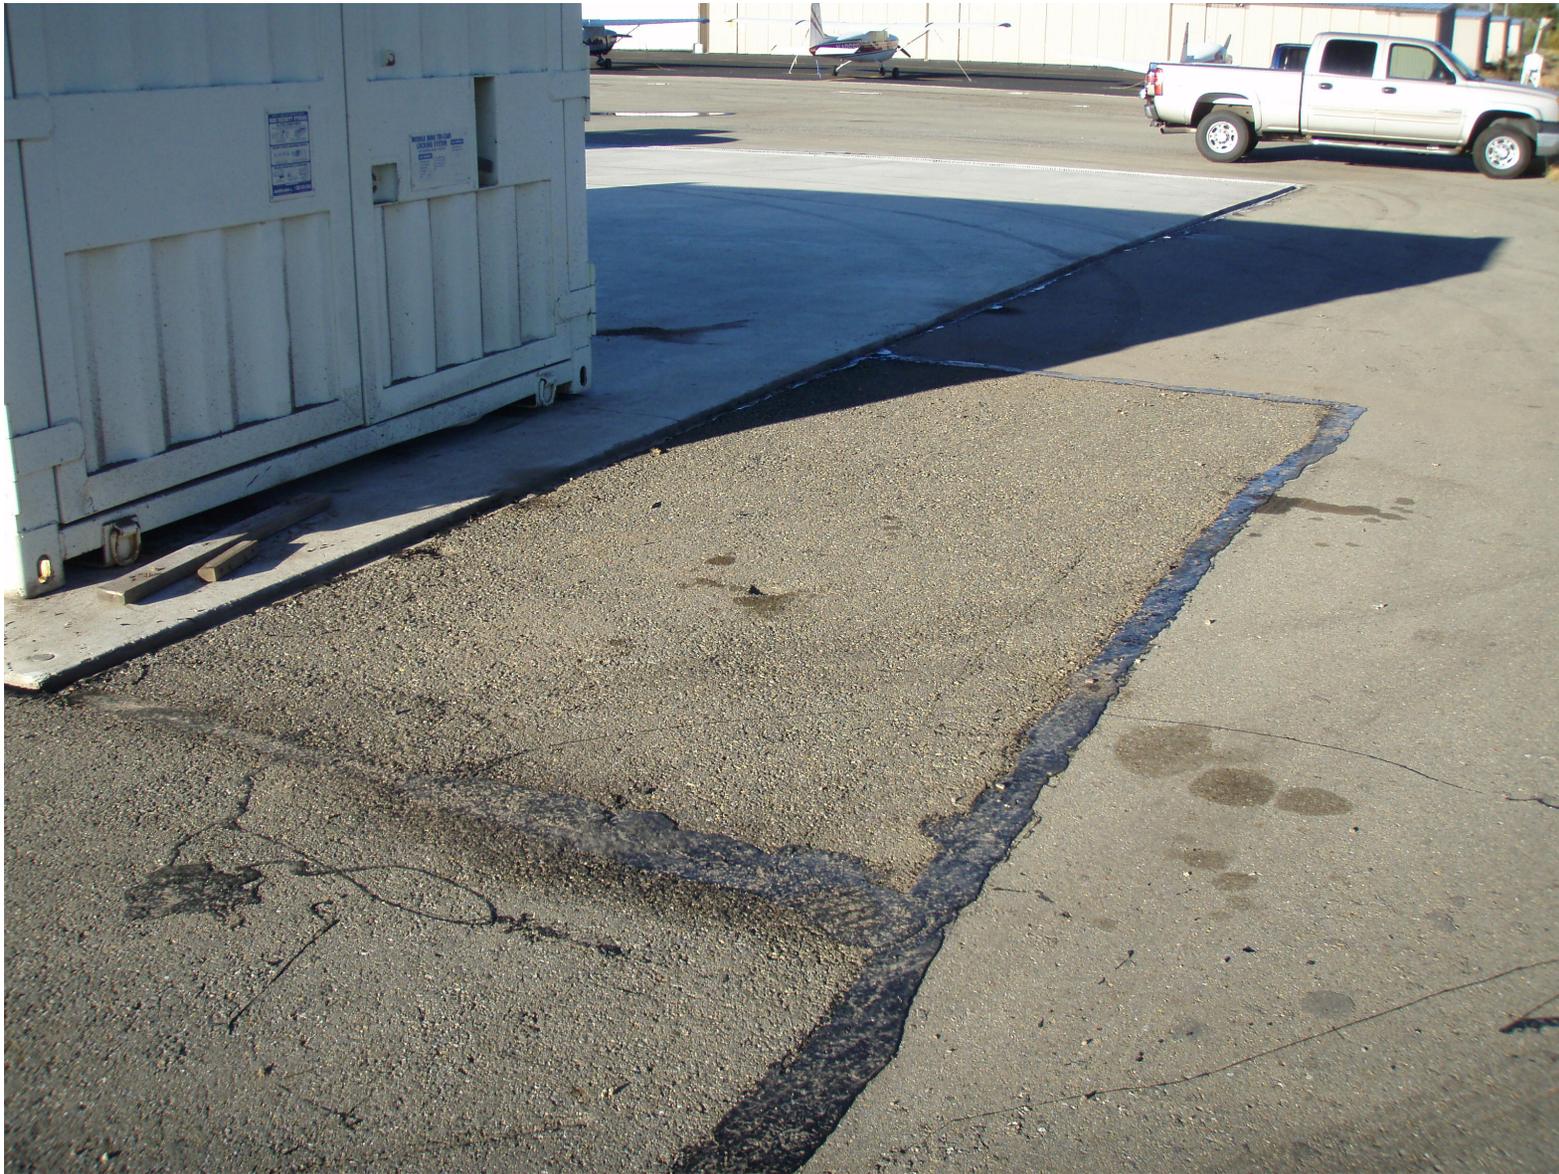
Photo 4: Crack repair in MatCon

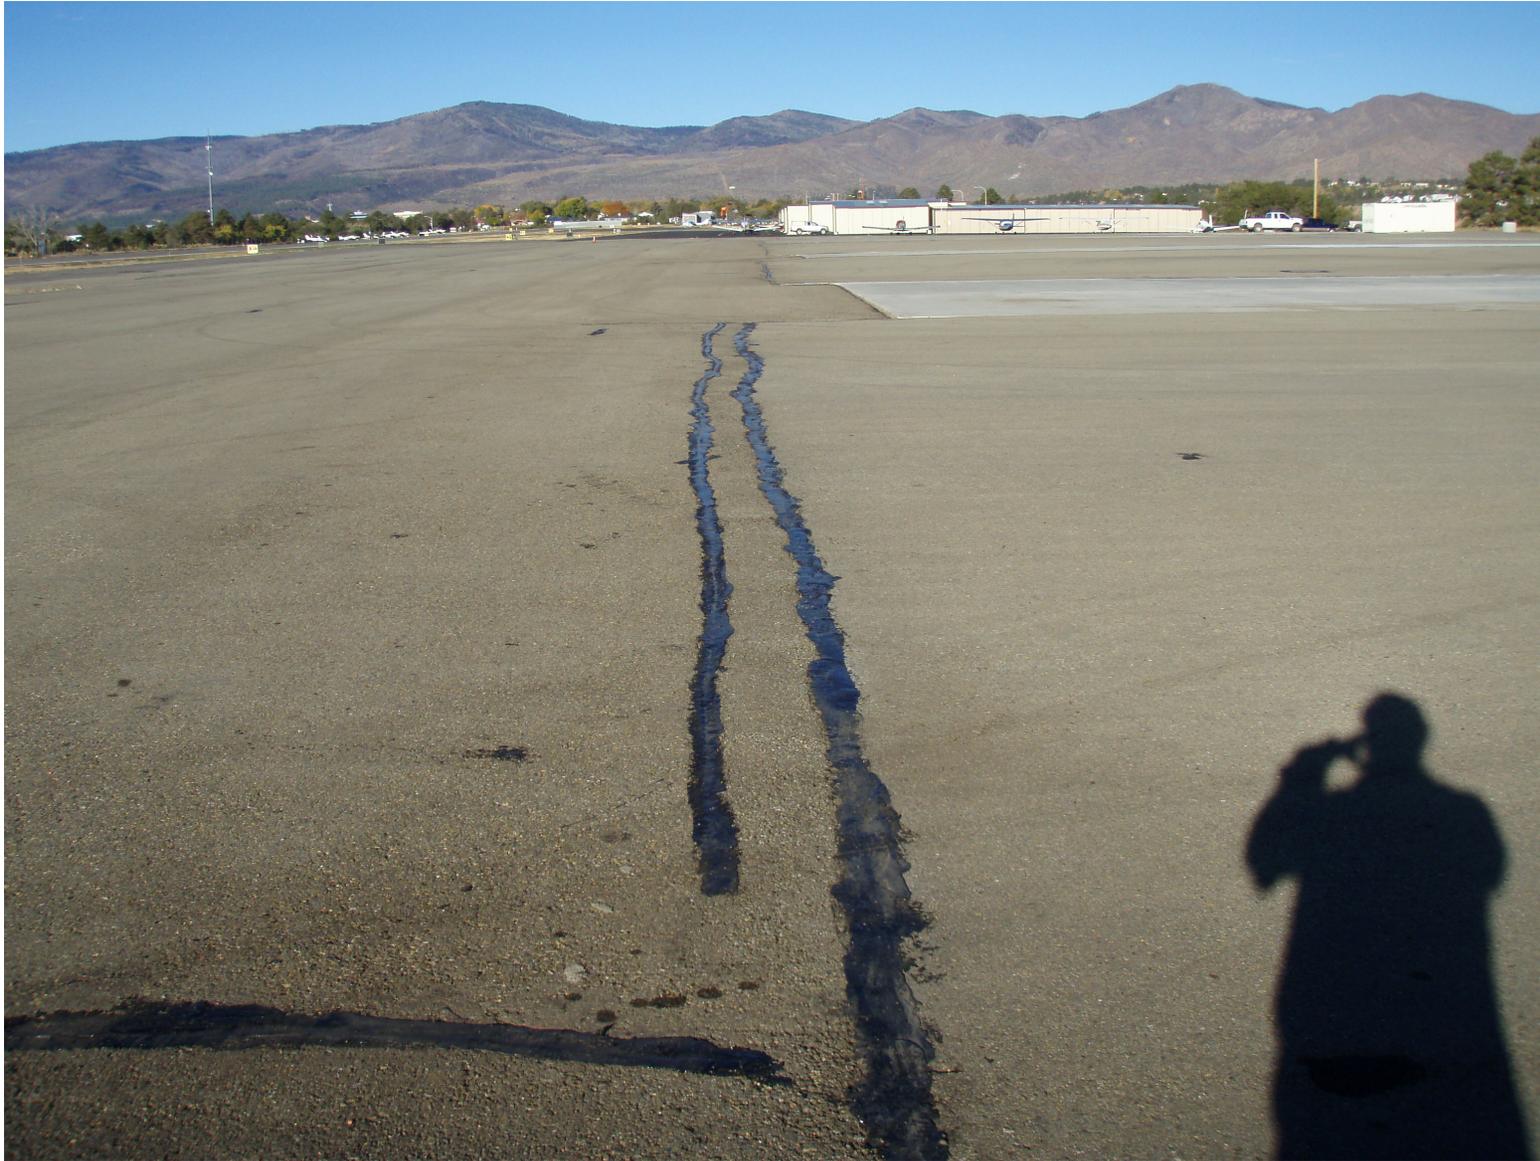
Photo 5: Crack repair in MatCon

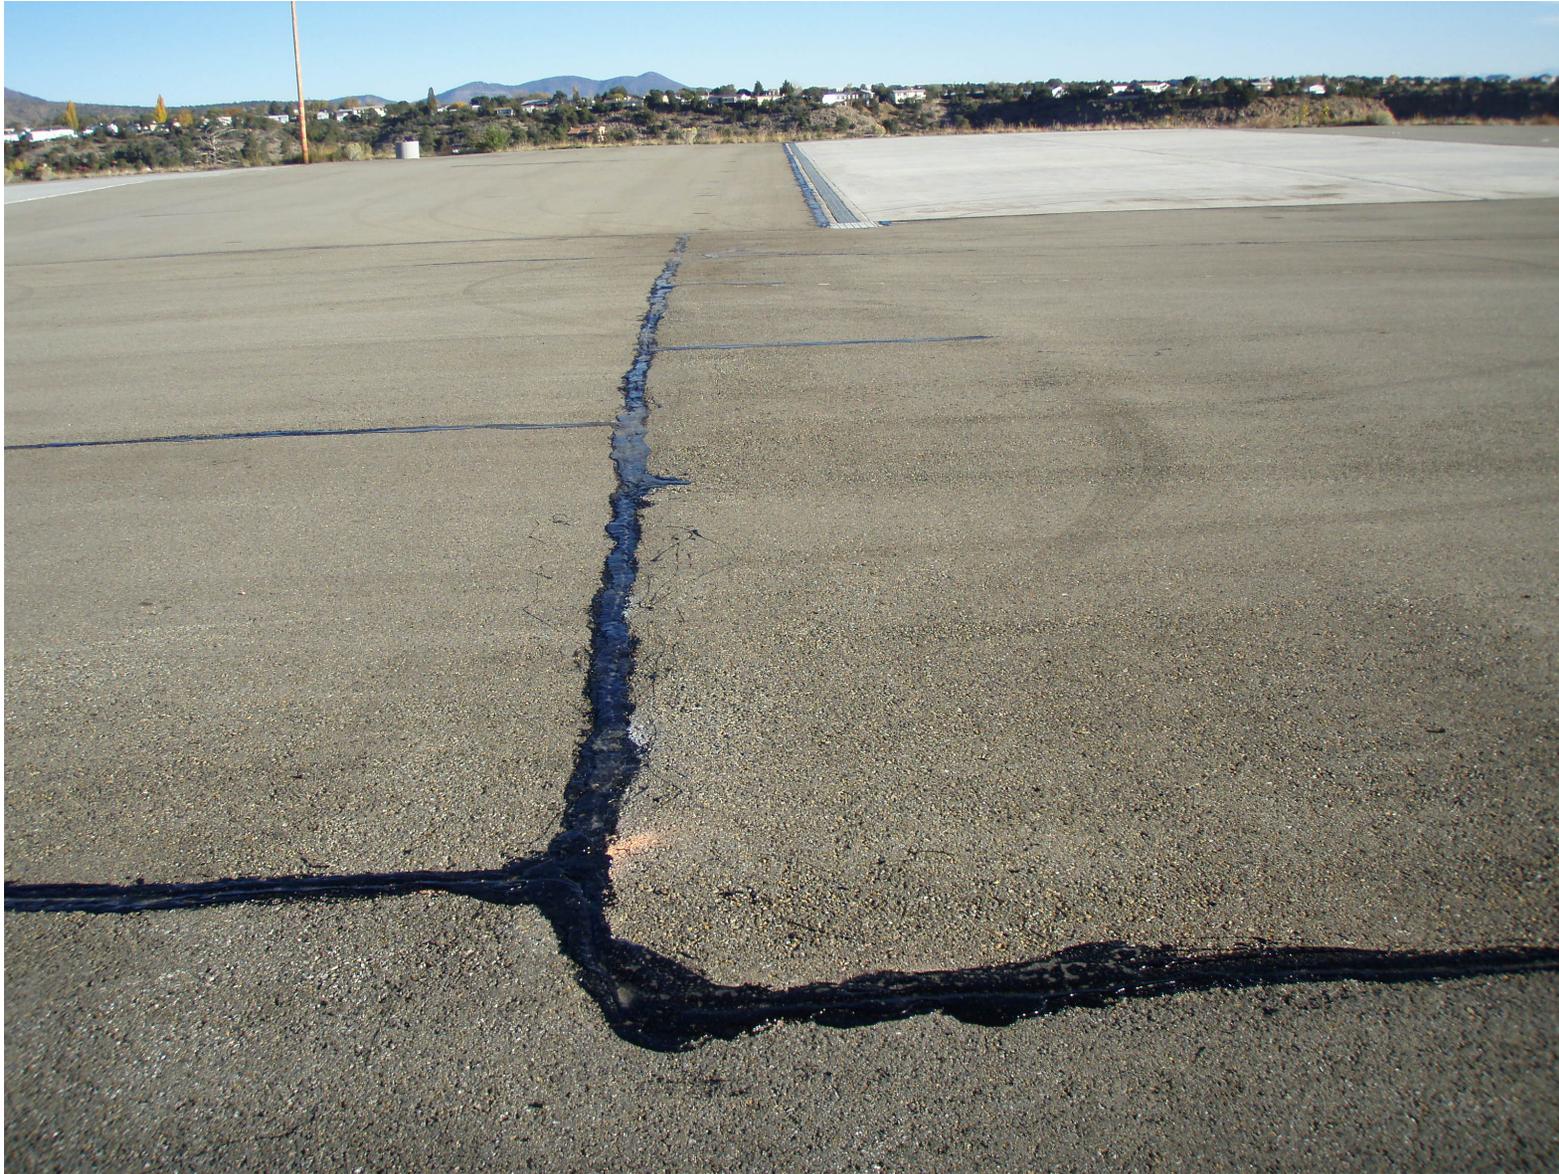
Photo 6: Crack repair in MatCon

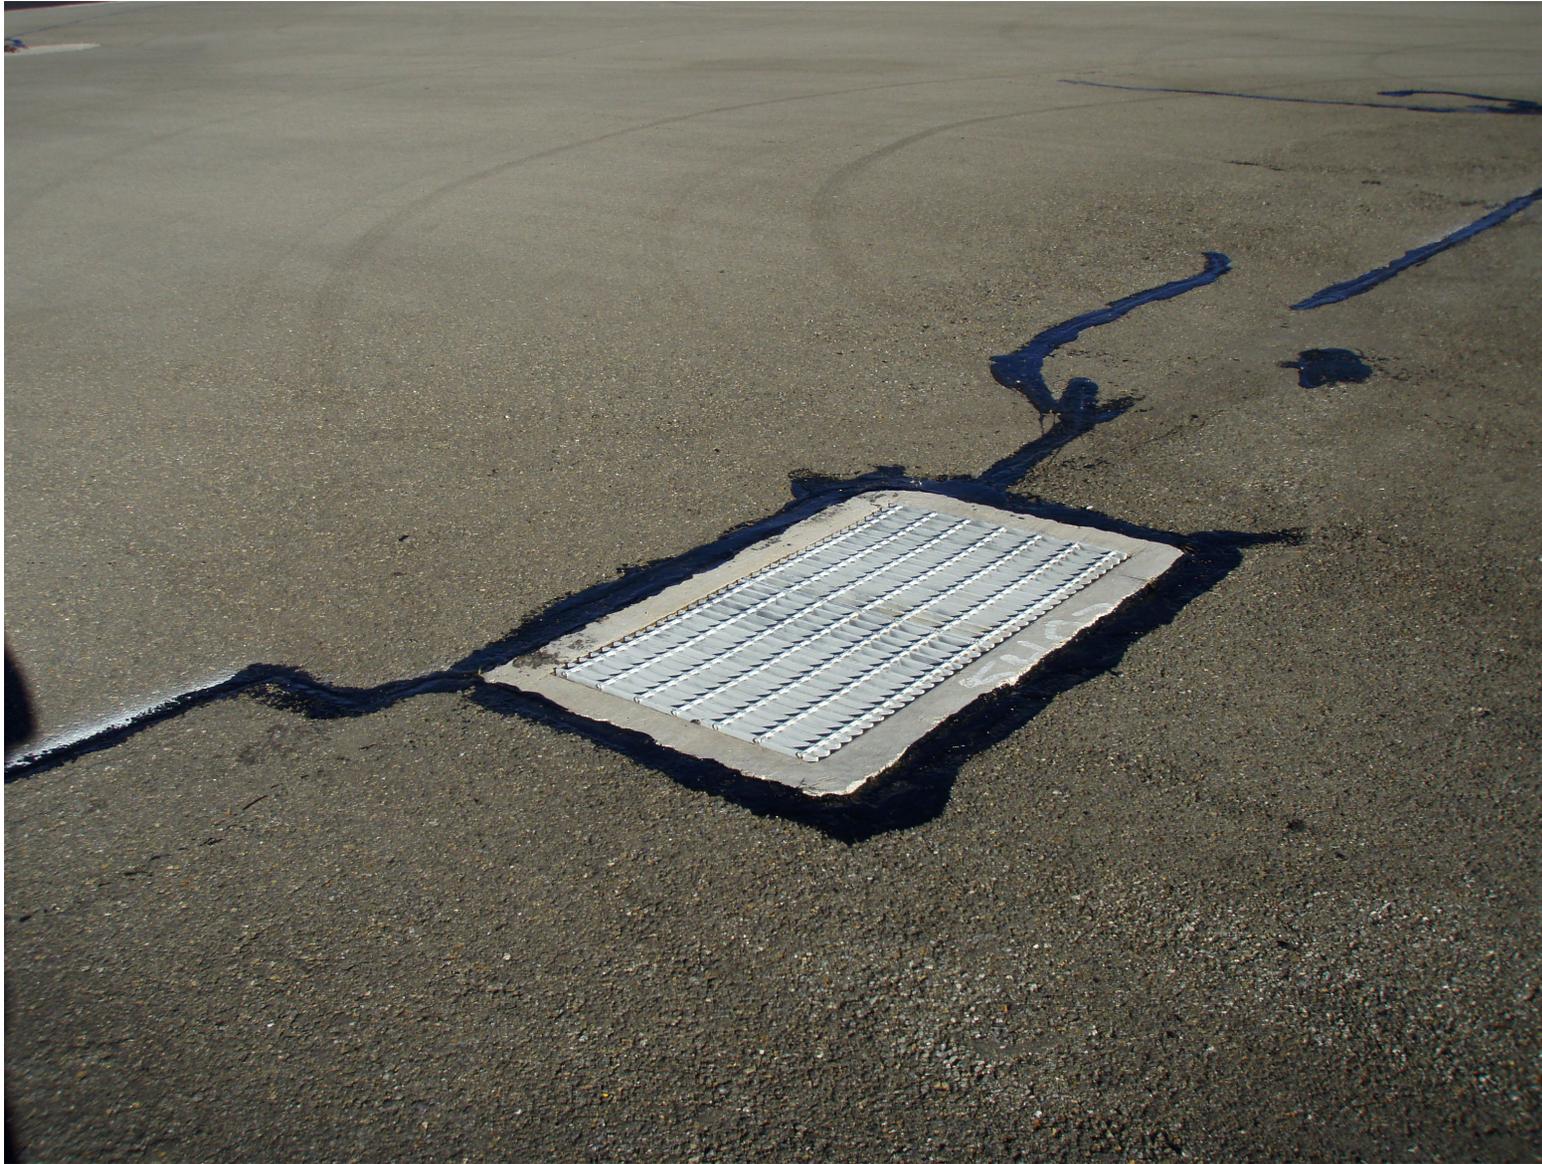
Photo 7: crack repair around drop inlet

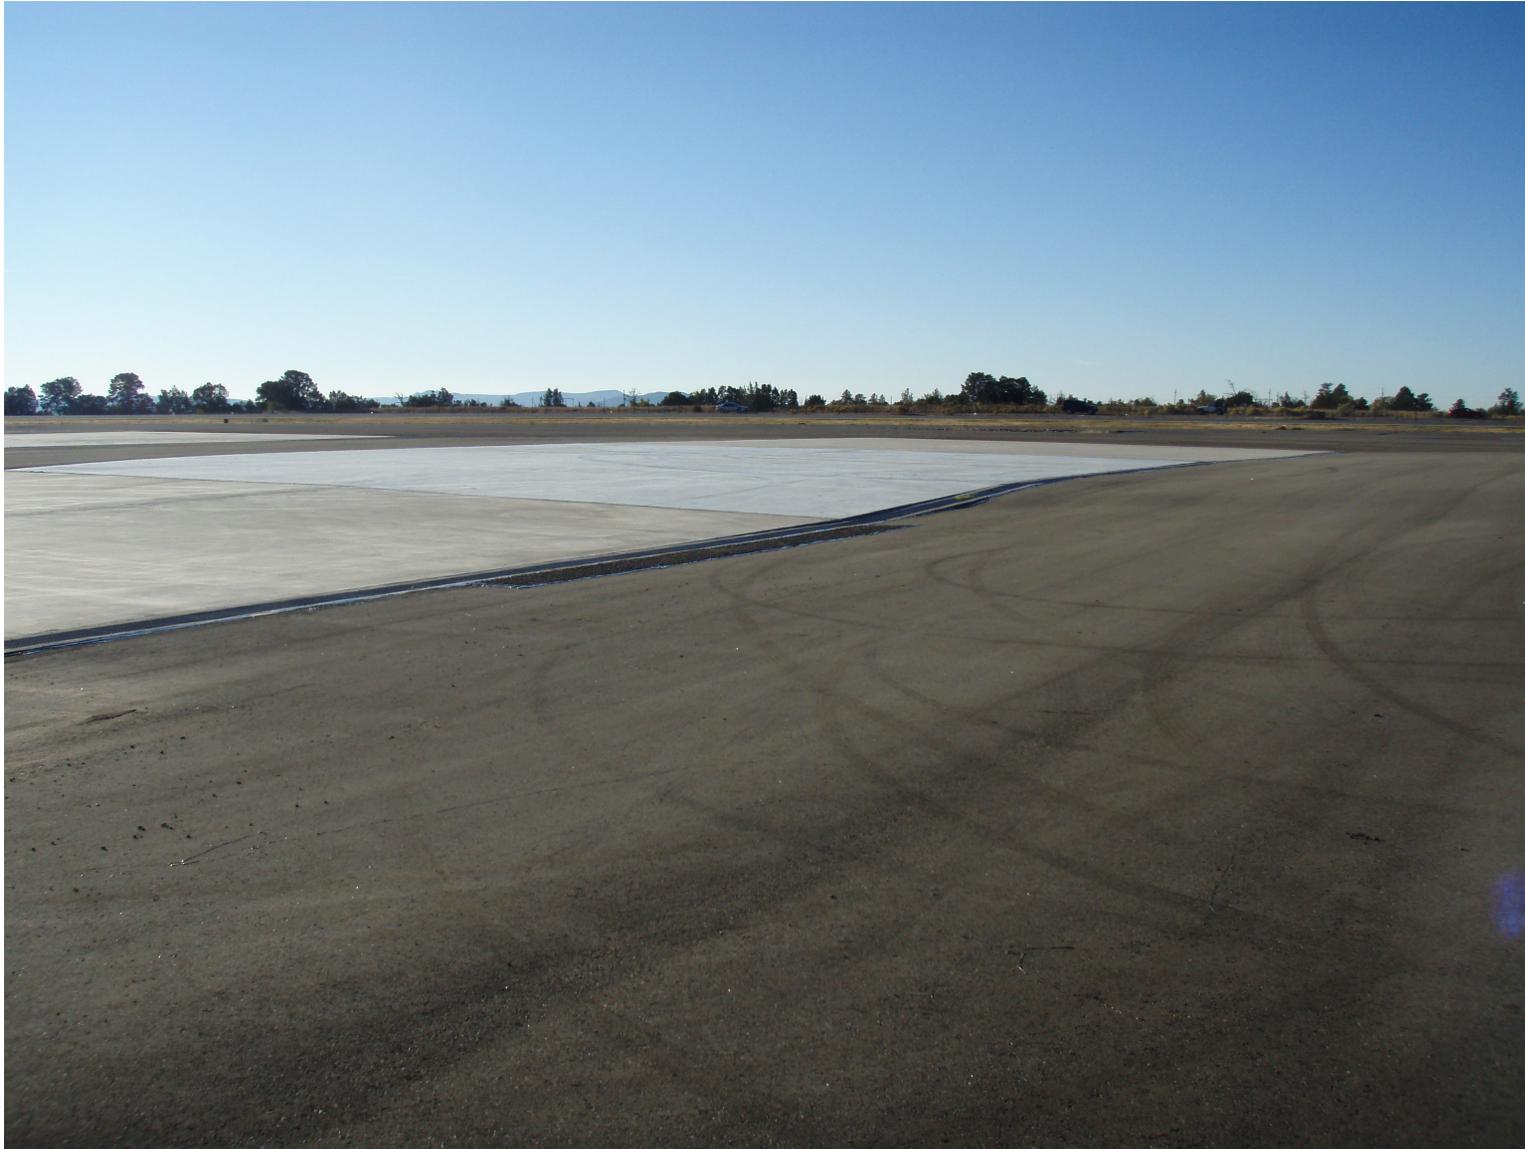
Photo14: Pad #3, note drop in trench drain elevation to north, pad does not drain correctly.

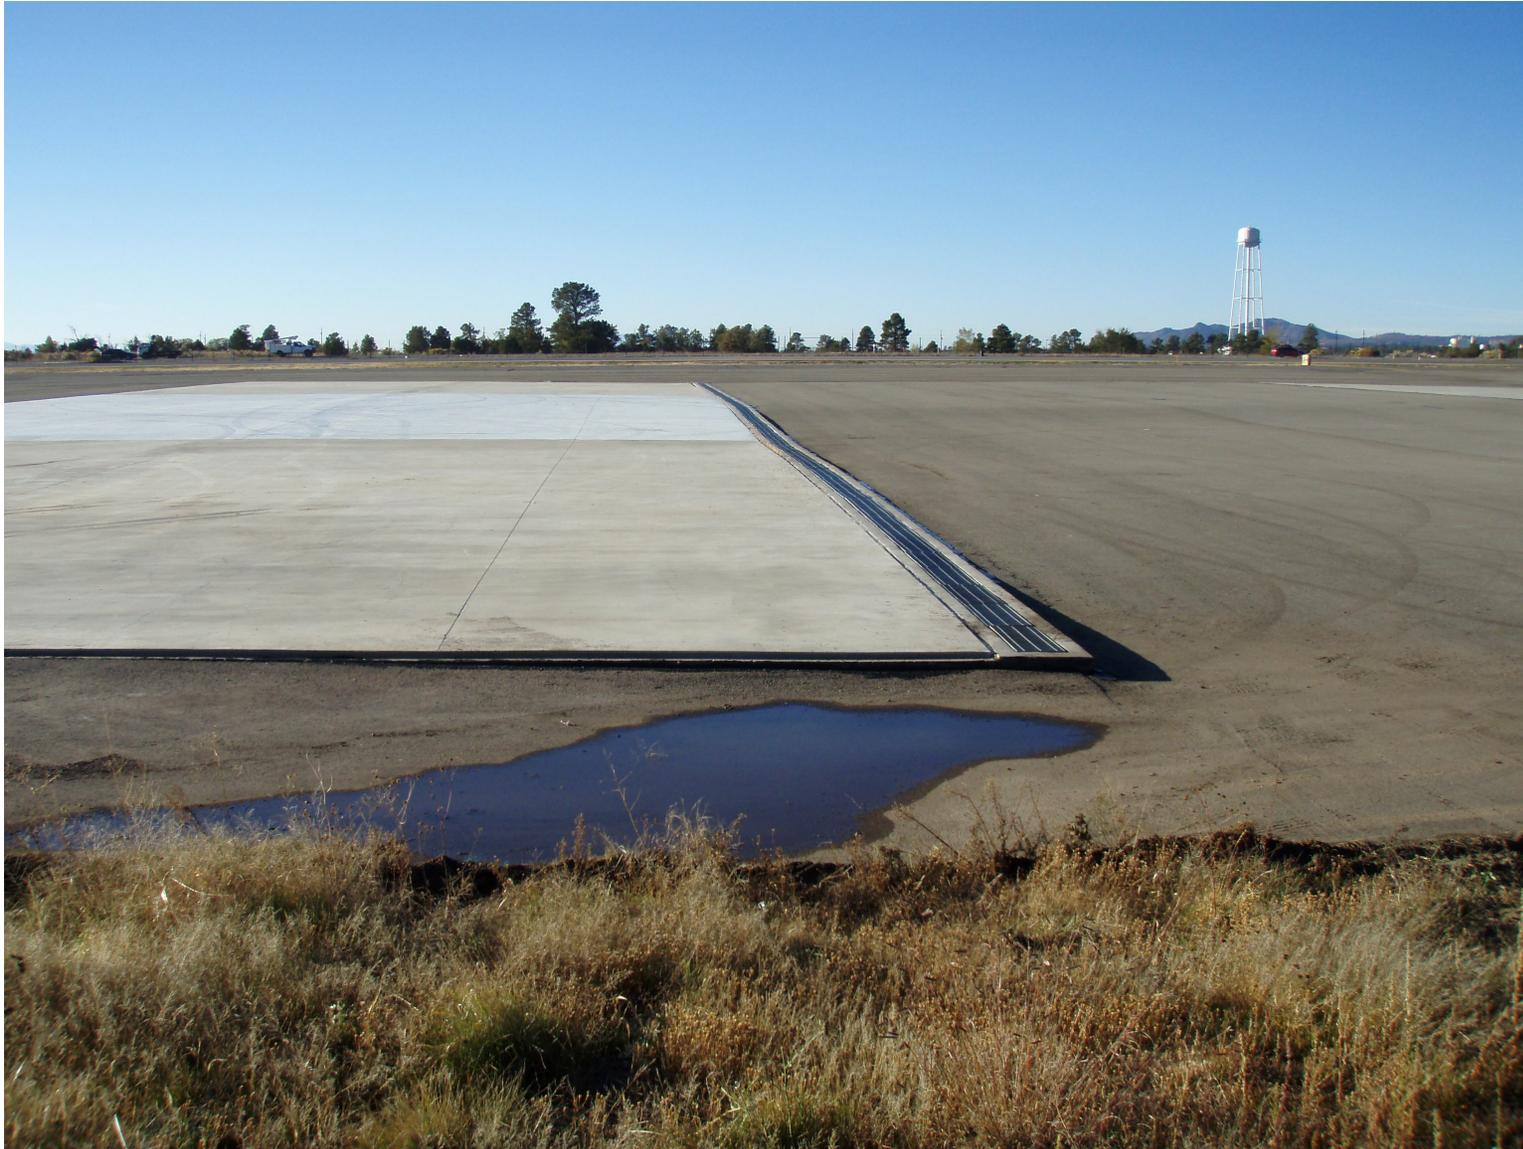
Photo 15: Puddle at north end of pad #2, note subsidence from pad and drop in trench drain. Water currently drains into soil cap.
