**Subject: Submittal of the 2011 Annual Inspection Report for Los Alamos County
Airport Landfill, Solid Waste Management Units 73-001(a) and 73-001(d),
Technical Area 73**

LA-UR-12-0671
February 2012
EP2012-0018

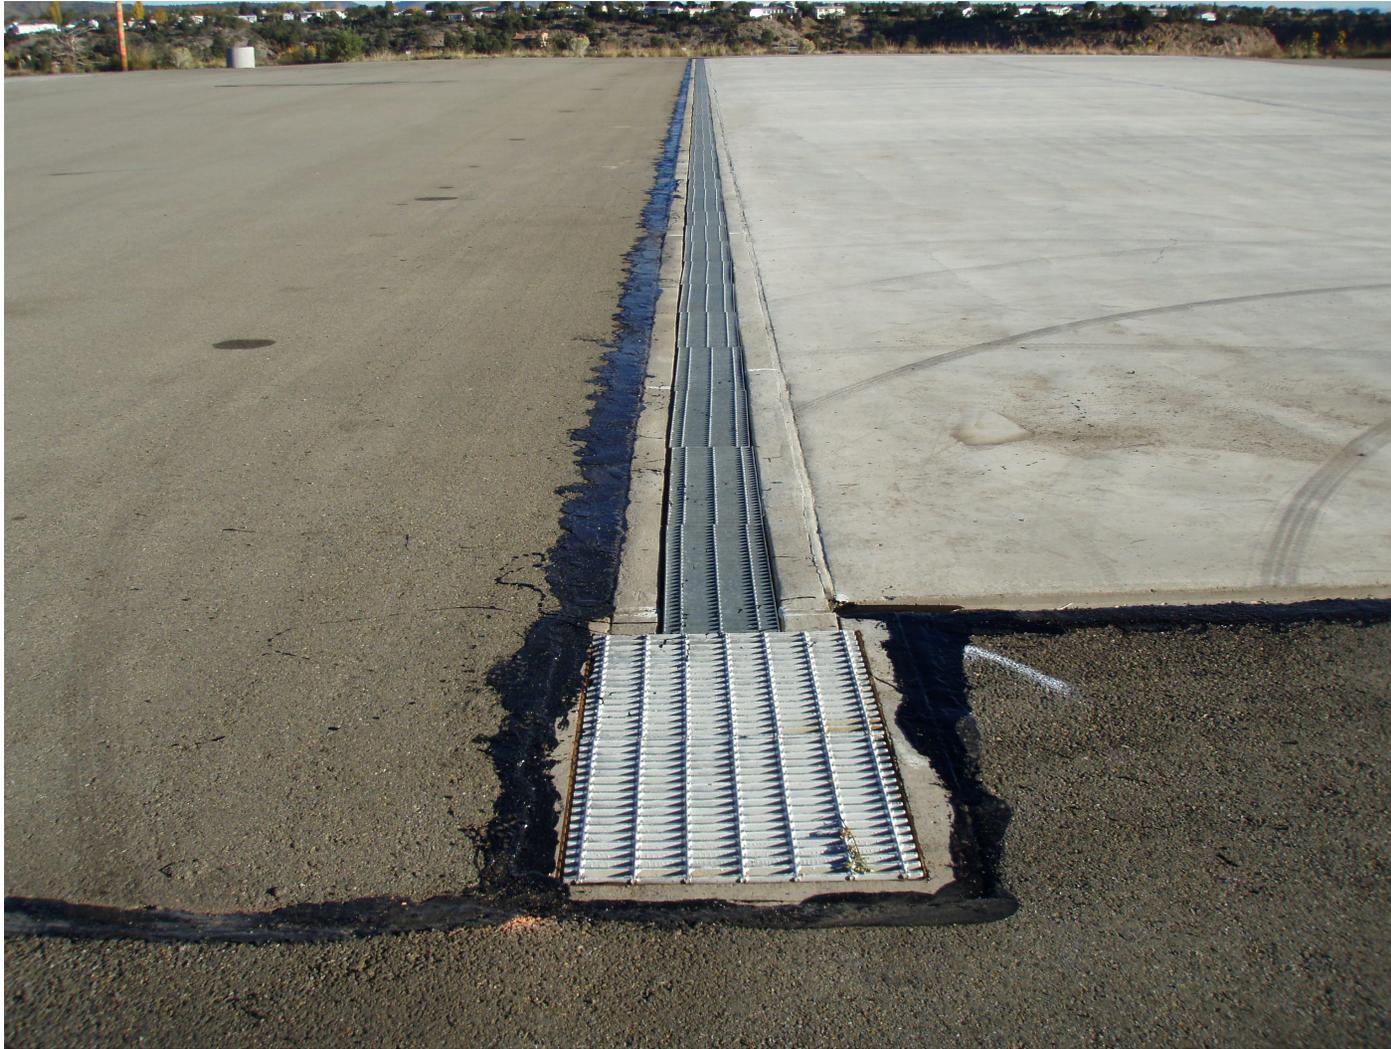
Photo 21: Seal between MatCon and pad #4.

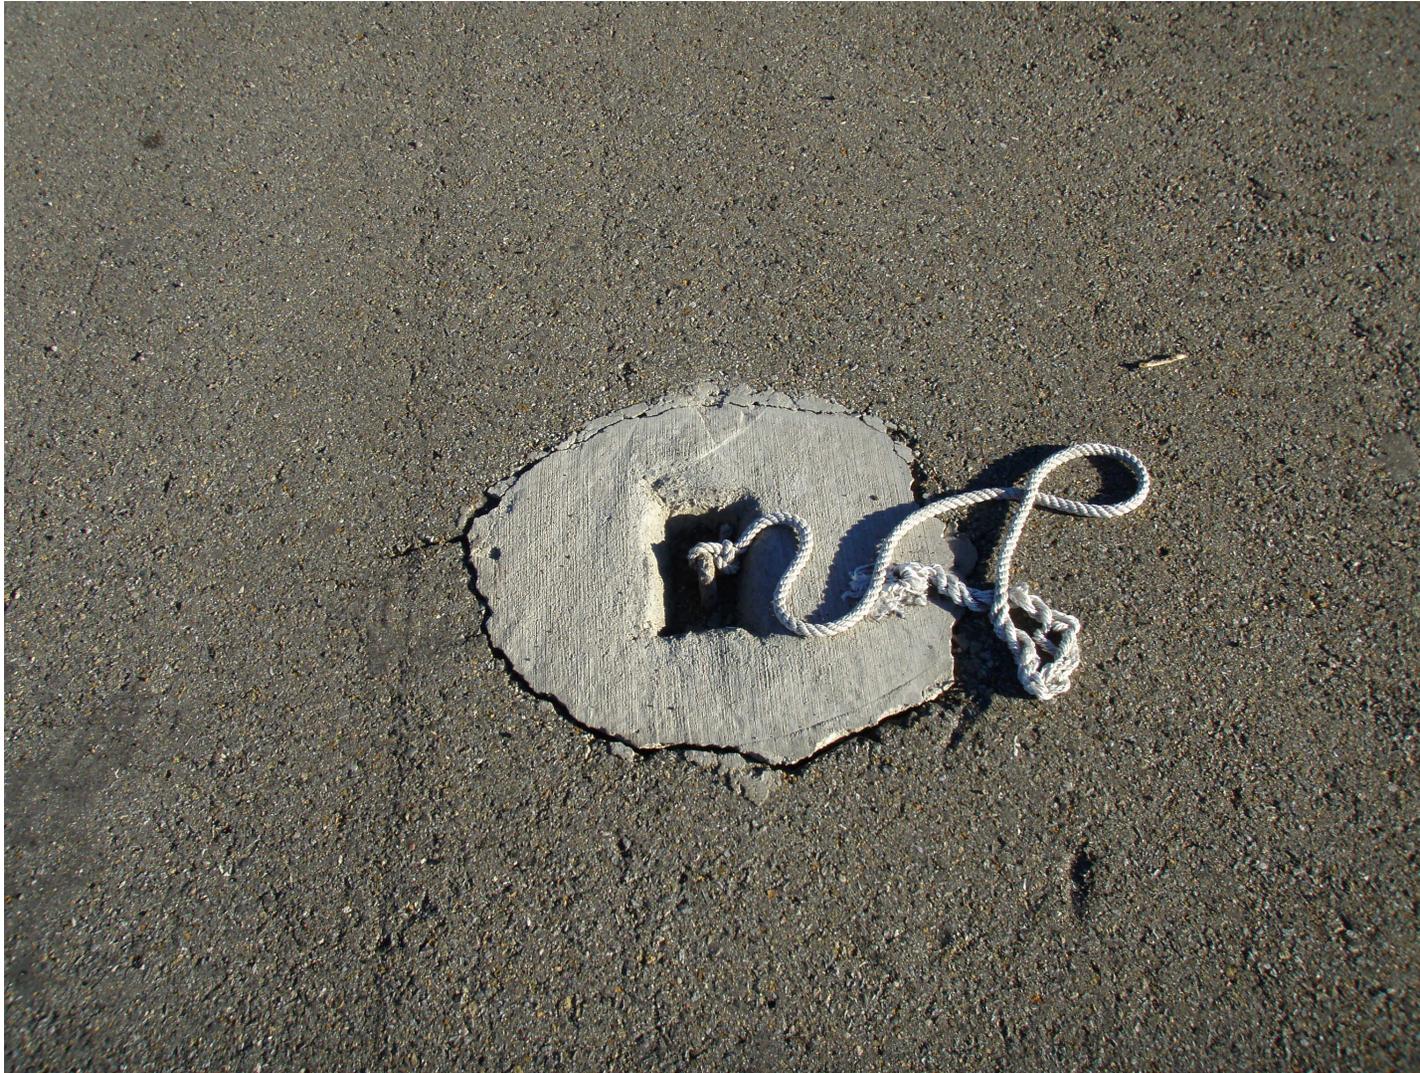
Photo 22: Tie downs were not sealed.

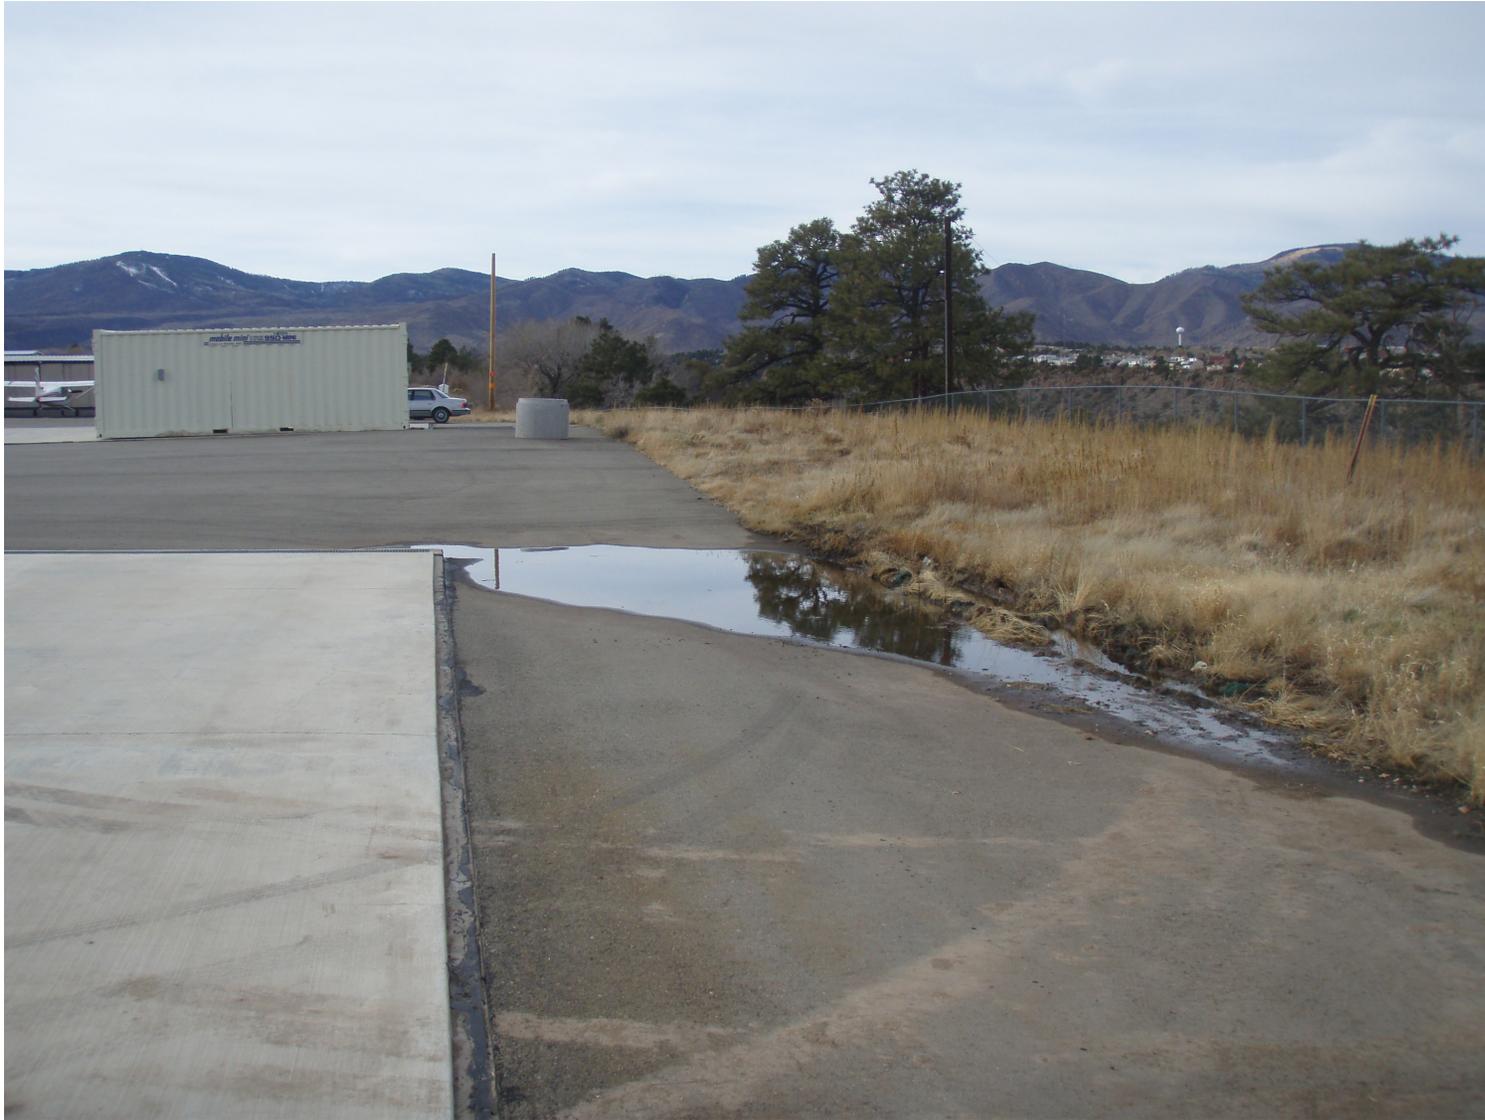
Photo 1: Puddle at north end of pad #2, note subsidence from pad and drop in trench drain. Water currently drains into soil cap.

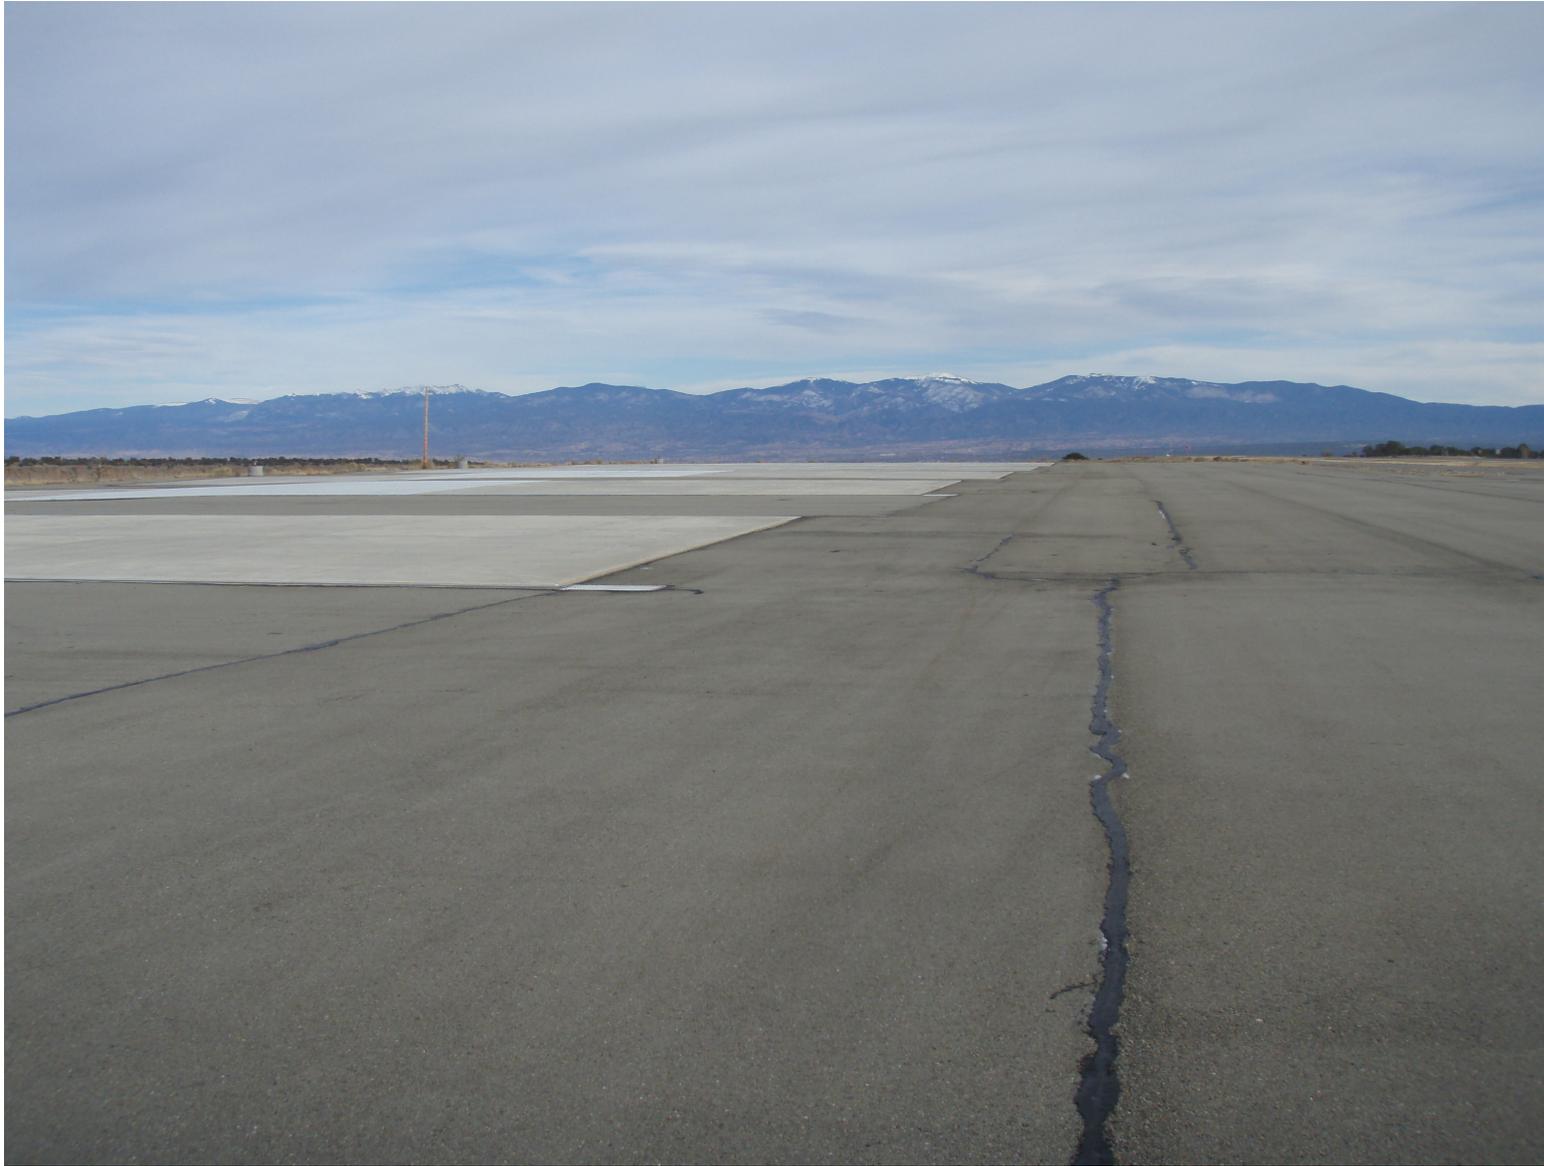
Photo 2: View of pads and MatCon.

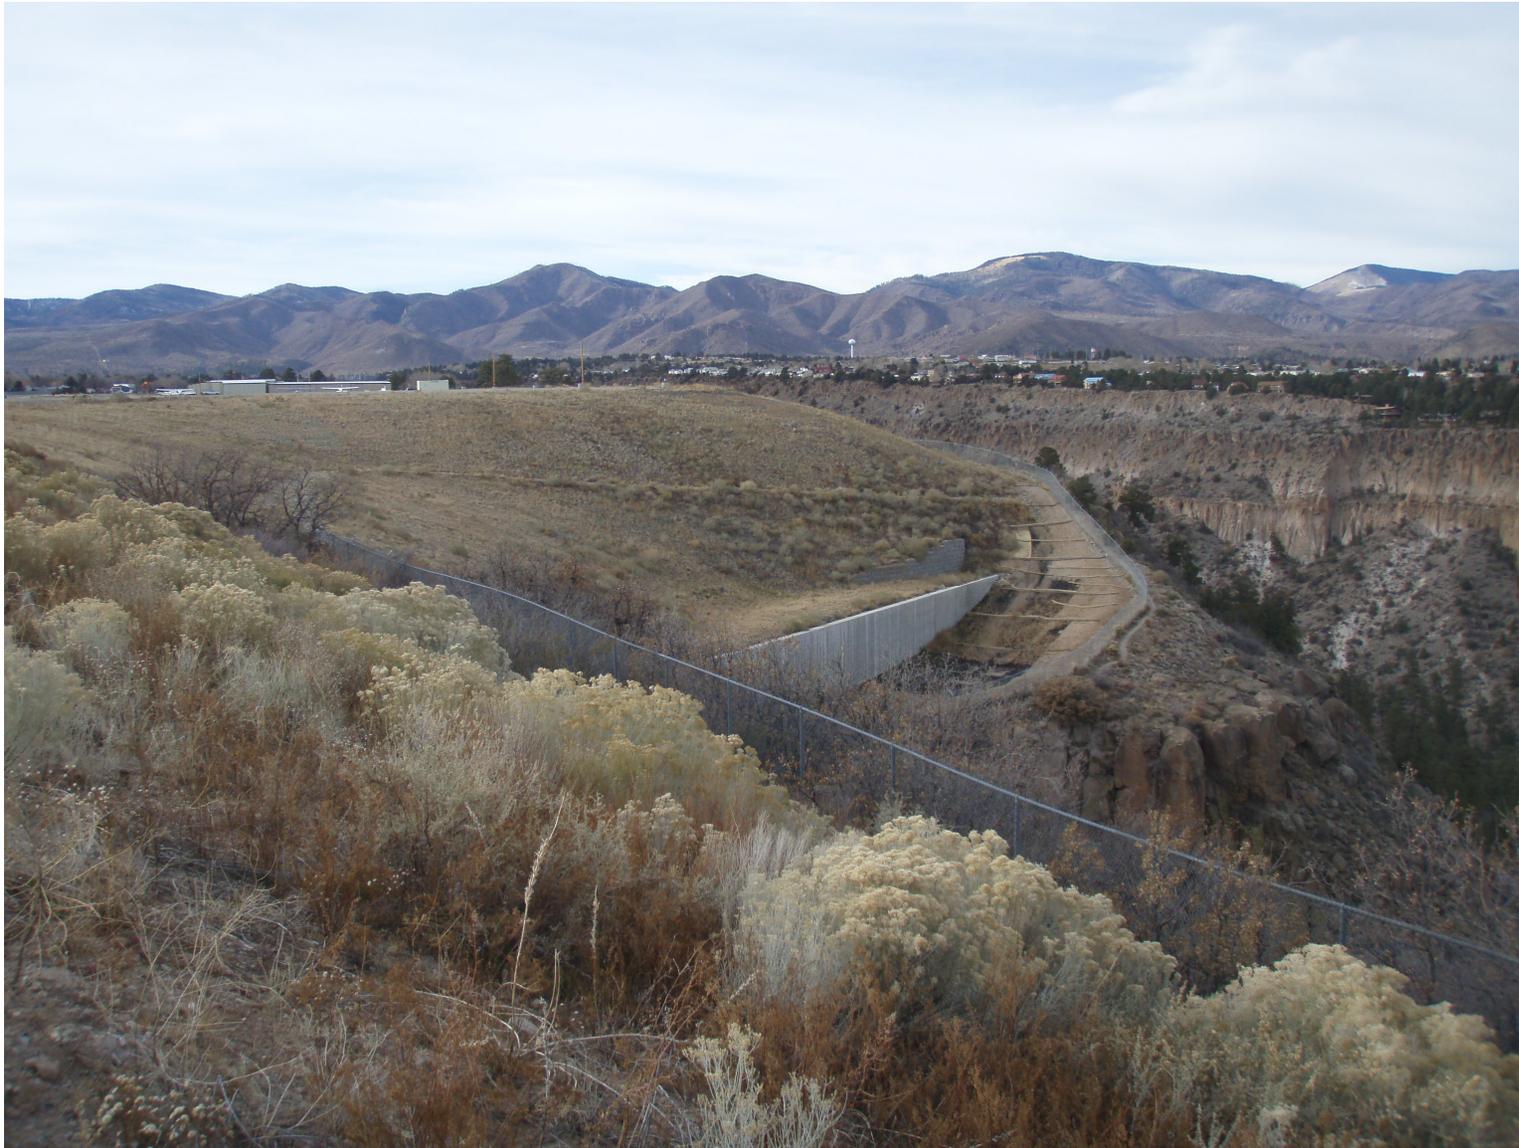
Photo 3: Wattles replaced in September.

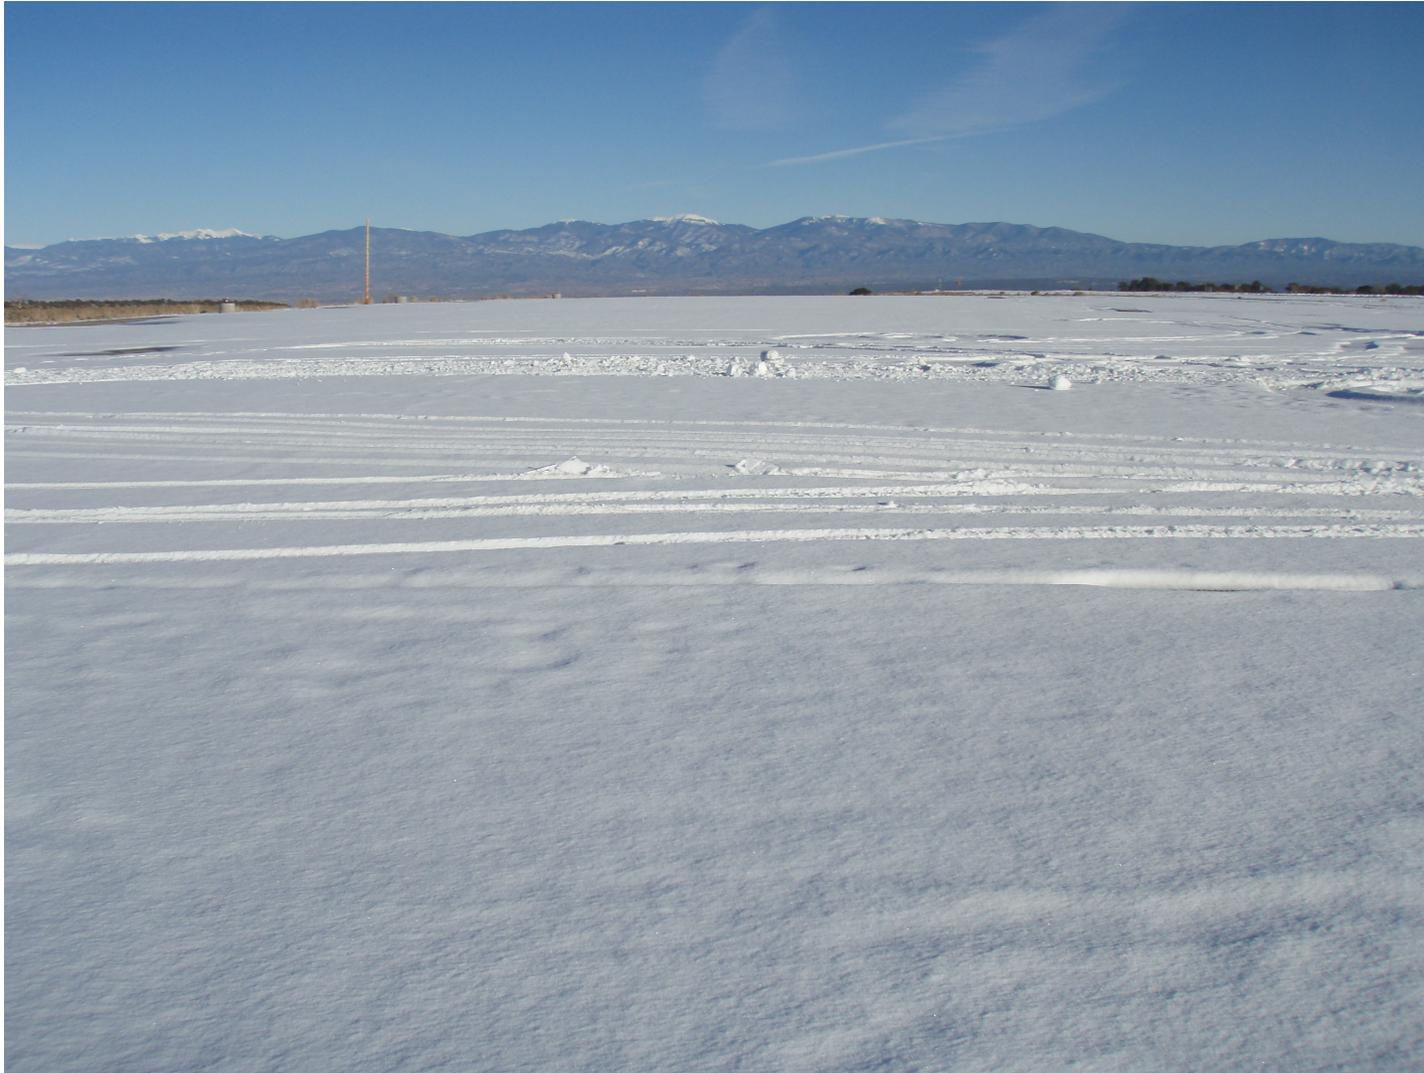
Photo 1: Looking east photo taken December 16, 2011.

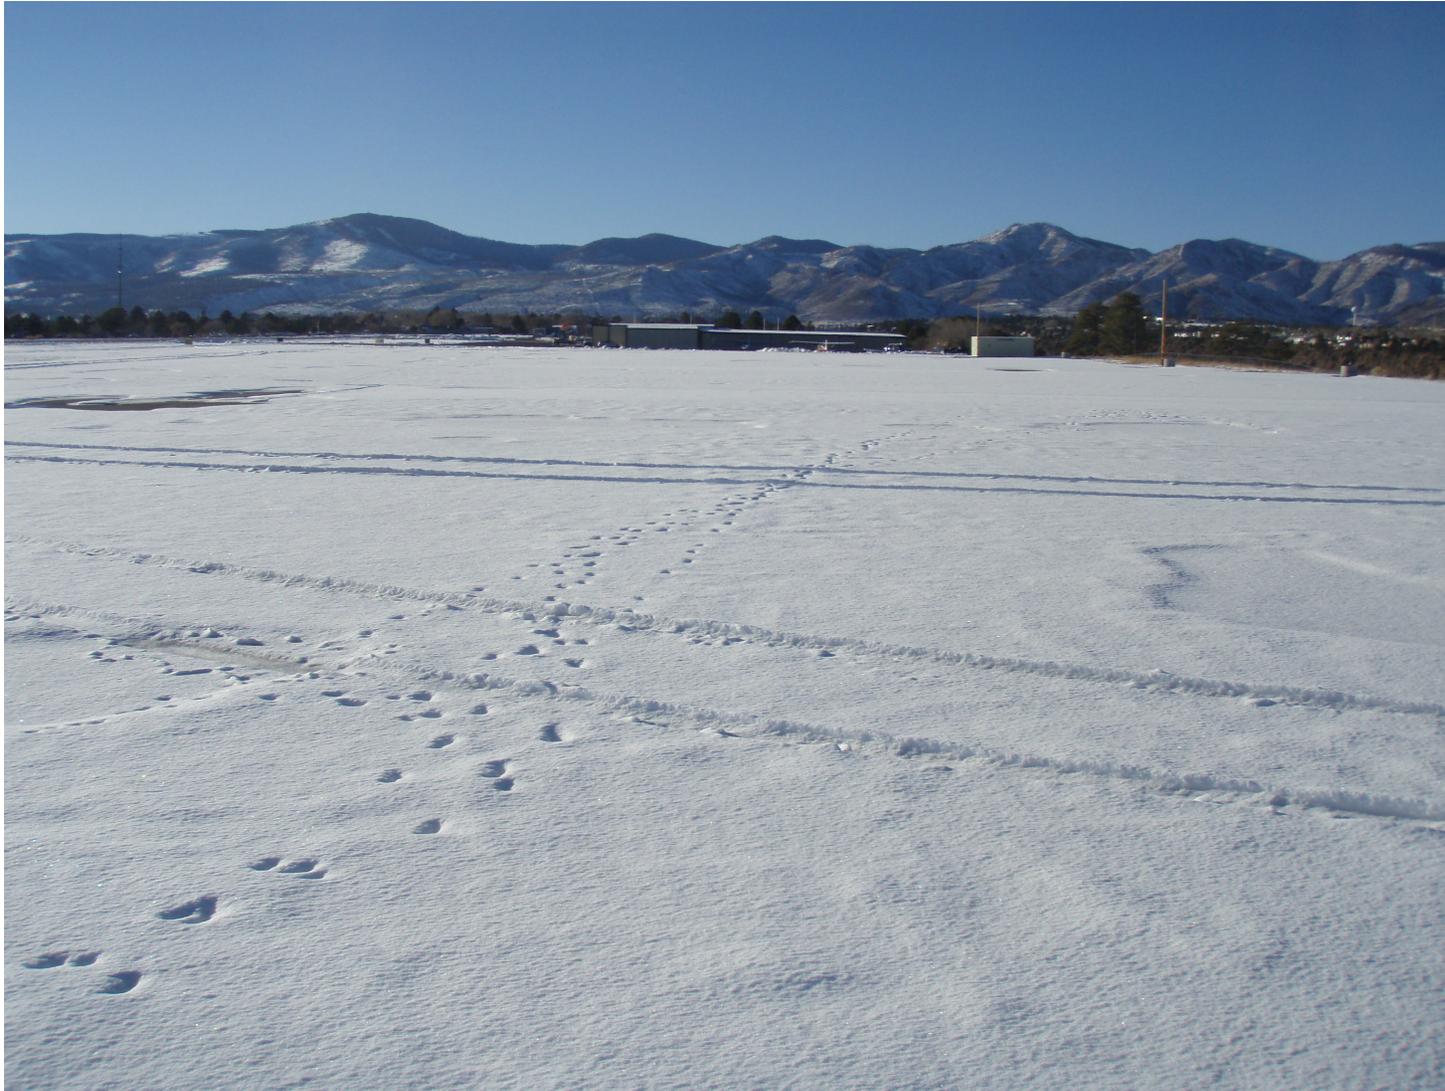
Photo 2: Looking west, photo taken December 16, 2011.

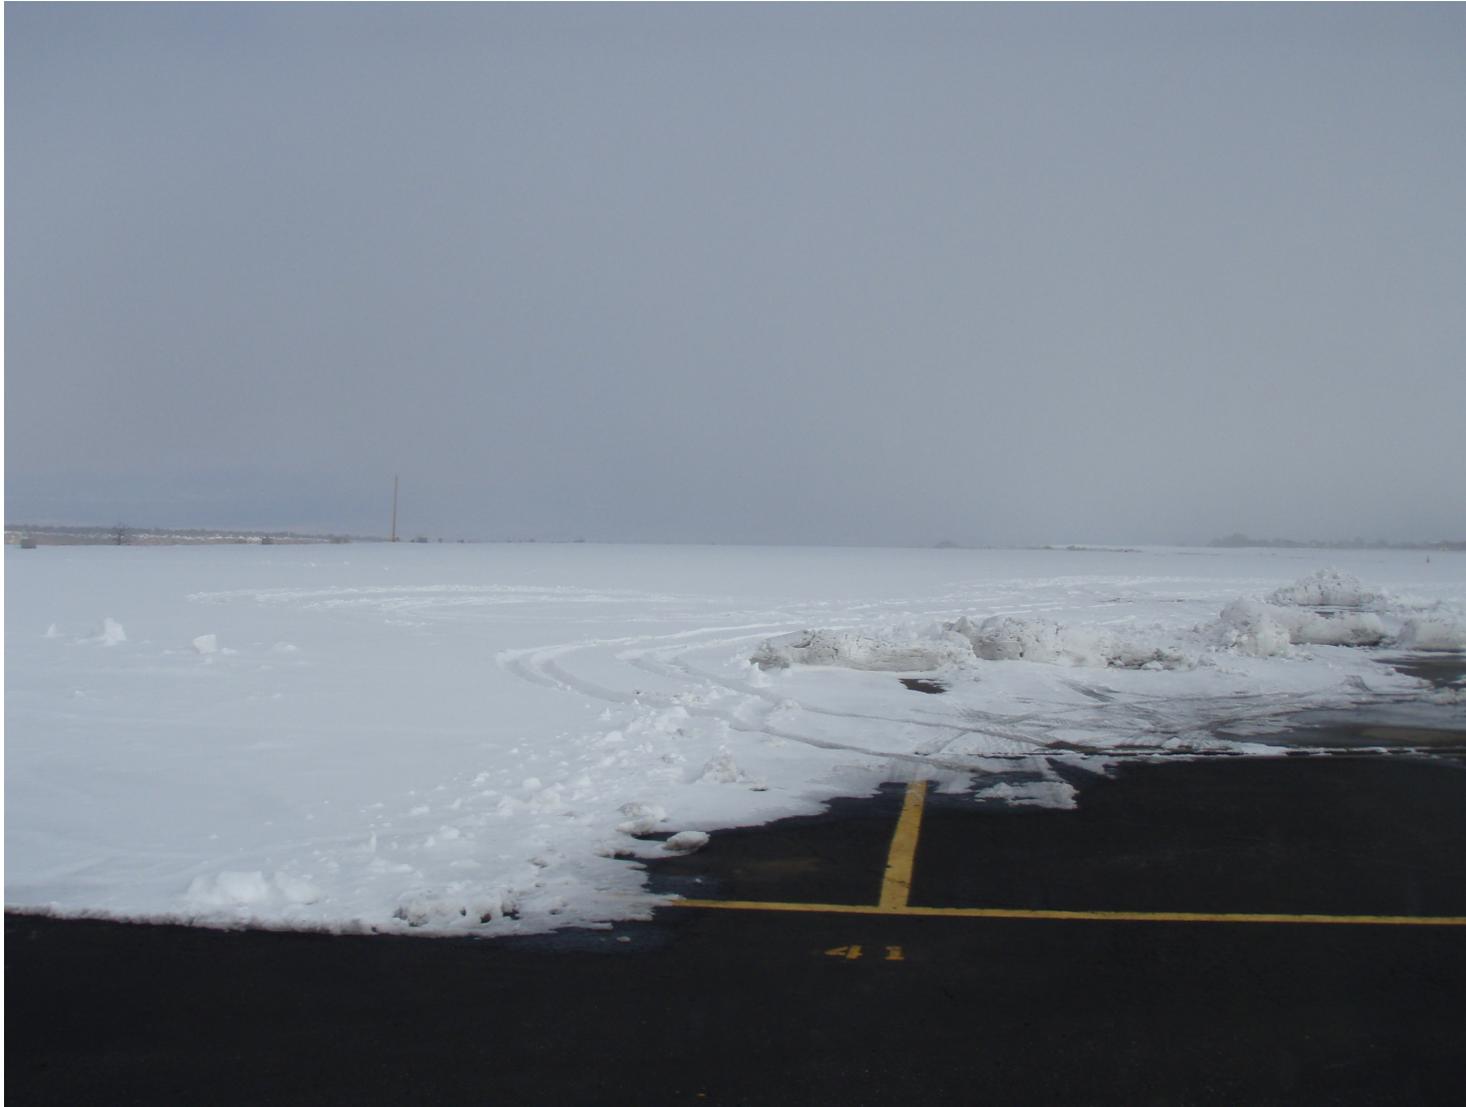
Photo 3: Looking east, photo taken December 20, 2011.

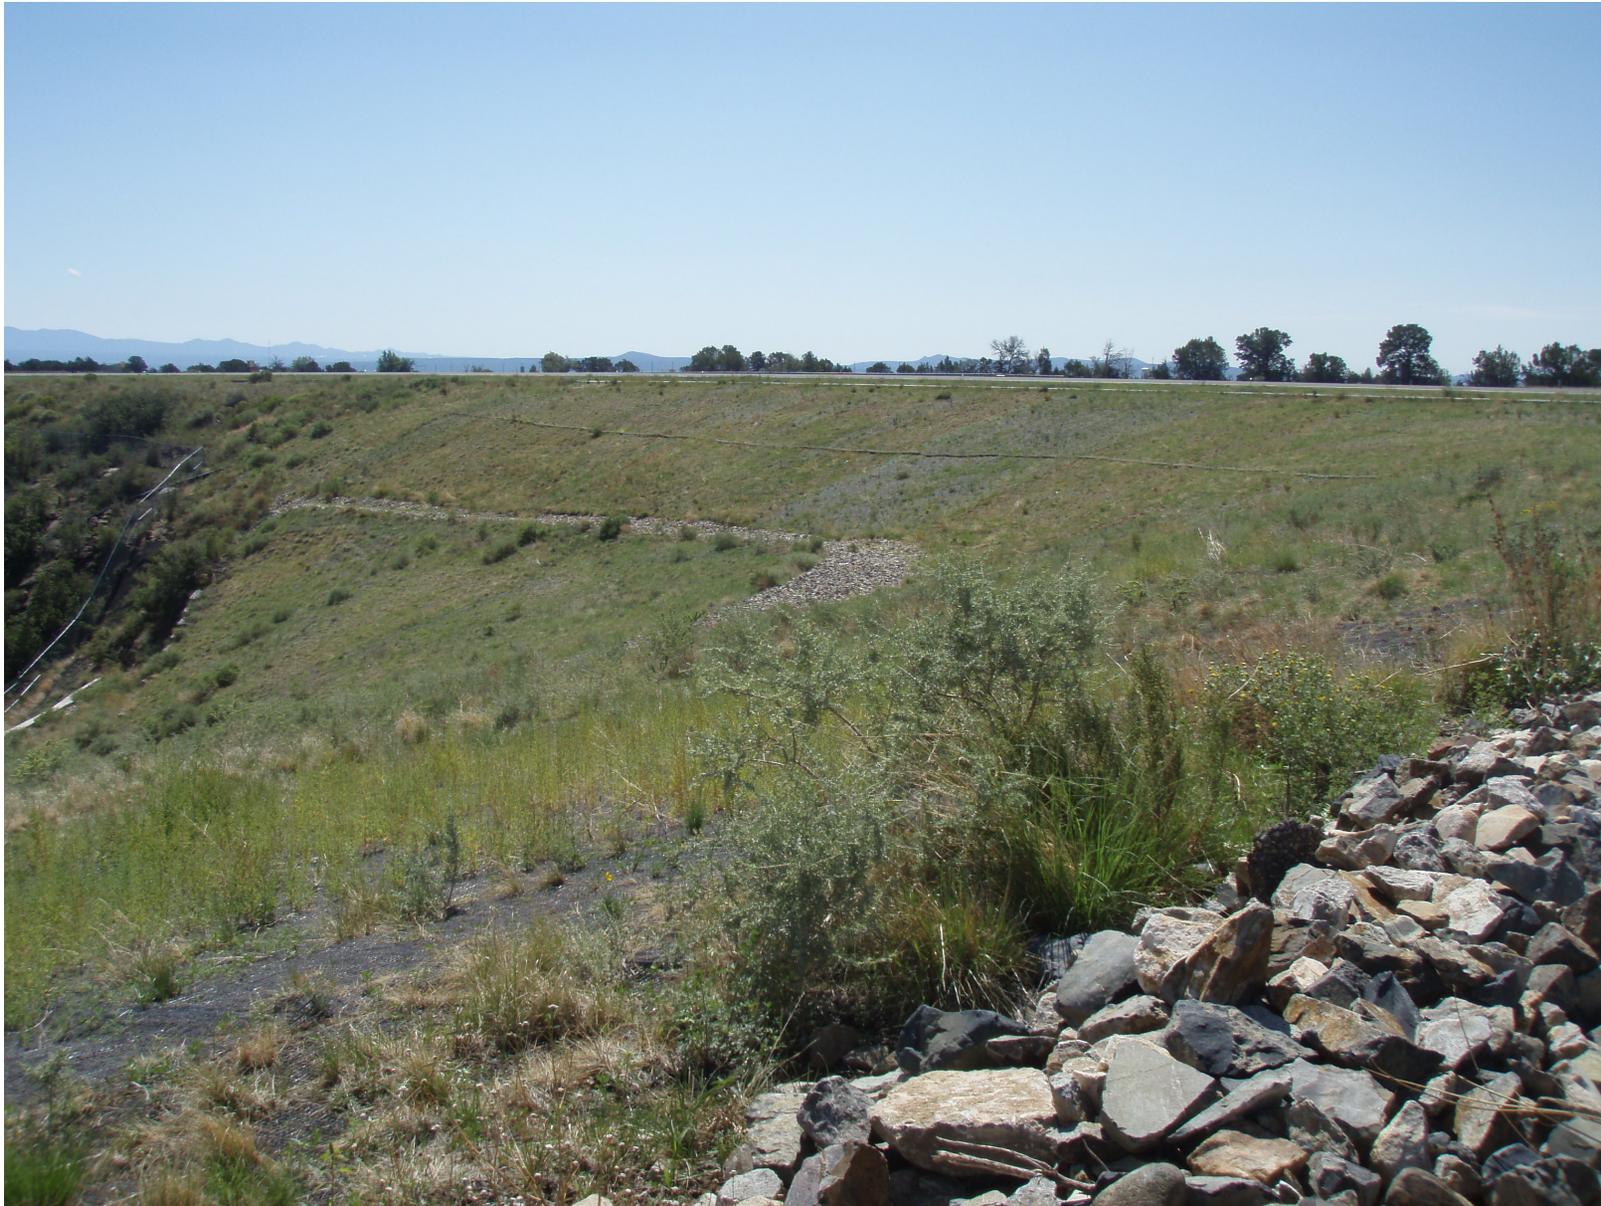
Photo 1: View SE at soil cap slope. No evidence of erosion, subsidence or sediment accumulation/movement. Note sage brush.

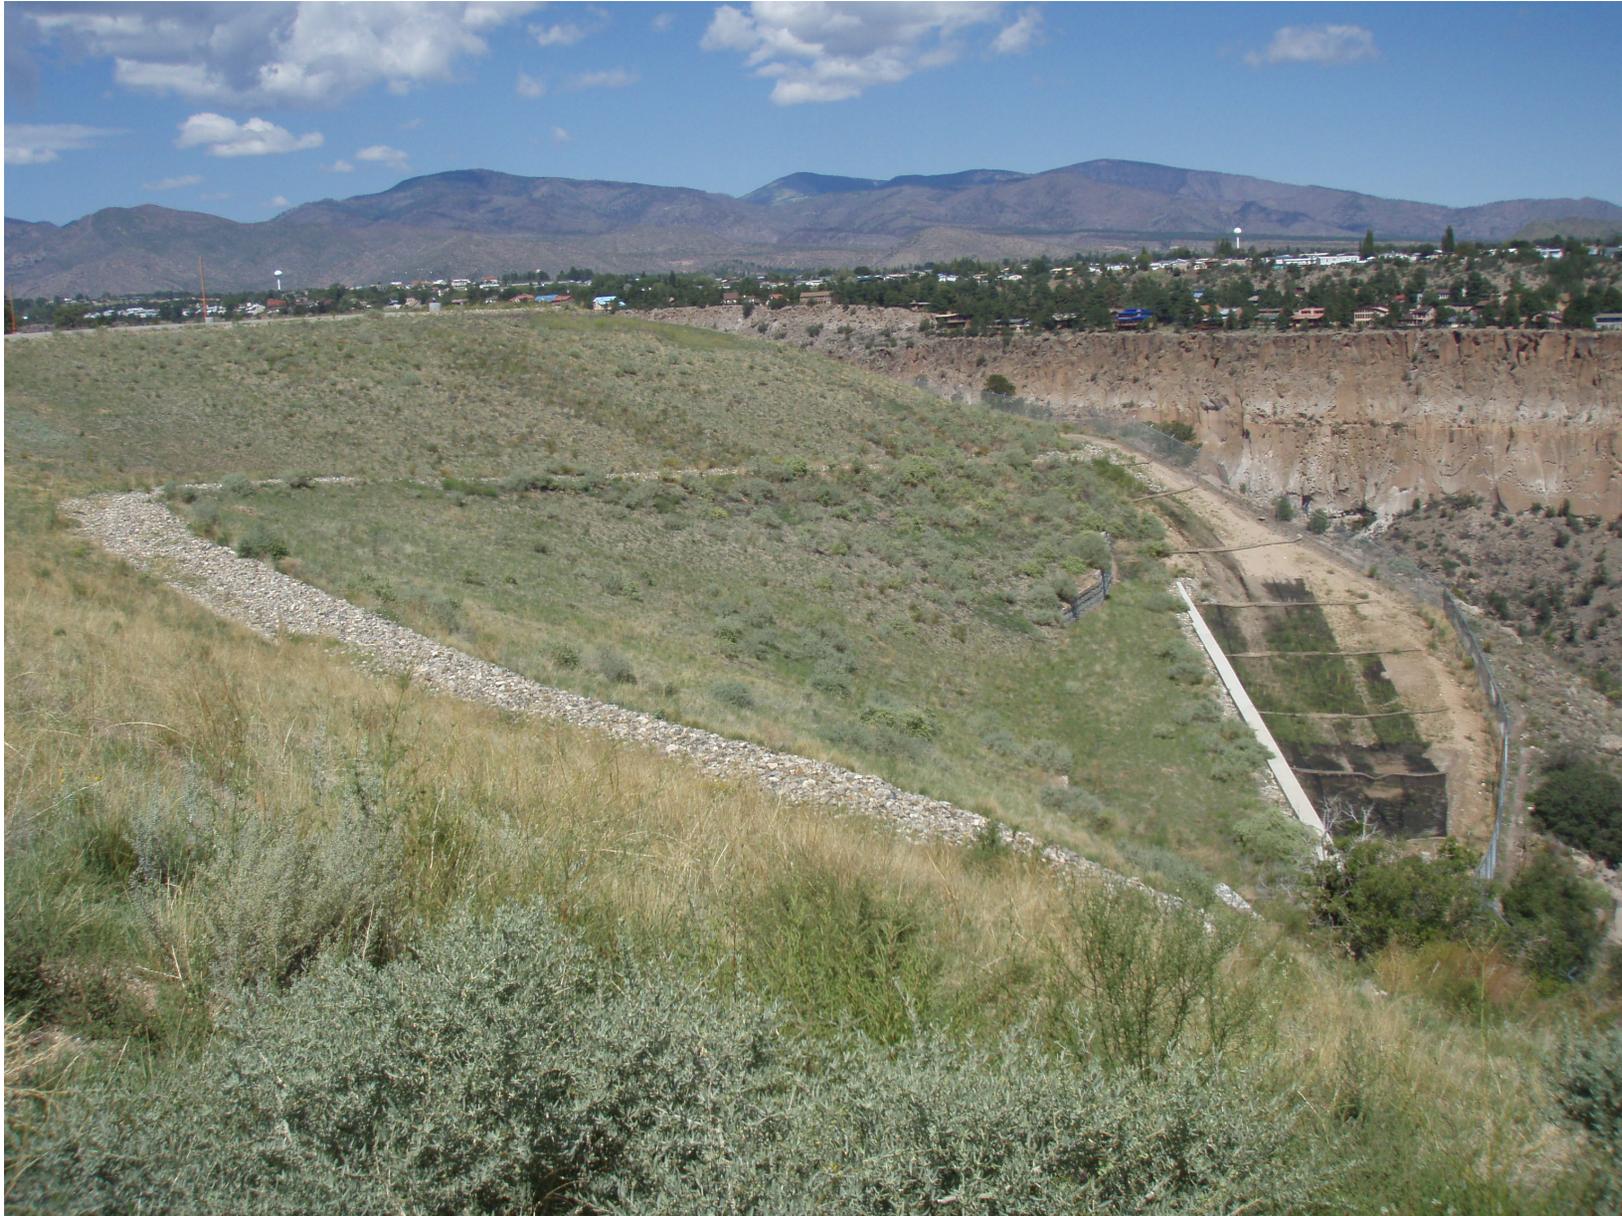
Photo 2: View NW across soil cap slope. Rill erosion and sediment accumulation behind wattles is evident along fence line. Remainder of slope is well vegetated. Rock channel is clean. Note sage brush across slope.

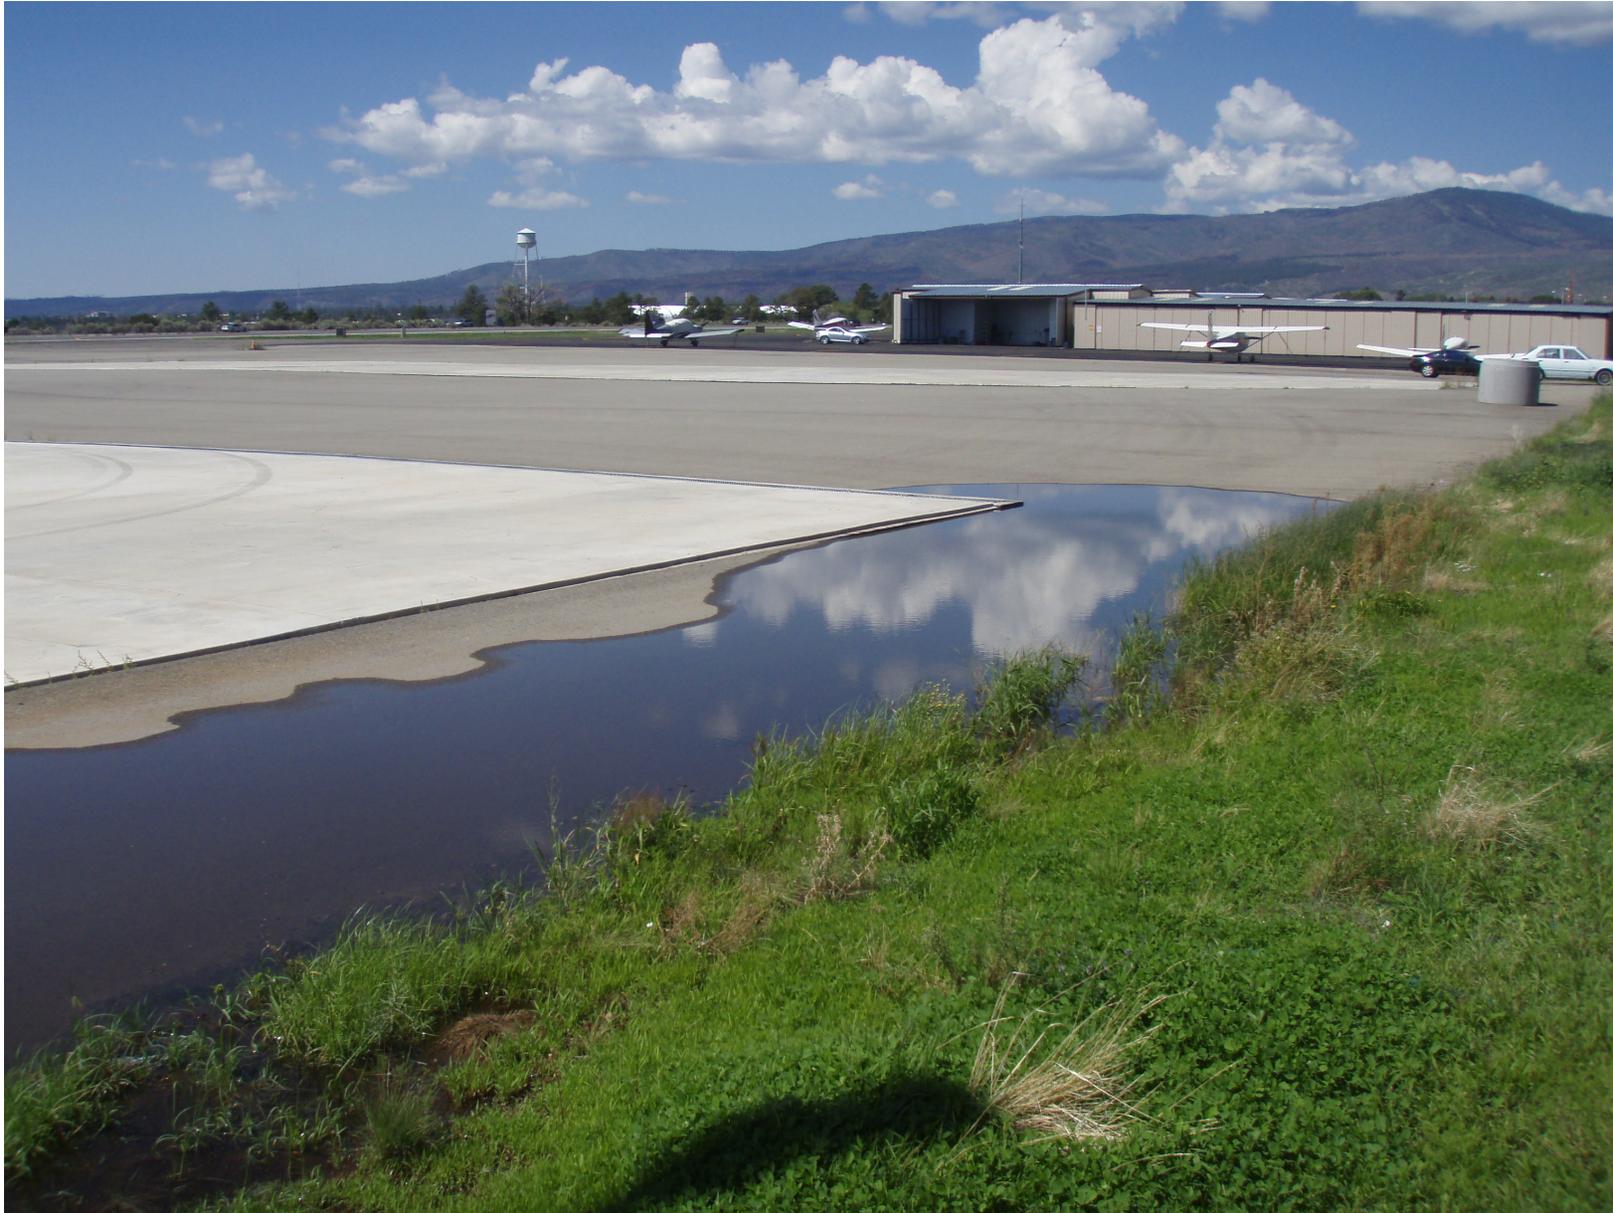
Photo 5: Puddle at north end of trench drain at pad # 2

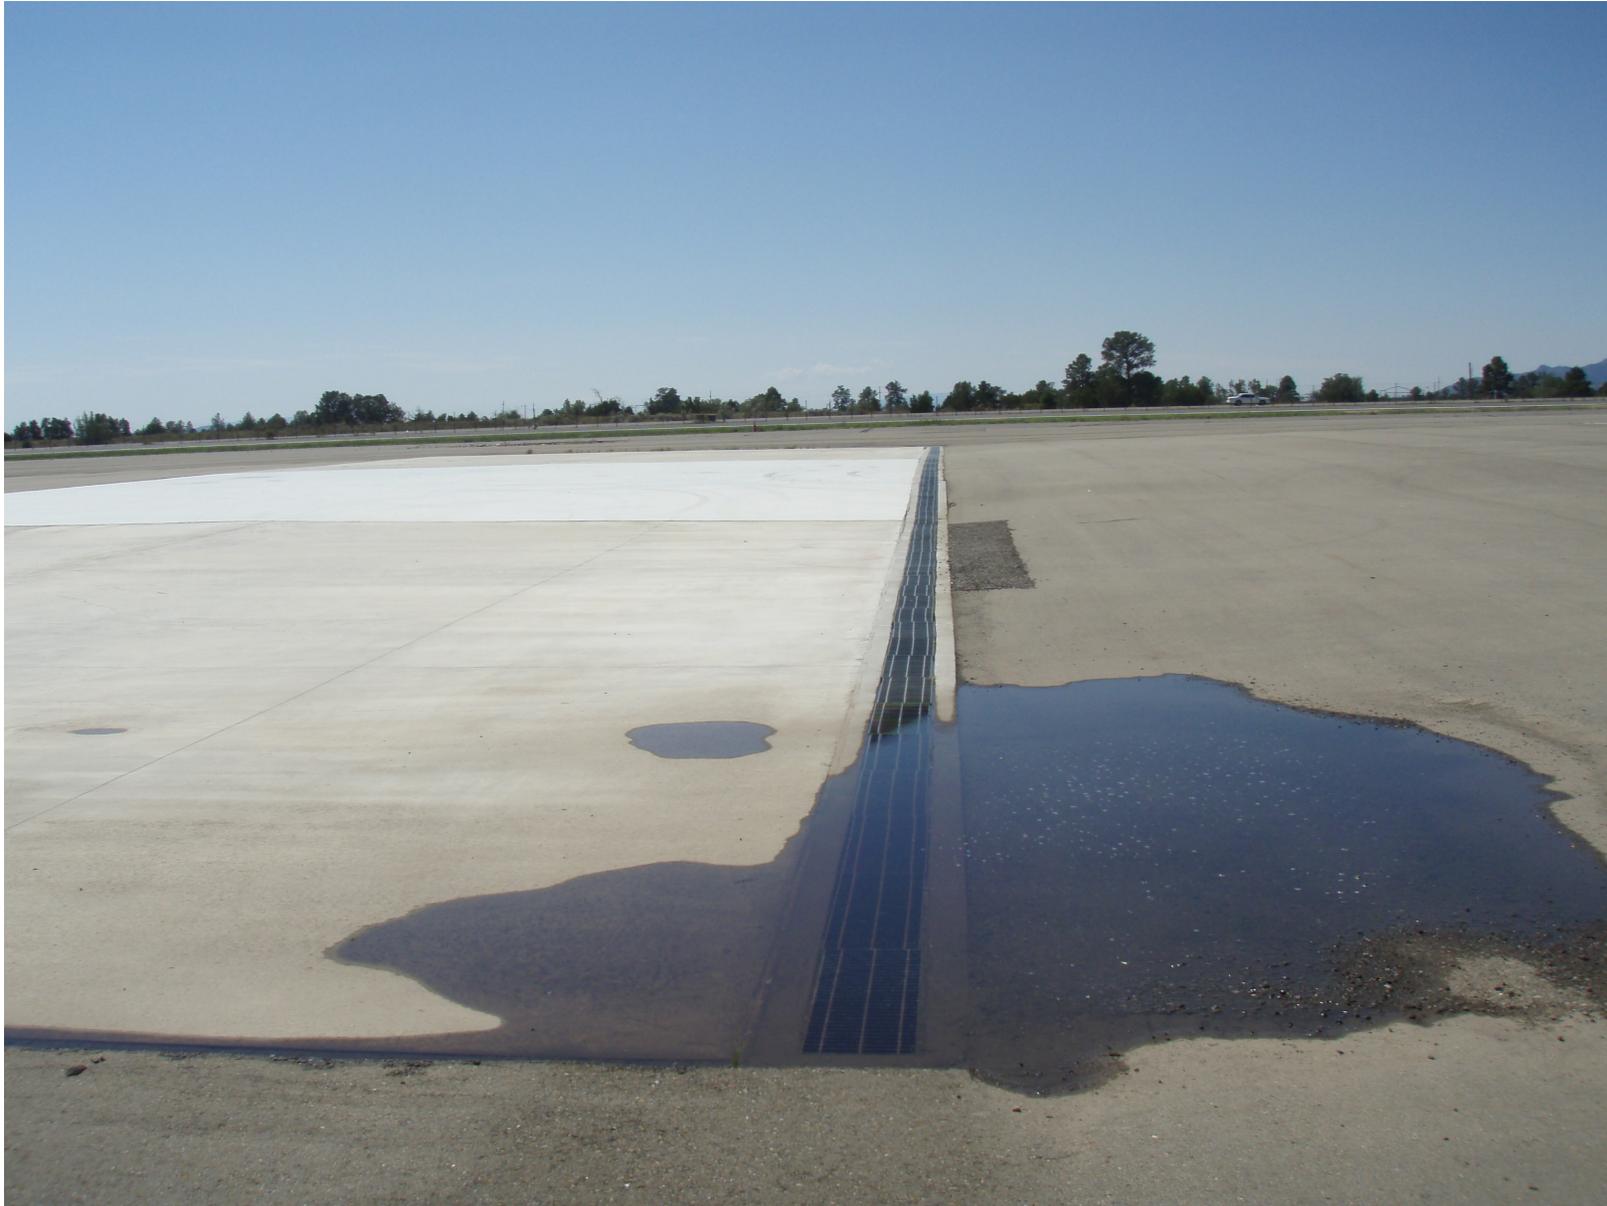
Photo 6: Looking east at pad # 3, puddle is at north end.

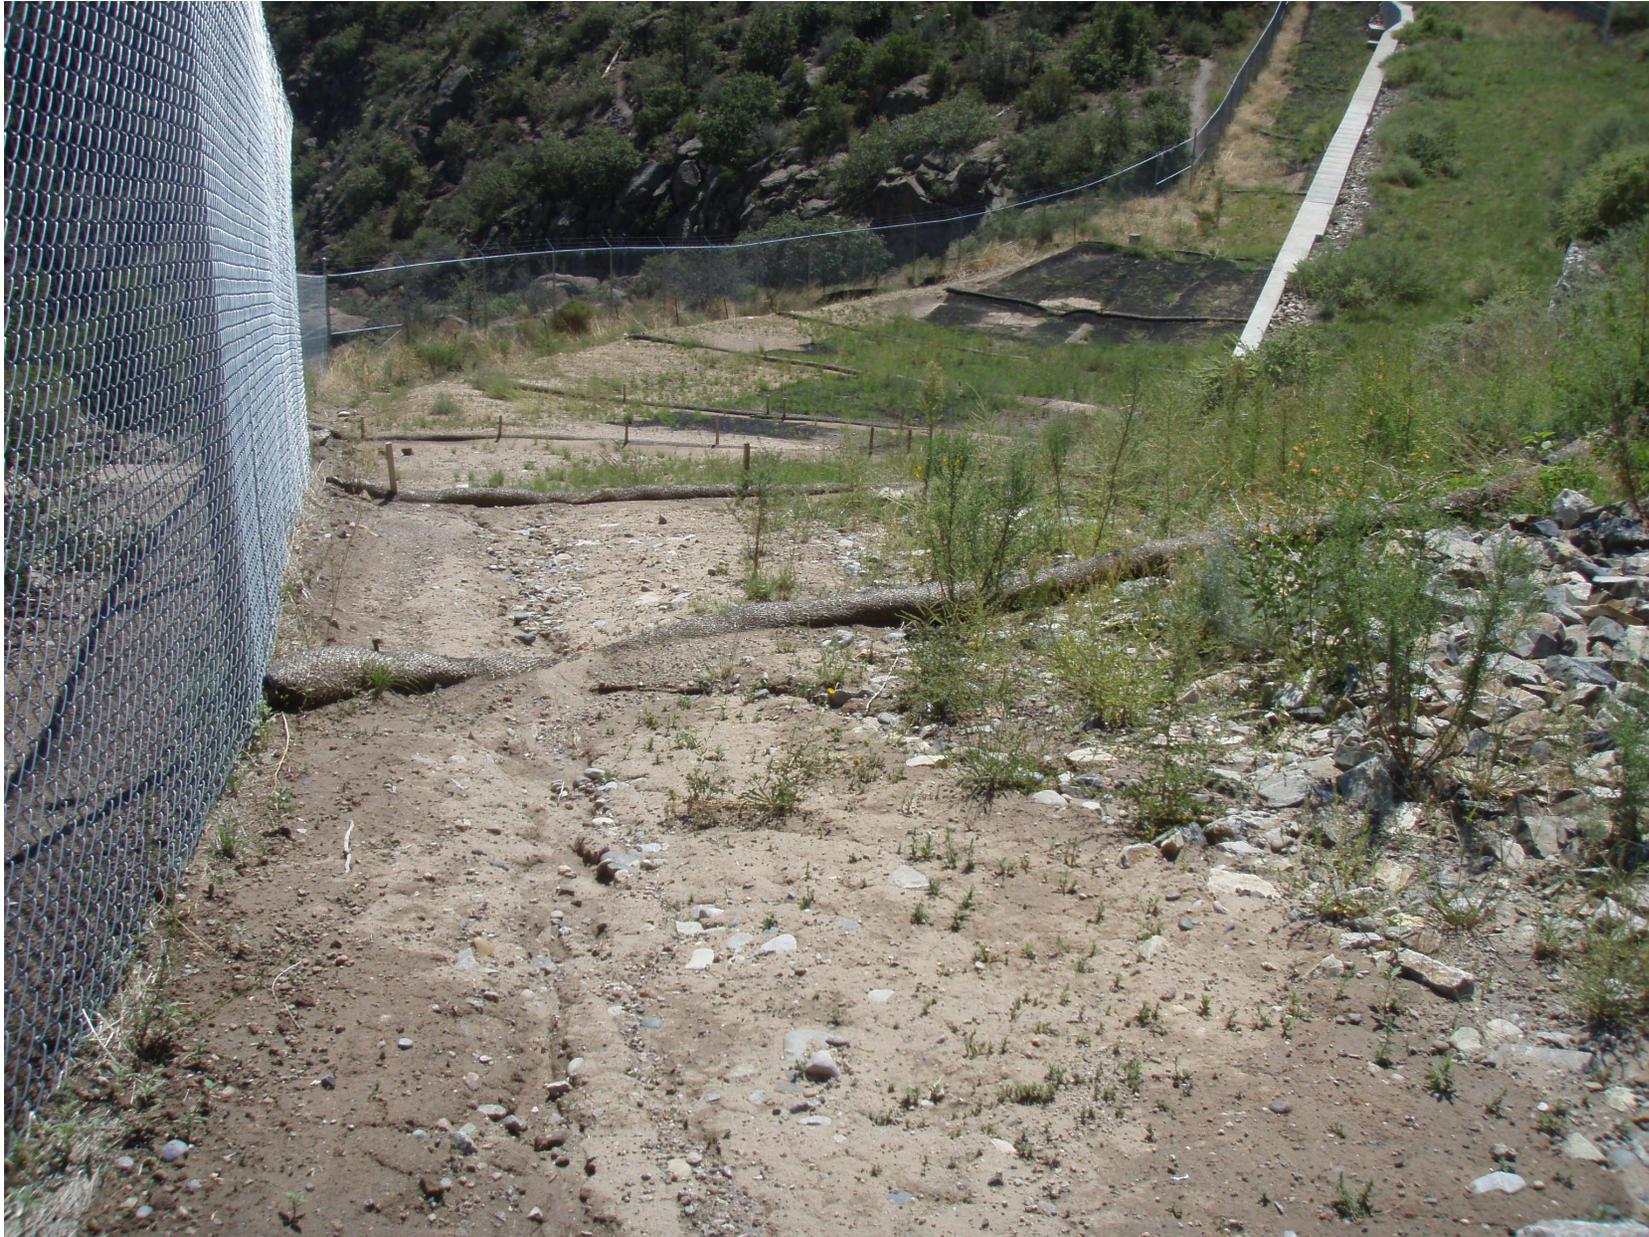
Photo 7: View of wattle area with sheet flow concerns.
