**Subject: Submittal of the 2011 Annual Inspection Report for Los Alamos County
Airport Landfill, Solid Waste Management Units 73-001(a) and 73-001(d),
Technical Area 73**

LA-UR-12-0671
February 2012
EP2012-0018

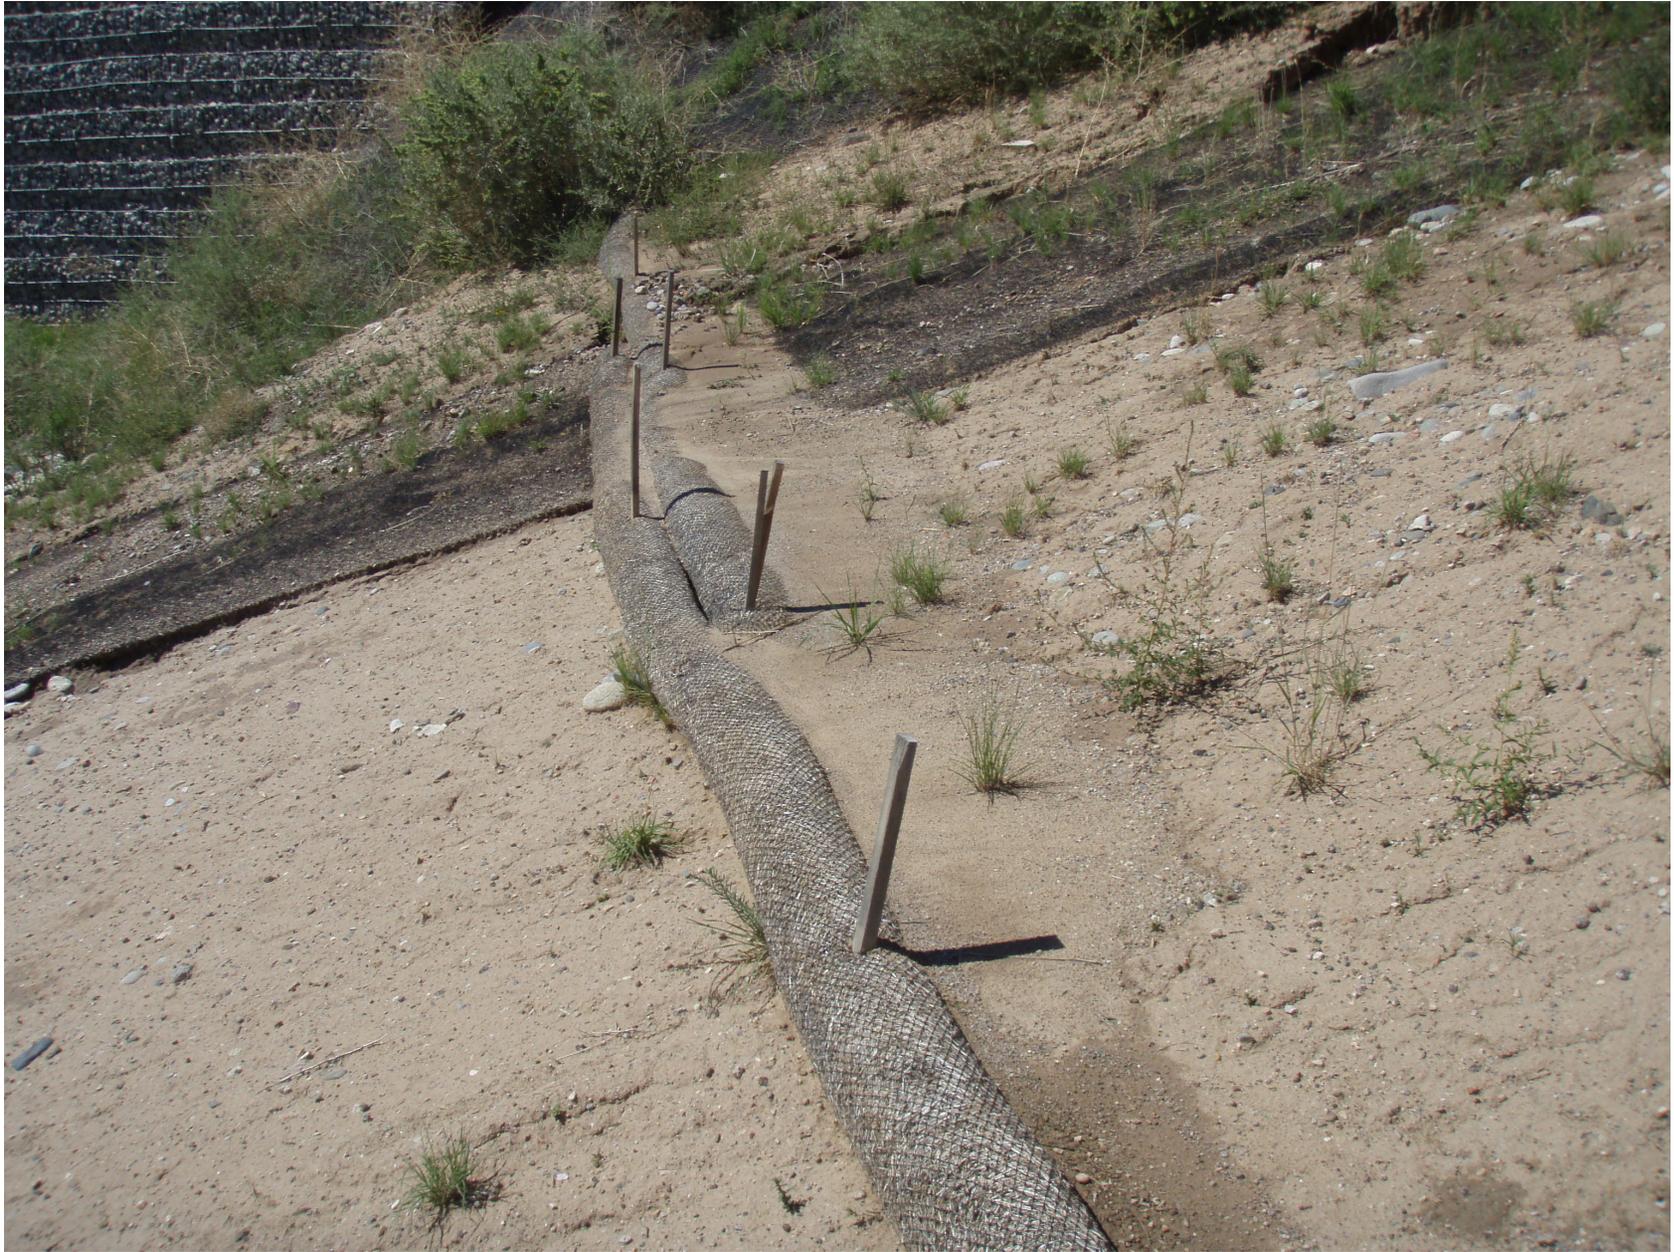
Photo 8: Sediment behind wattles and rilling along erosion control matting.

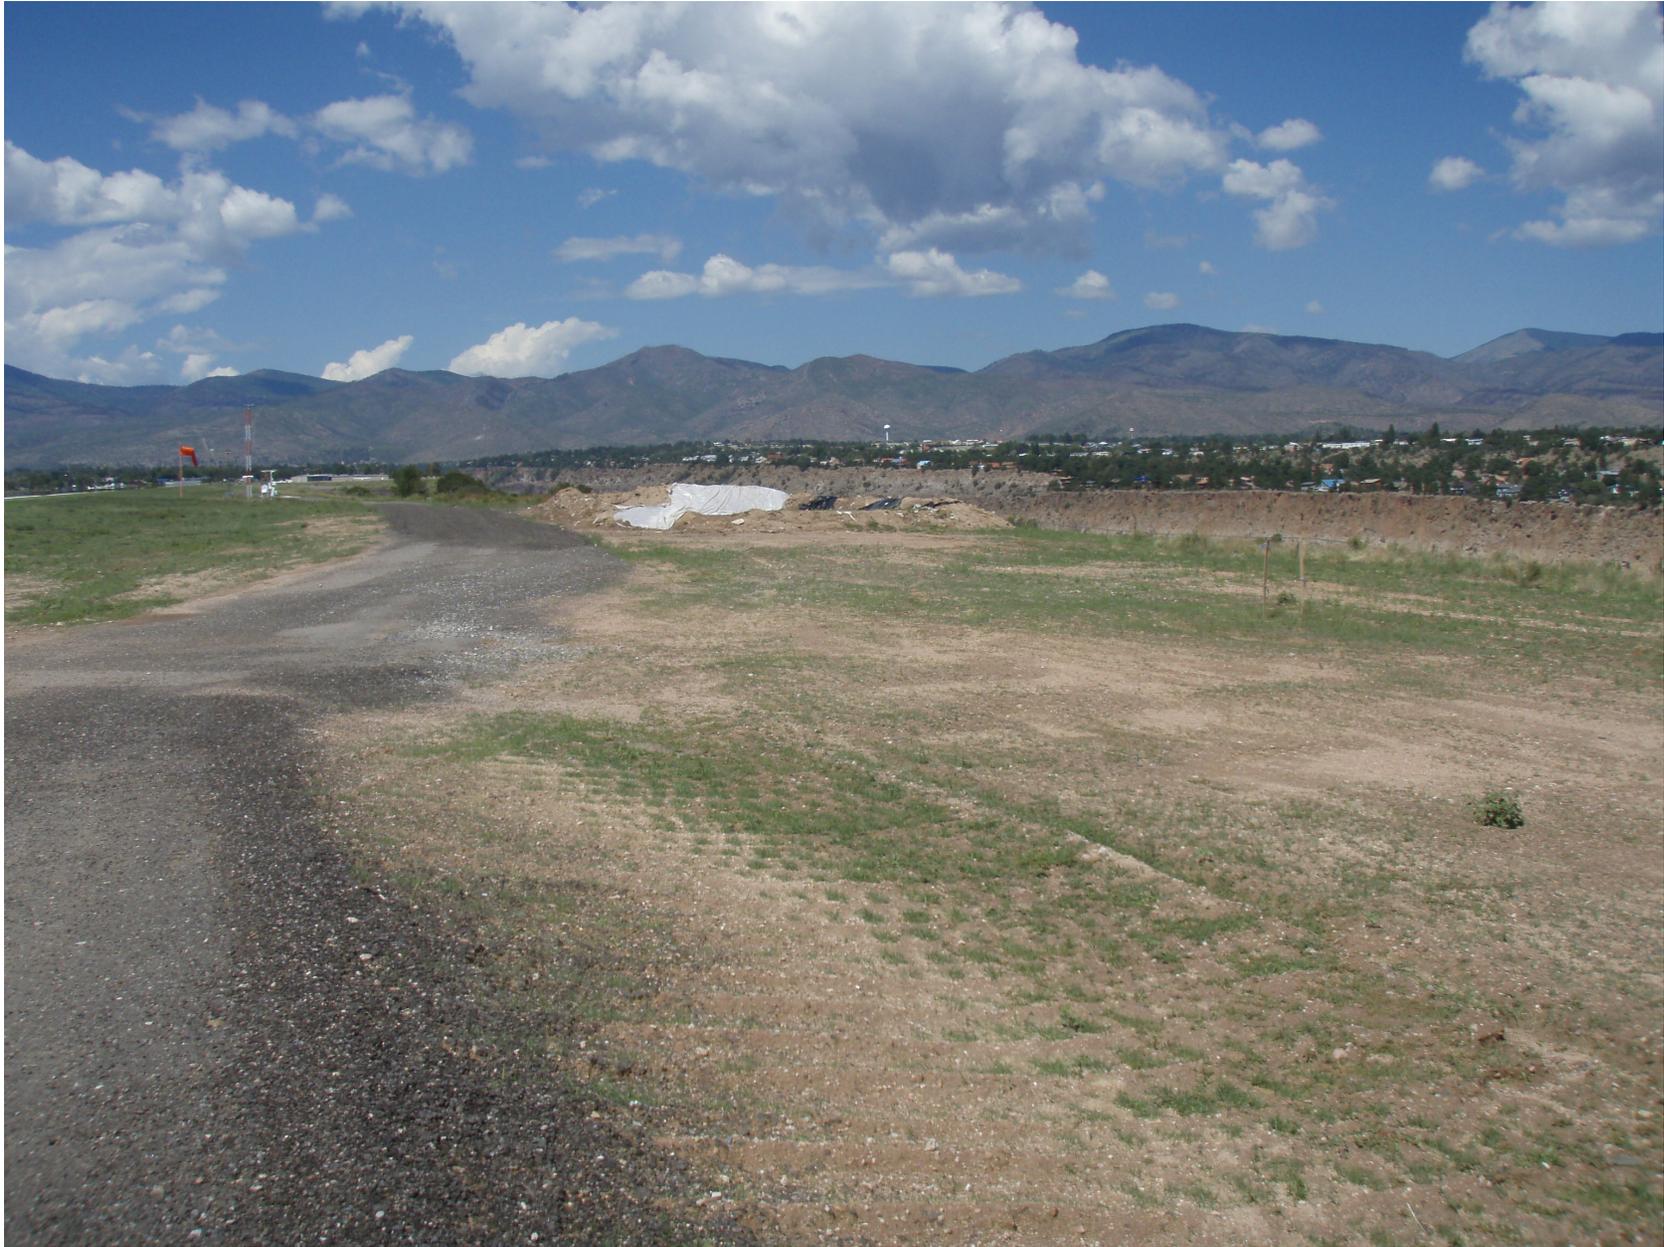
Component: Concern(s)	Inspection Frequency*	Inspection Findings	Corrective Action Needed Yes/No?	Description of Corrective Action	Corrective Action Completed Yes/No? & Date
Debris Disposal Area					
Seeded (hydromulched) Areas: animals burrows >4 inches deep, barren areas >1,000 square feet, subsidence >1 ft deep, rills/cracks >4 inches deep, large vegetation (trees, shrubs, bushes, deep-rooting weeds)	A, ASR	<p>NOTE: The County started runway extension (450 ft) work in March 2011. The very eastern section of the DDA is being built up to extend the runway (acting as additional capping material).</p> <p>Runway extension project completed in July 2011.</p> <p>The DDA cover has been reworked and added to for the runway extension. Upon completion of work the area was reseeded. Grass is currently growing. Evidence of rill erosion following the storm event. LAC and their contractor are responsible for any issues/concerns with reseeded areas.</p> <p>A concrete wash-out basin was built over part of the DDA cap. Basin is still in place while drying out.</p> <p>Photo 9, 10</p>	No

Photo 9: Concrete washout basin over the DDA.

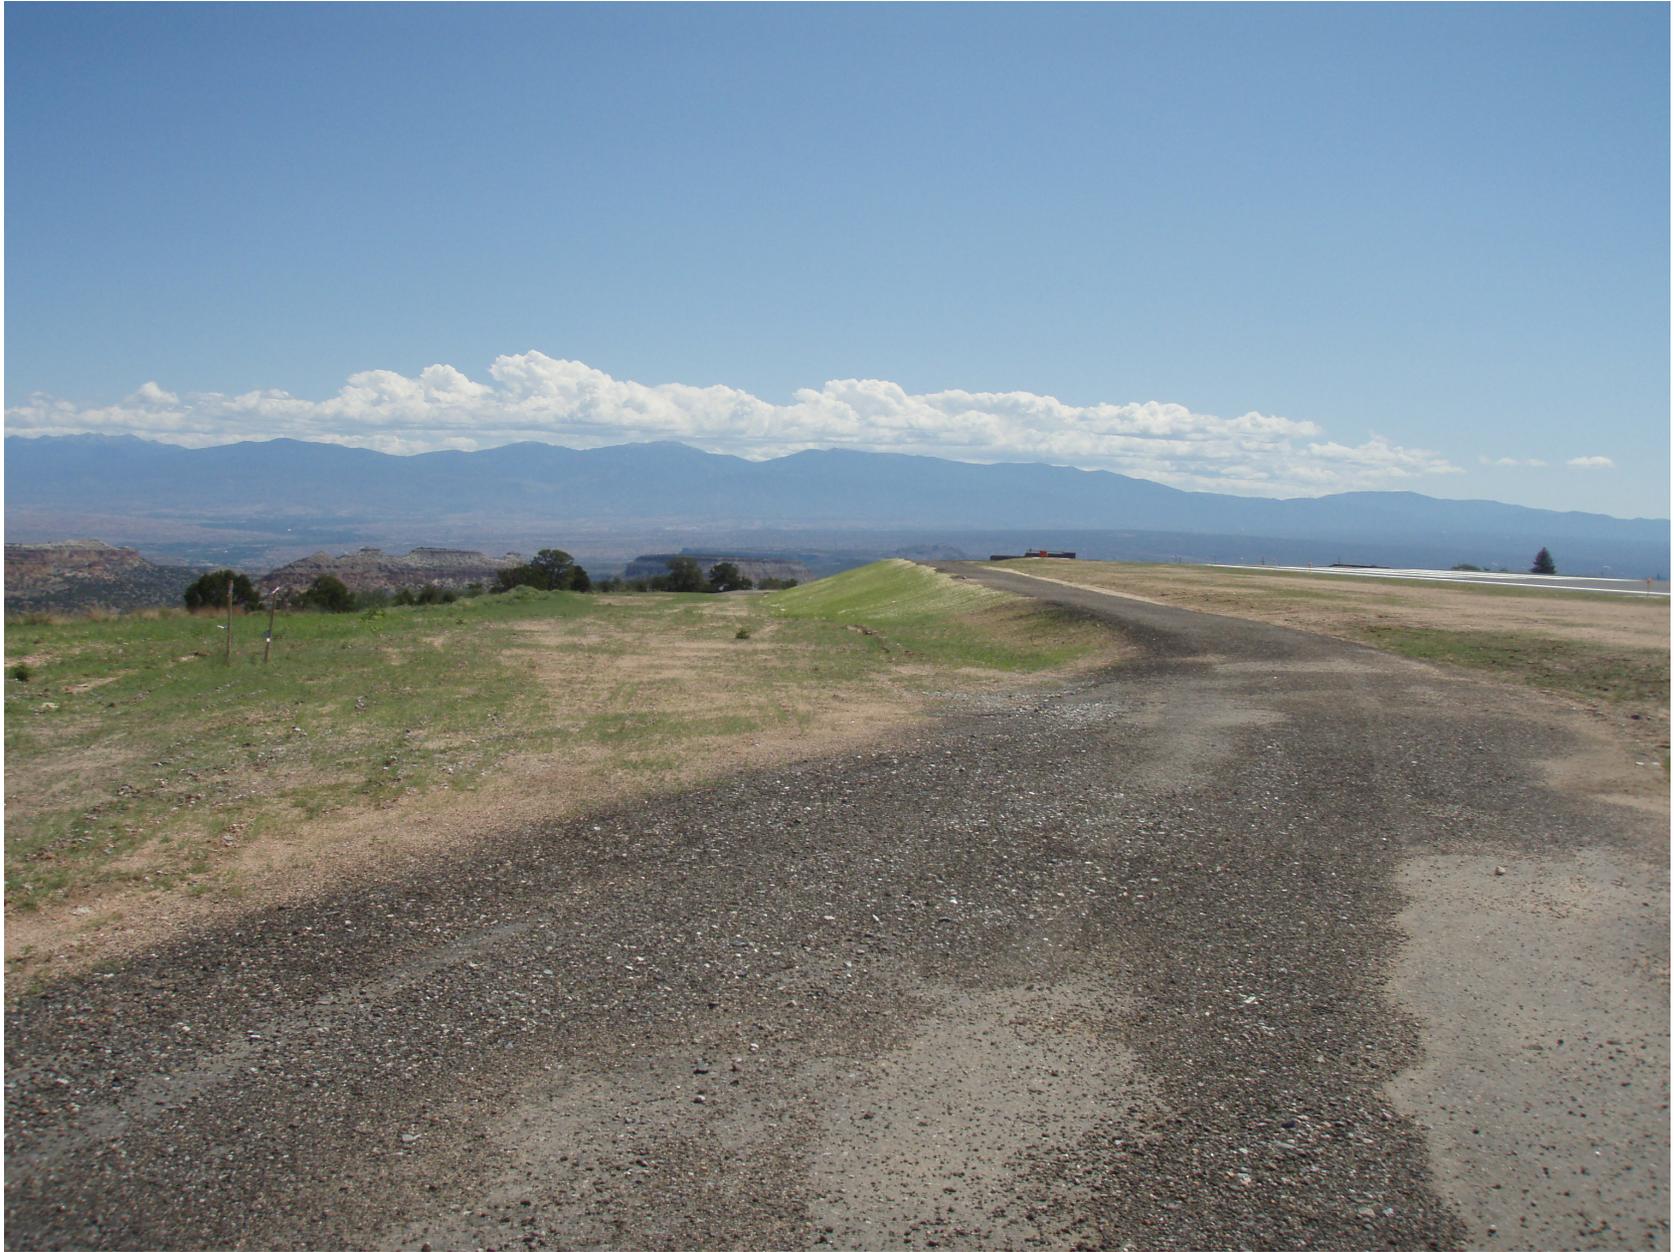
Photo 10: Runway extension and reseeding of the DDA.

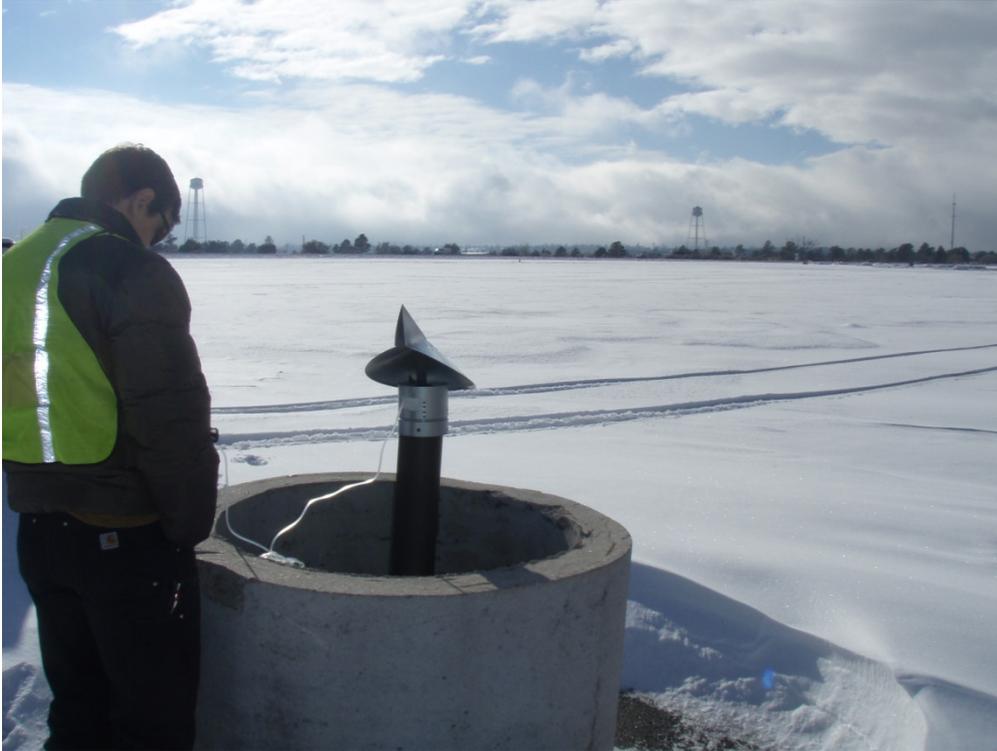
Comments: All sites with NA were not accessible due to snow from the December 6 and 20 storms, see attached photos. PS-02, PS-03 & PS-05 are capped. PS-04 and PS-06 registered at 100% for instrument alarm. Recommend additional monthly monitoring.

Monitoring PS-06

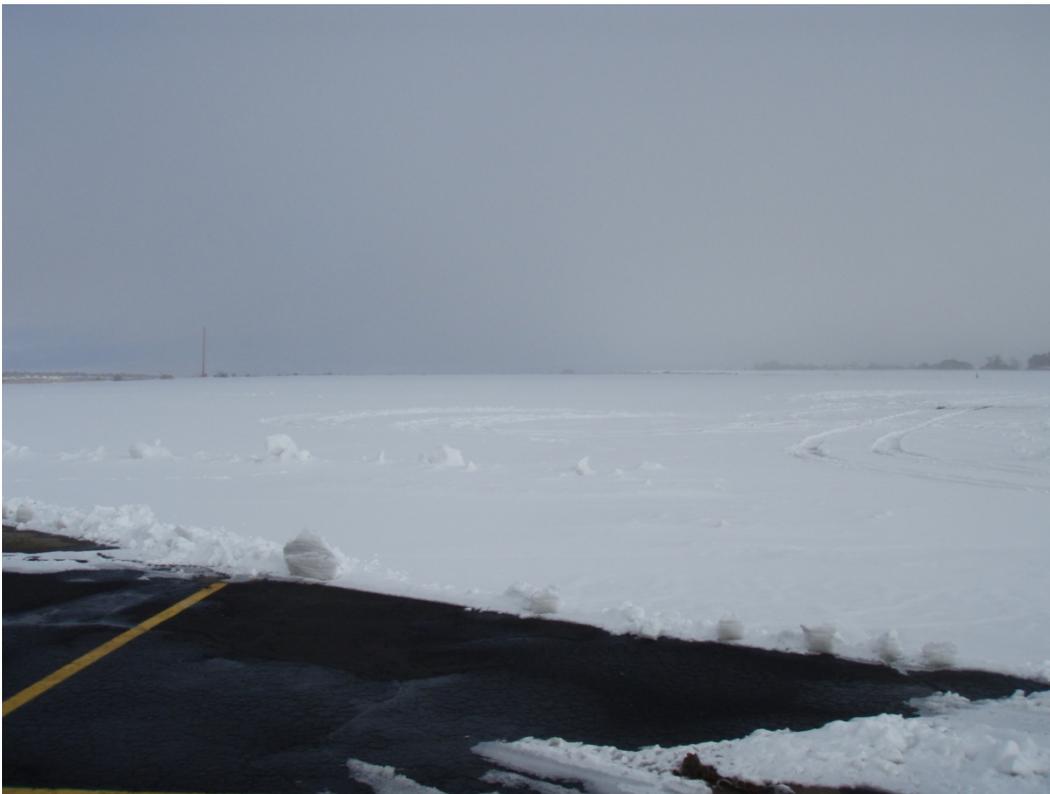
Snow across hangar pads. Pads, trench drains and drop inlets were not accessible due snow accumulation and drifting snow from the December 6th and 20th storm events.
