Subject: Submittal of the 2013 Annual Inspection Report for Los Alamos County Airport Landfill, Solid Waste Management Units 73-001(a) and 73-001(d), Technical Area 73

**2013 Annual Inspection Report for
Los Alamos Country Airport Landfill,
Solid Waste Management Units
73-001(a) and 73-001(d),
Technical Area 73**

Prepared by the Los Alamos Field Office

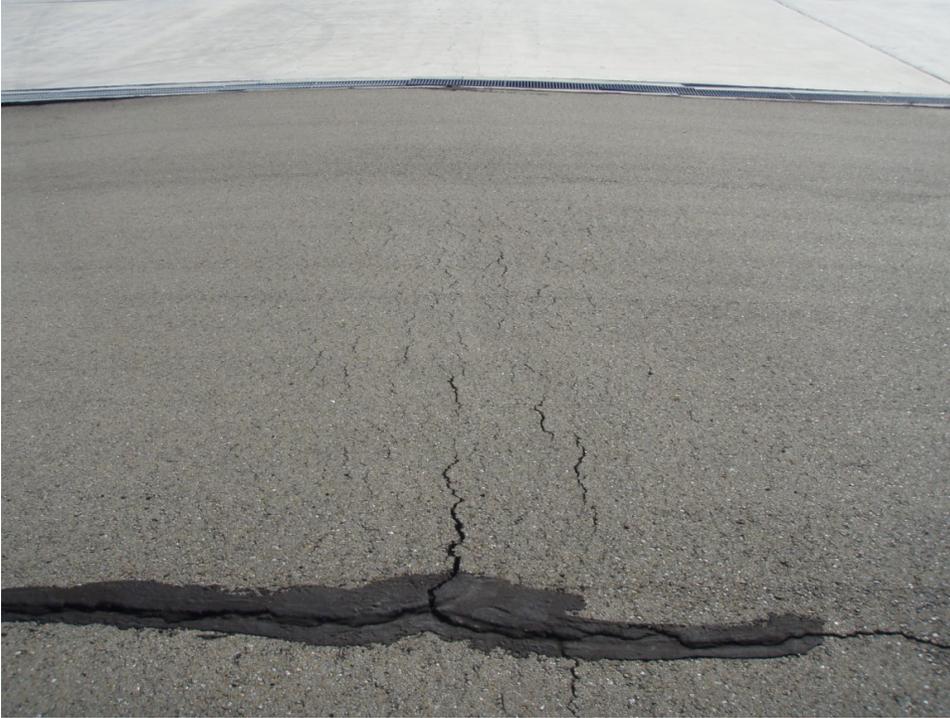
Figure 3.1-1 Cracks in MatCon asphalt between hangar pads 3 and 4

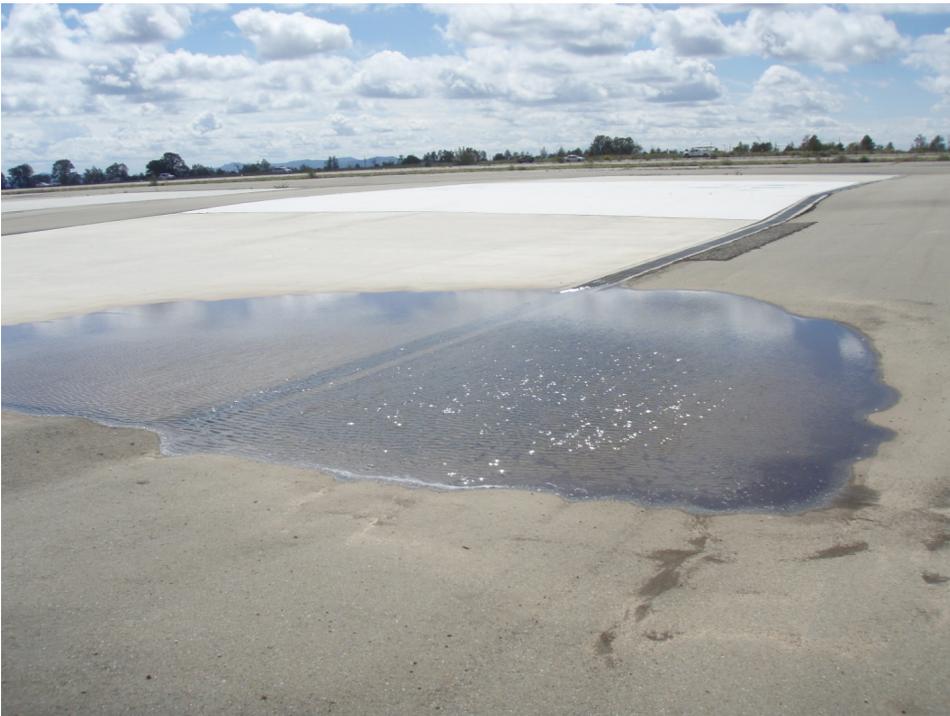
Figure 3.1-2 Subsidence at hangar pad 3

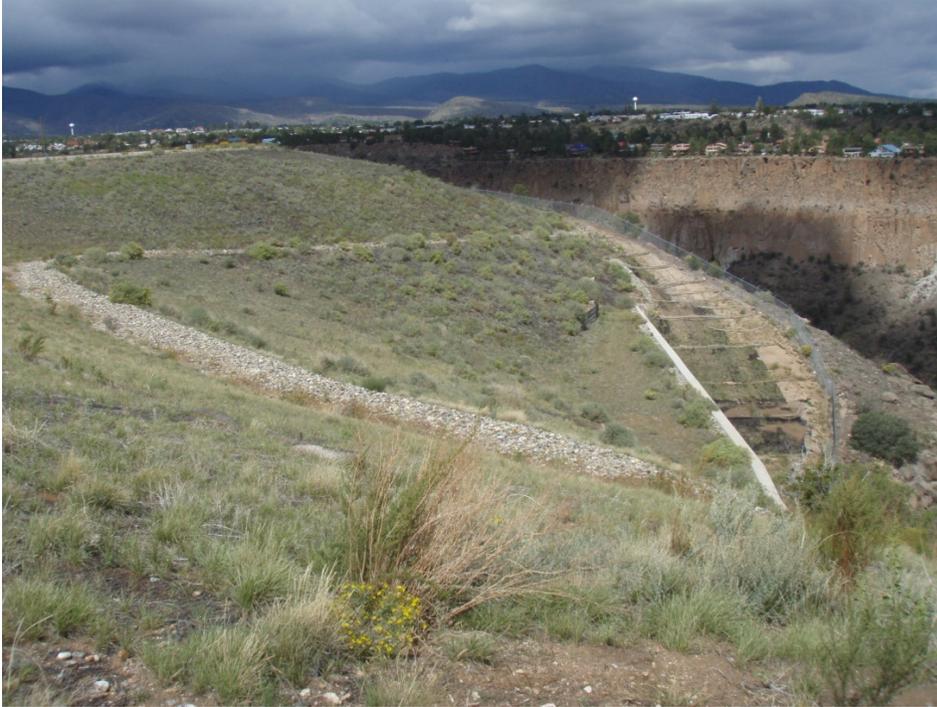
Figure 3.2-1 Vegetated slope area

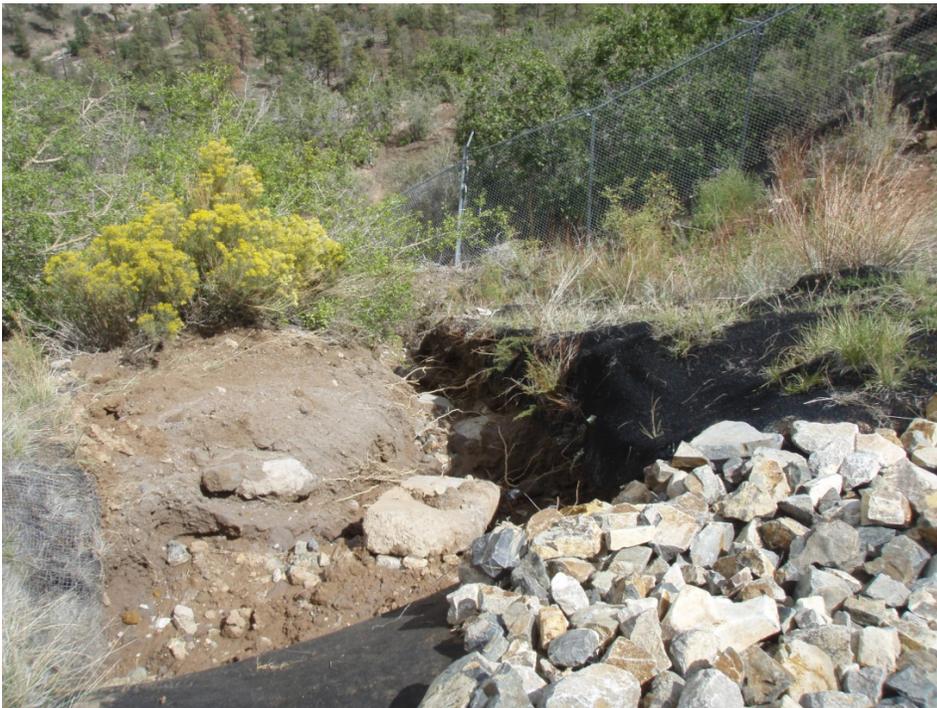
The mid-slope rip-rap channel within the vegetated slope area has some minor sedimentation. The far eastern end of the channel has contributed to the erosion channel cut into the vegetated slope (Figure 3.2-2). The riprap has failed and the liner is exposed (Figure 3.4-1).

Figure 3.2-2 Erosion channel from runoff from the riprap channel

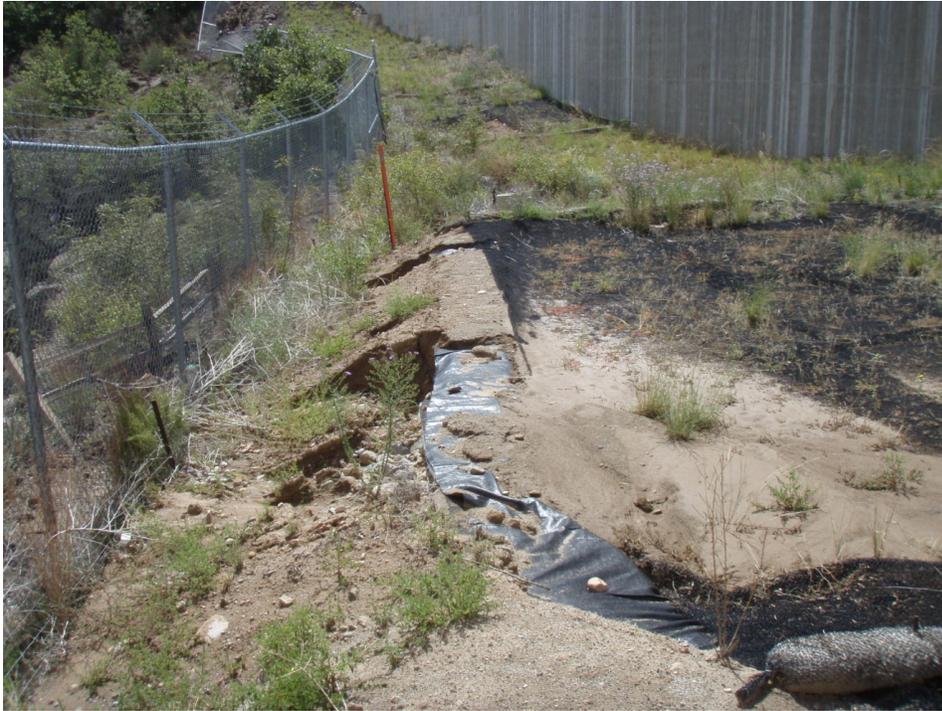
Three small detention areas are located east of the concrete retaining wall to enhance sediment removal and reduce storm water velocity from the adjacent slopes. At two of the detention areas, the retention berm failed after the September rain events (Figure 3.5-1).

Figure 3.5-1 Failure of retention berm

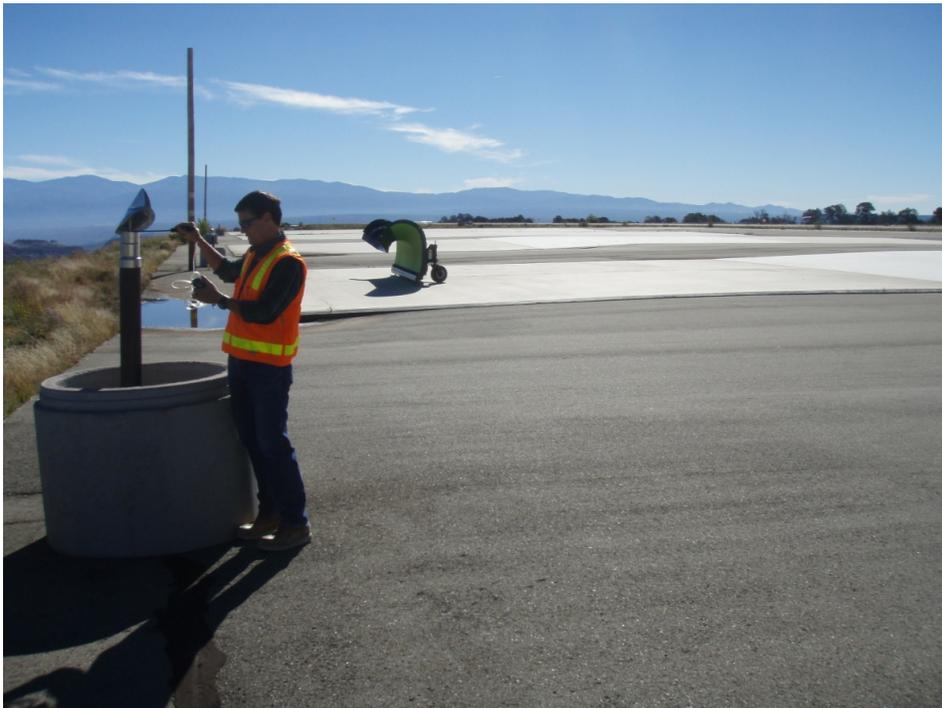
Figure 3.7-1 Gas monitoring at PS-02

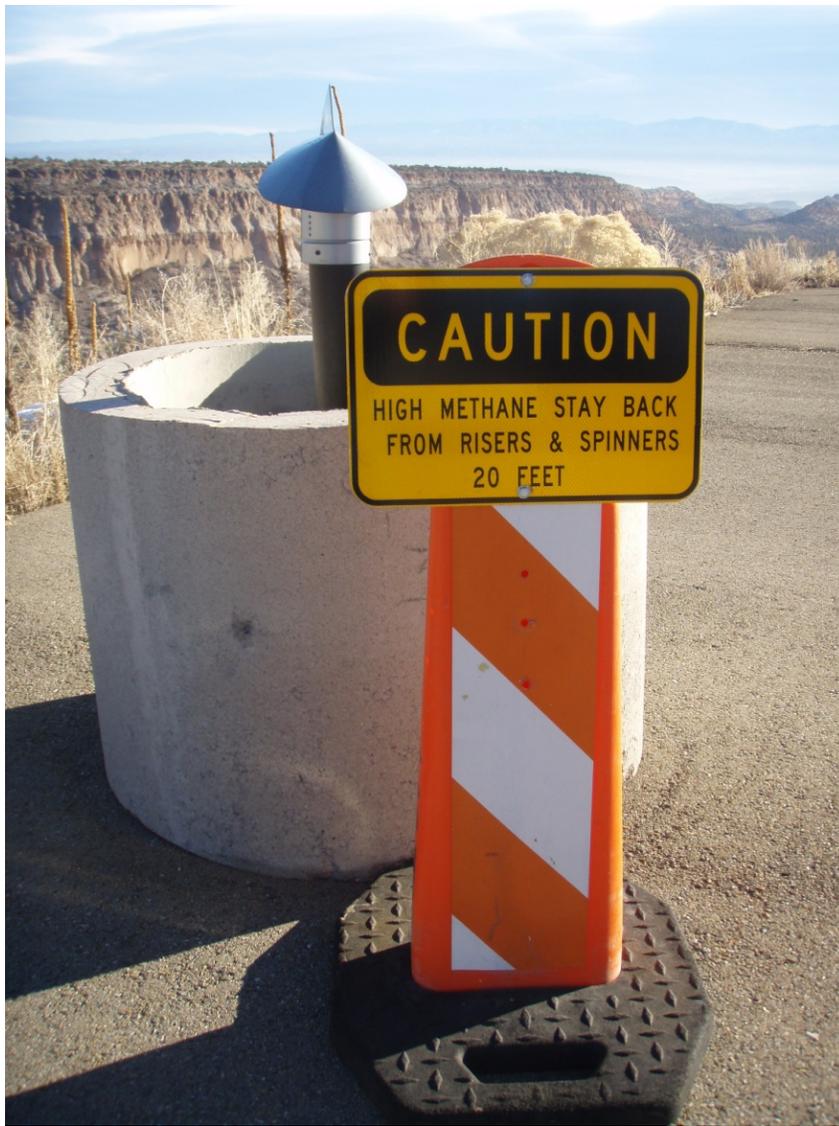
Figure 3.7-2 Caution sign at PS-06

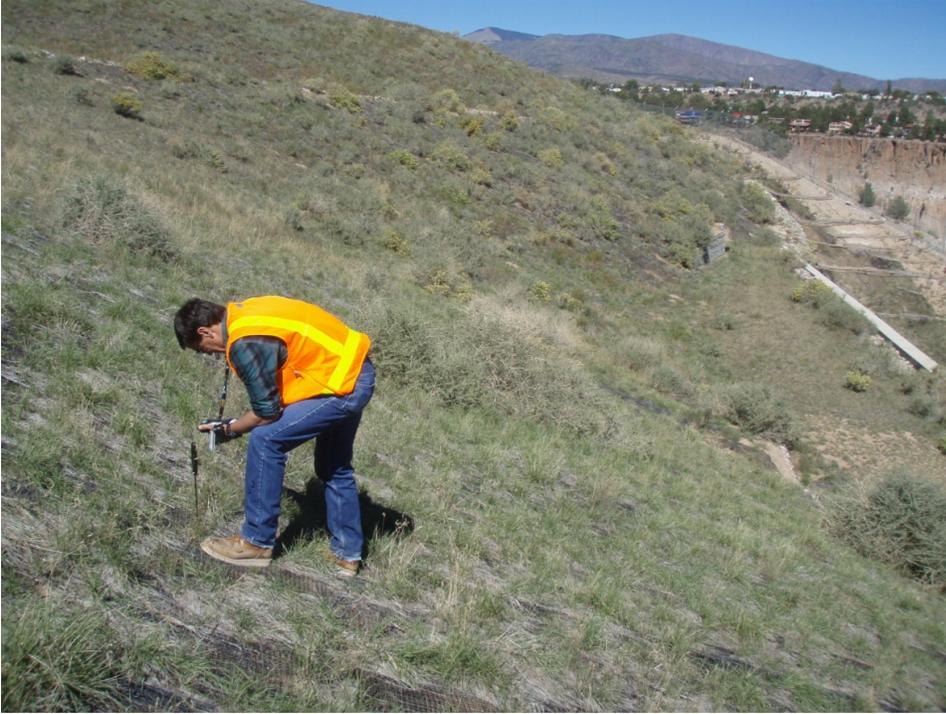
Figure 3.7-3 Gas monitoring at PG-14 on vegetated slope

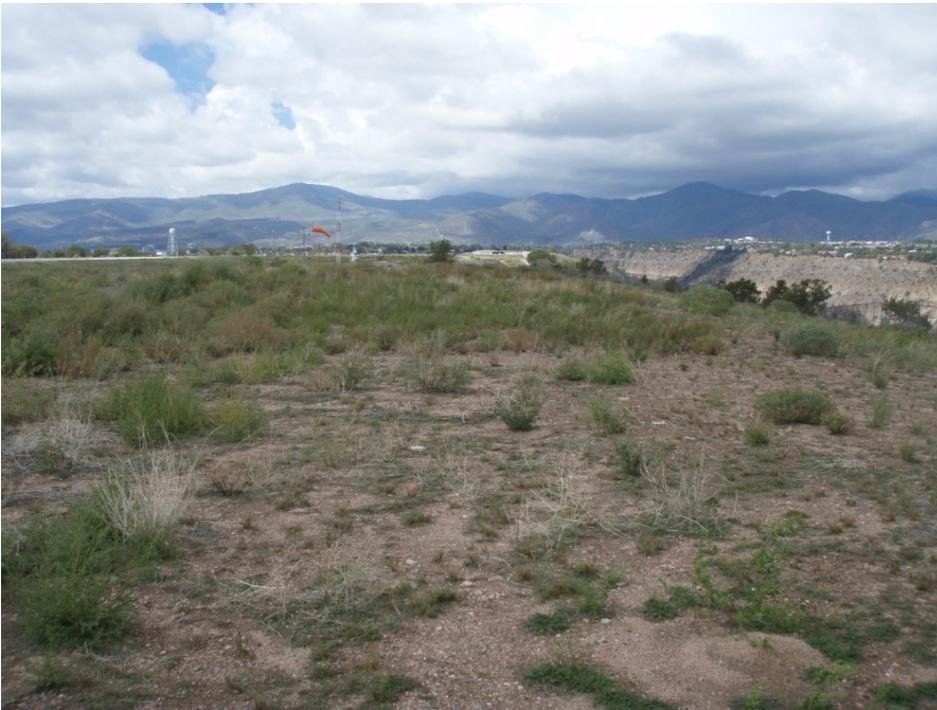
Inspections of the DDA were conducted annually and after significant rainfall events. The DDA has a well-established vegetative cover with no evidence of erosion (Figure 3.8-1).

Figure 3.8-1 Vegetative cover at the DDA

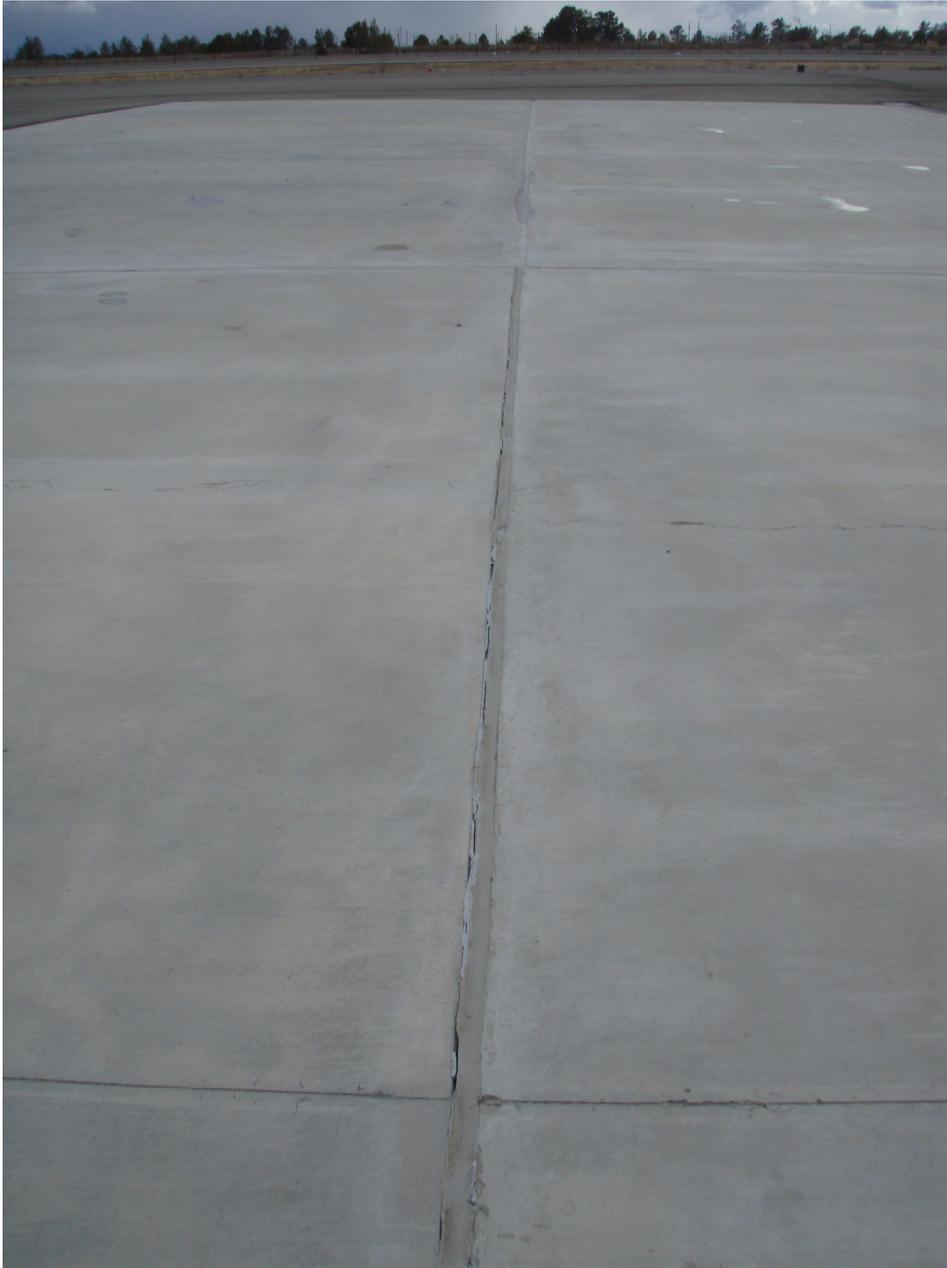
Photo 23: Separation along joints in pad 4. Similar separation is occurring at all pads.

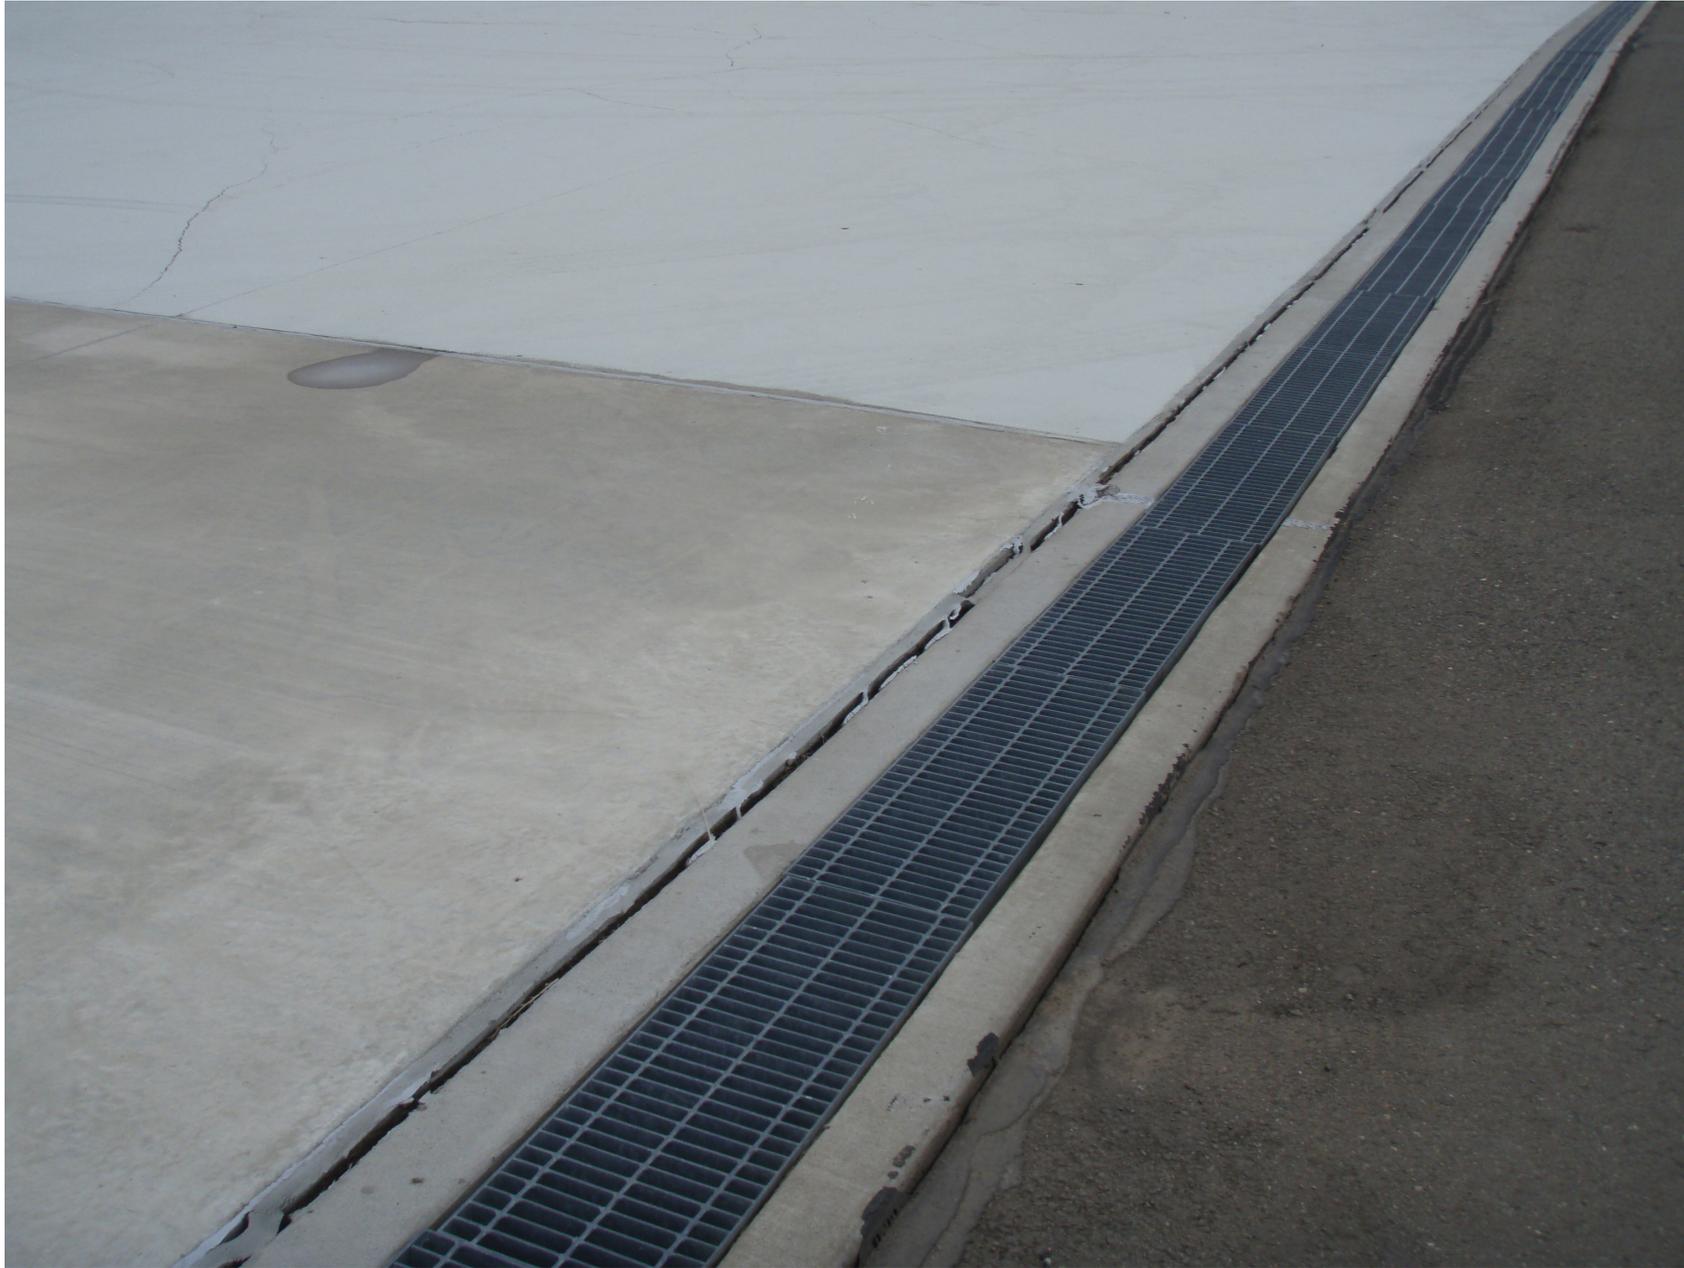
Photo 24: Separation of the pad and trench drain at Pad 3. Similar separation is occurring at pads 1-4.

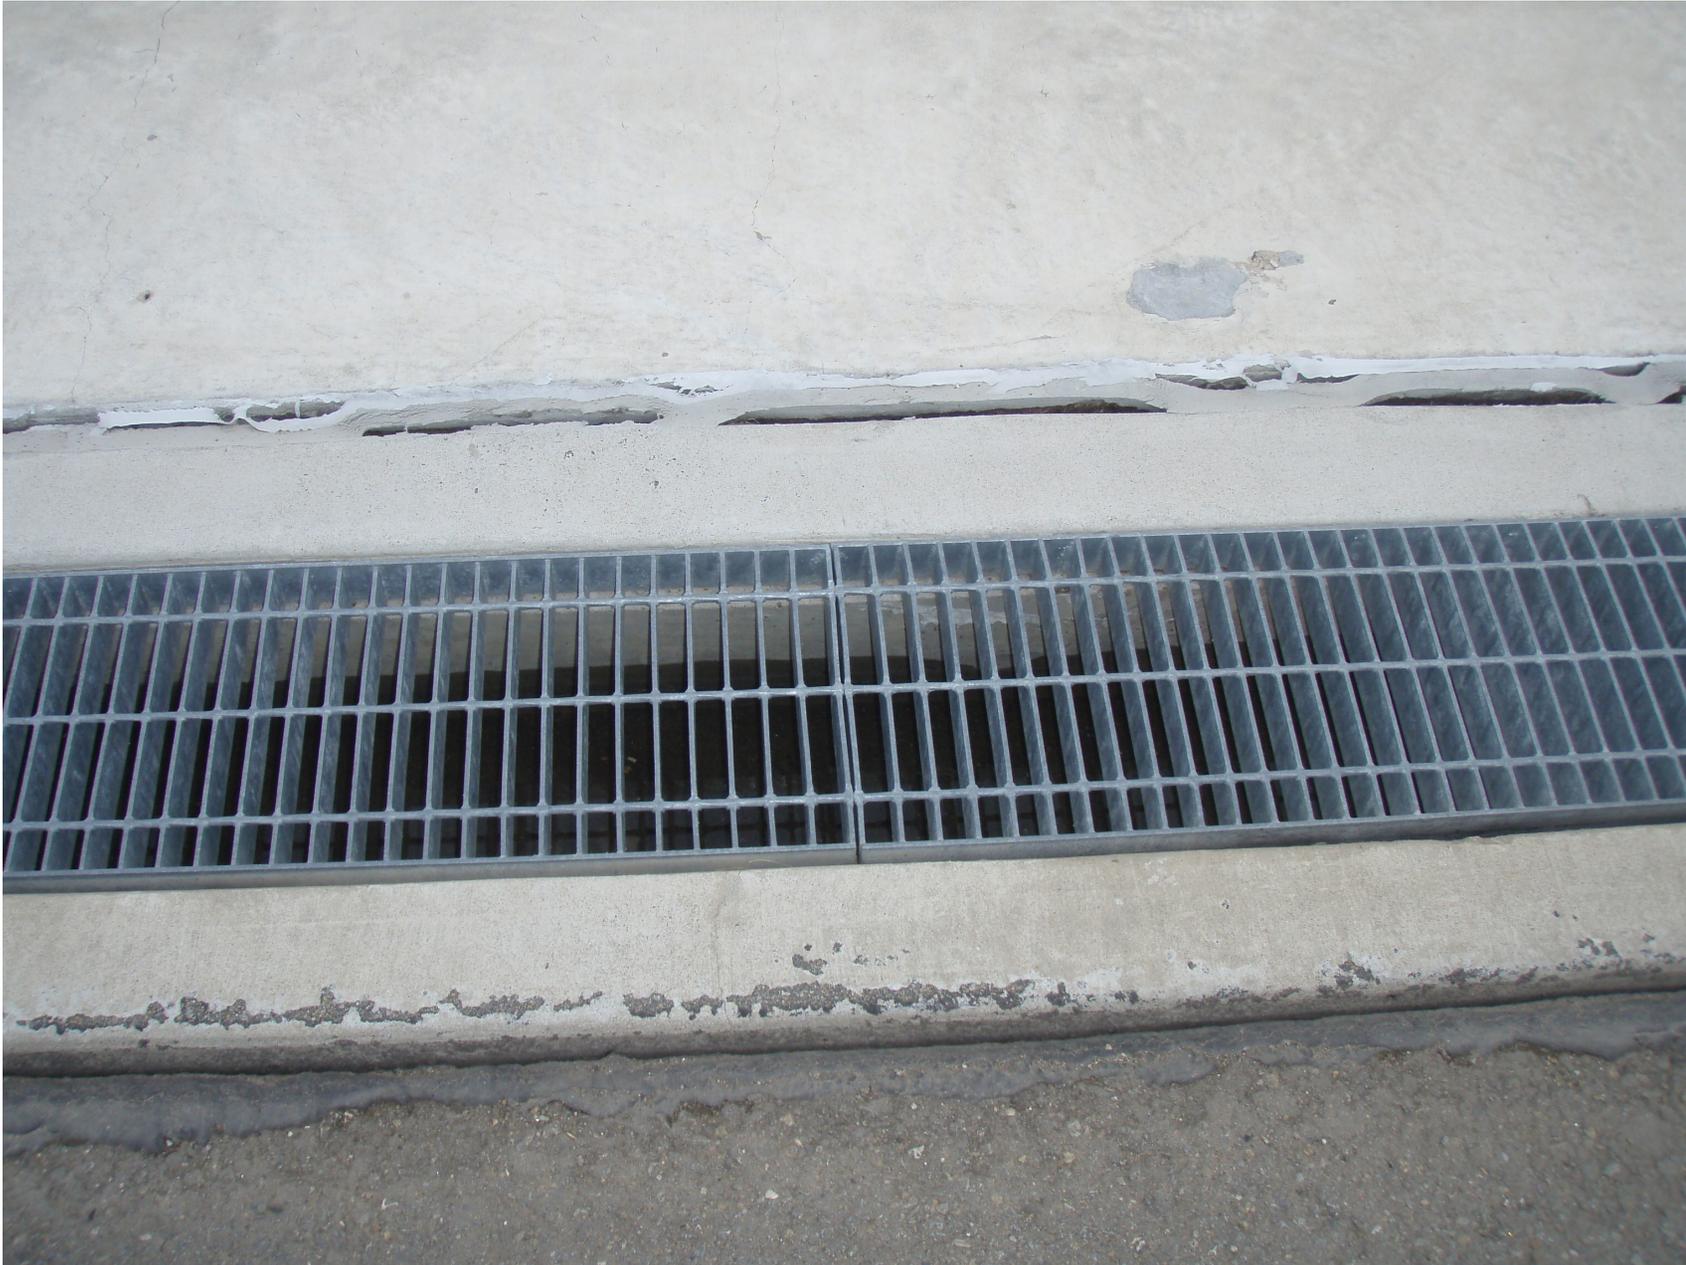
Photo 25: Separation of pad and trench drain. Also note subsidence of MatCon pavement.

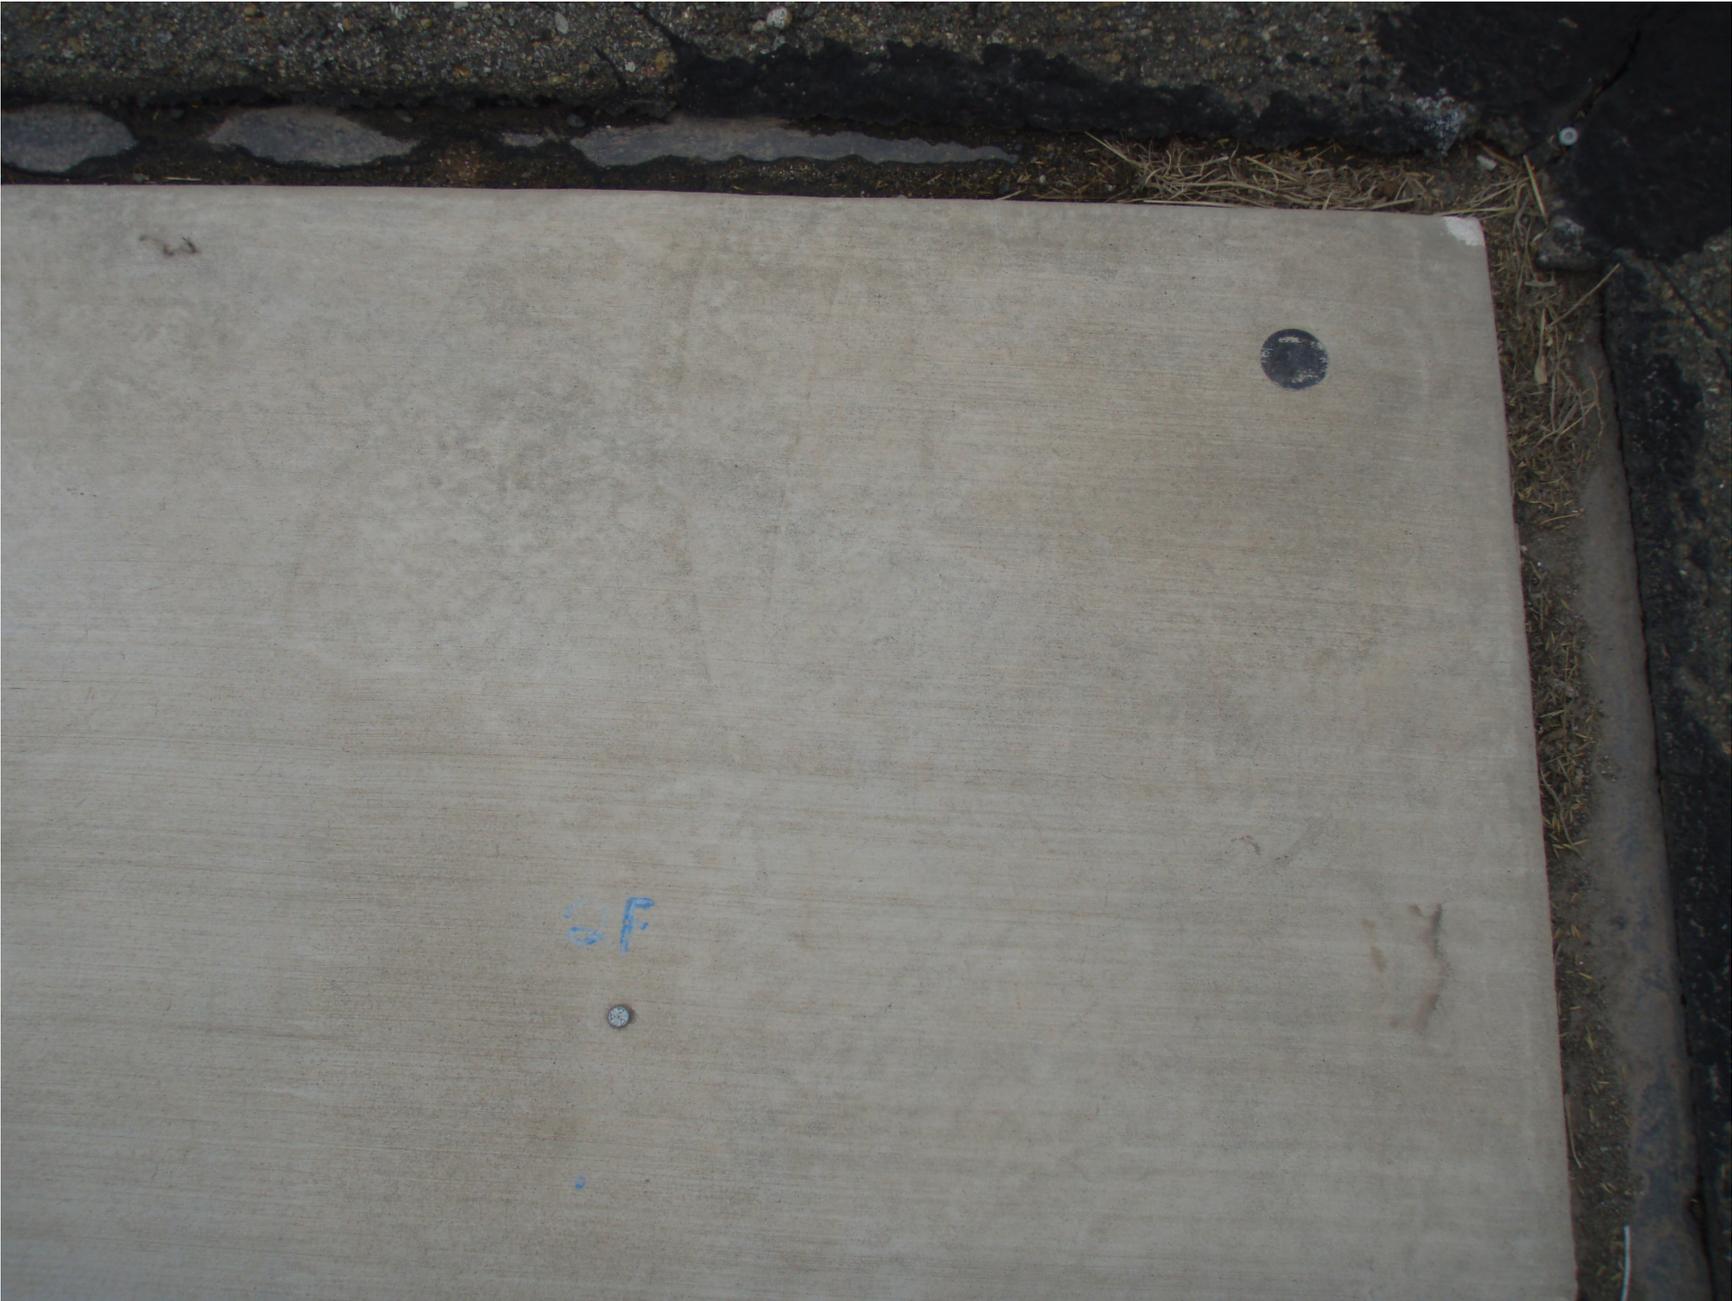
Photo 26: Original survey benchmark at upper corner, ACOE nail near lower middle of photo.

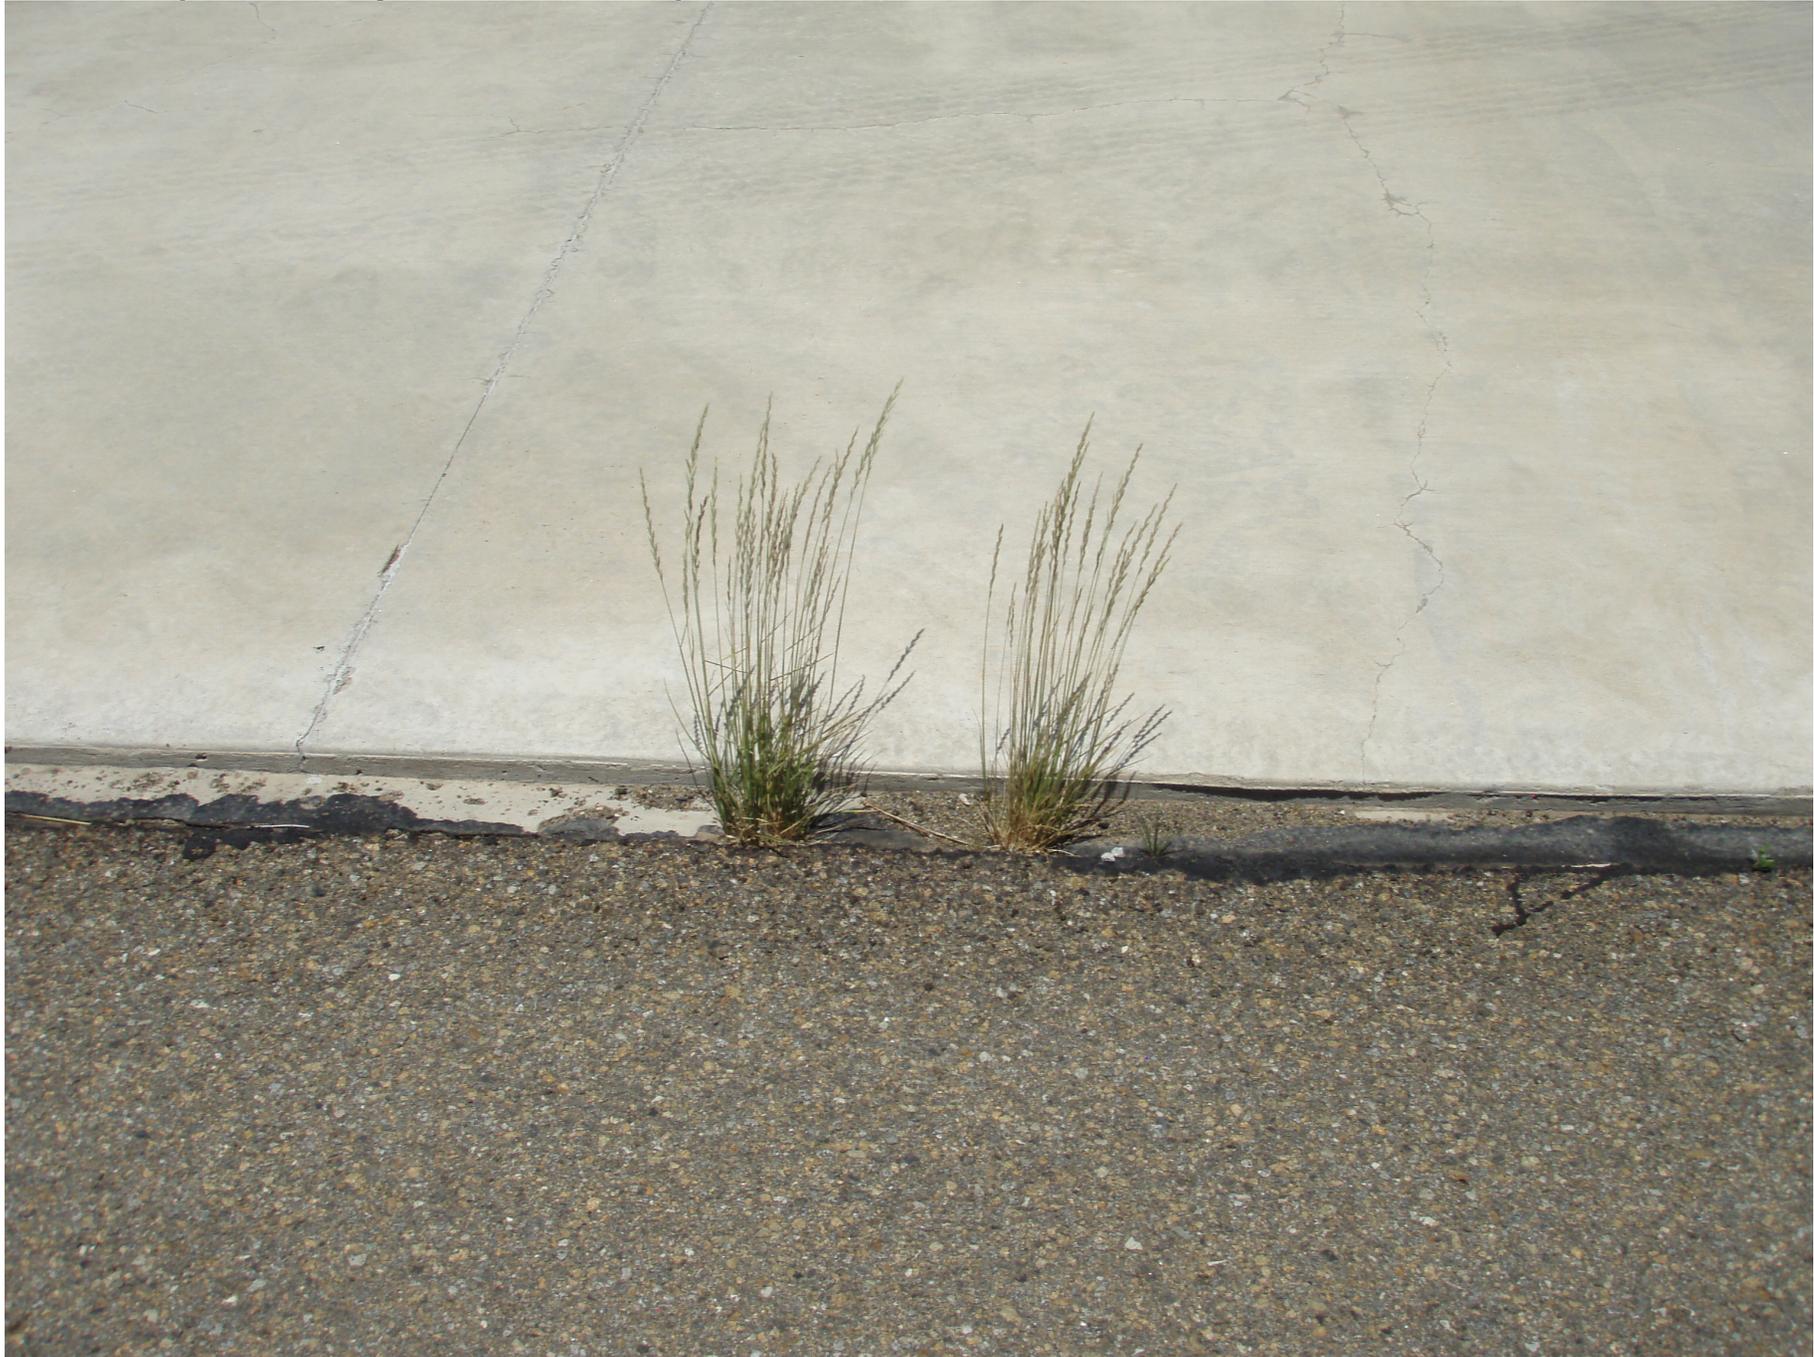
Photo 2: Weeds growing between MatCon pavement and concrete hangar pad.

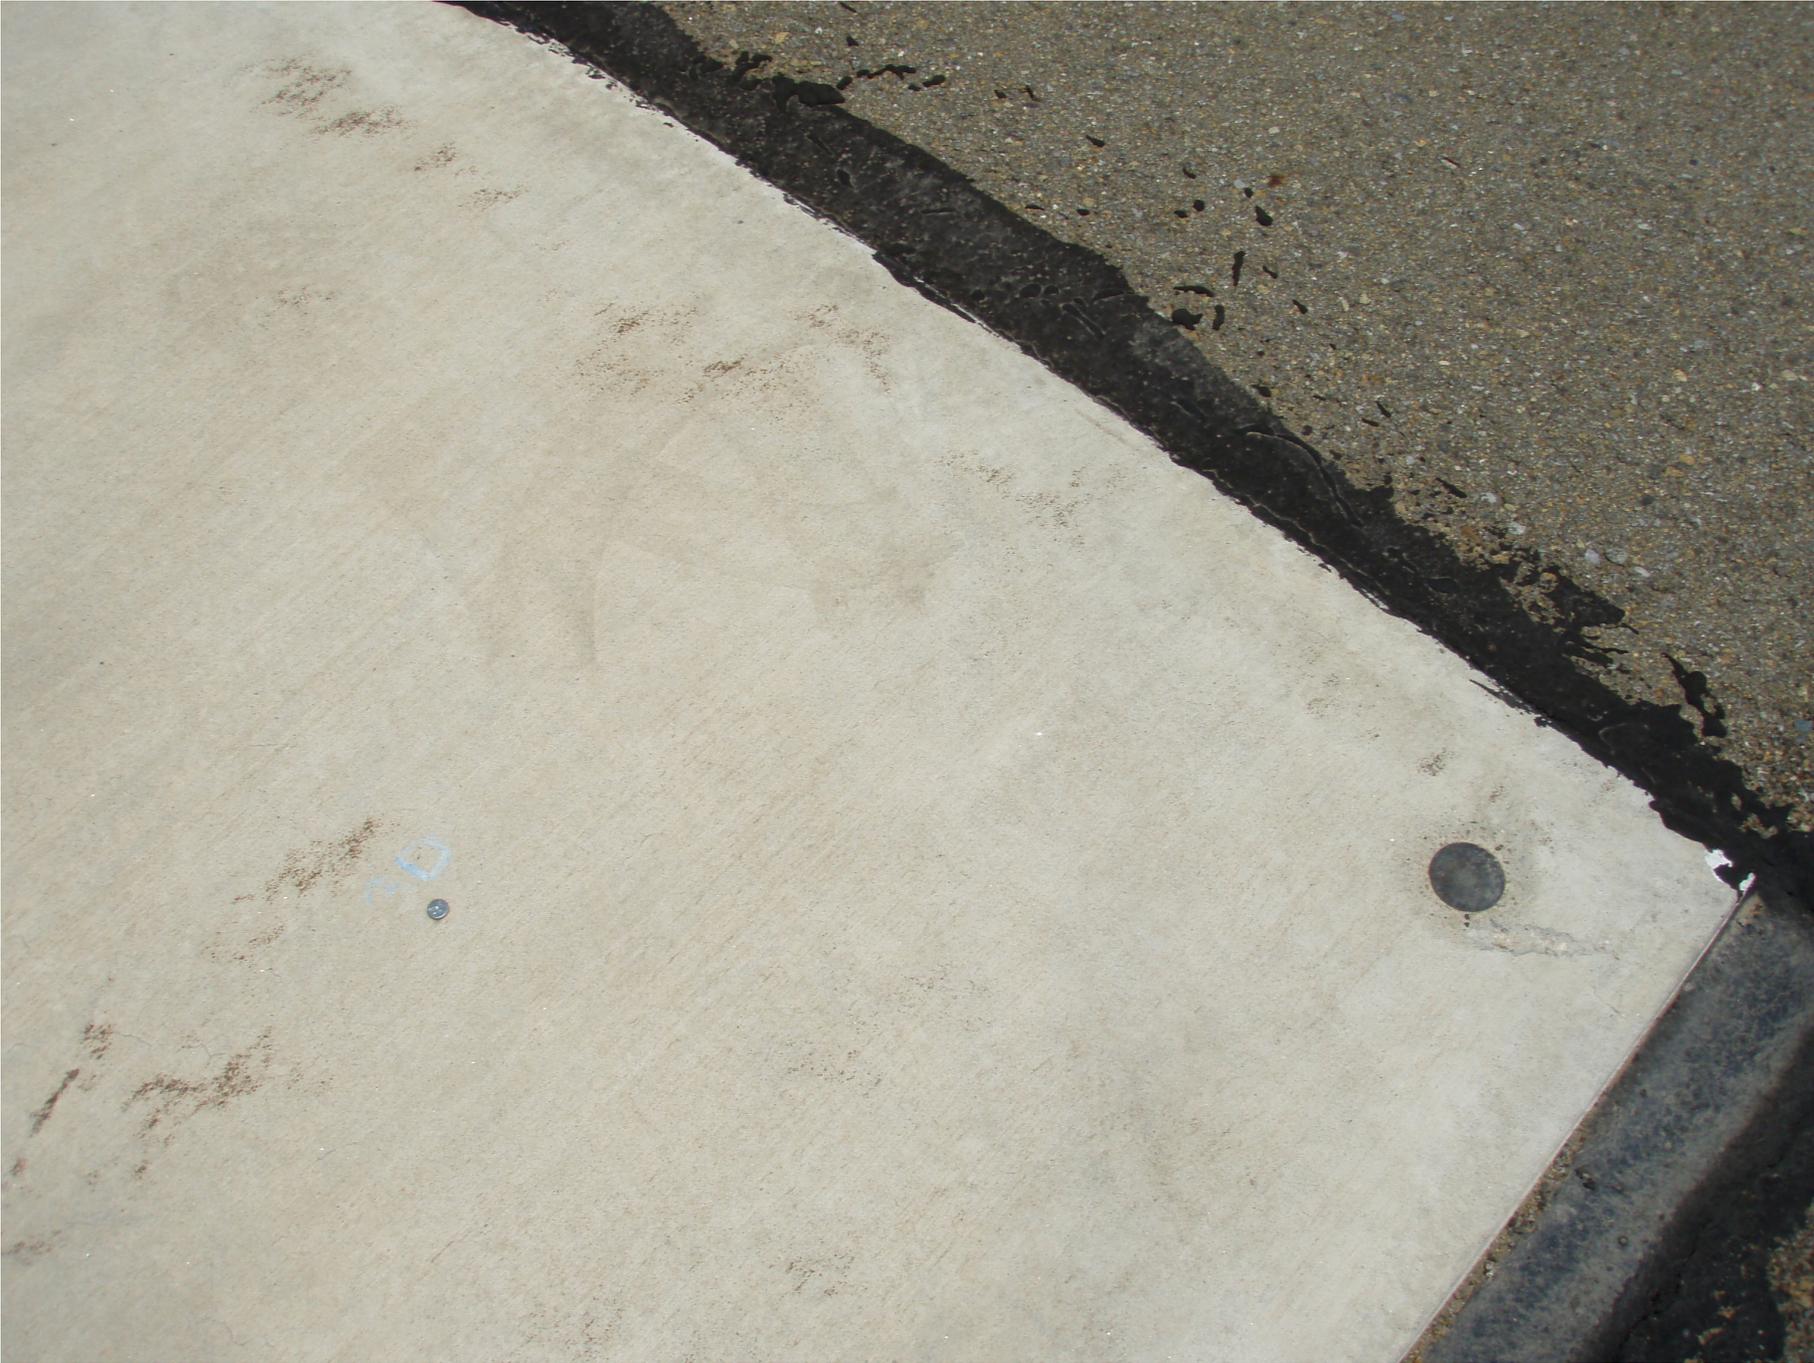
Photo 3: Survey markers in concrete pad. Brass cap is the original point silver nail cap is the Army Corp. of Engineers survey point.

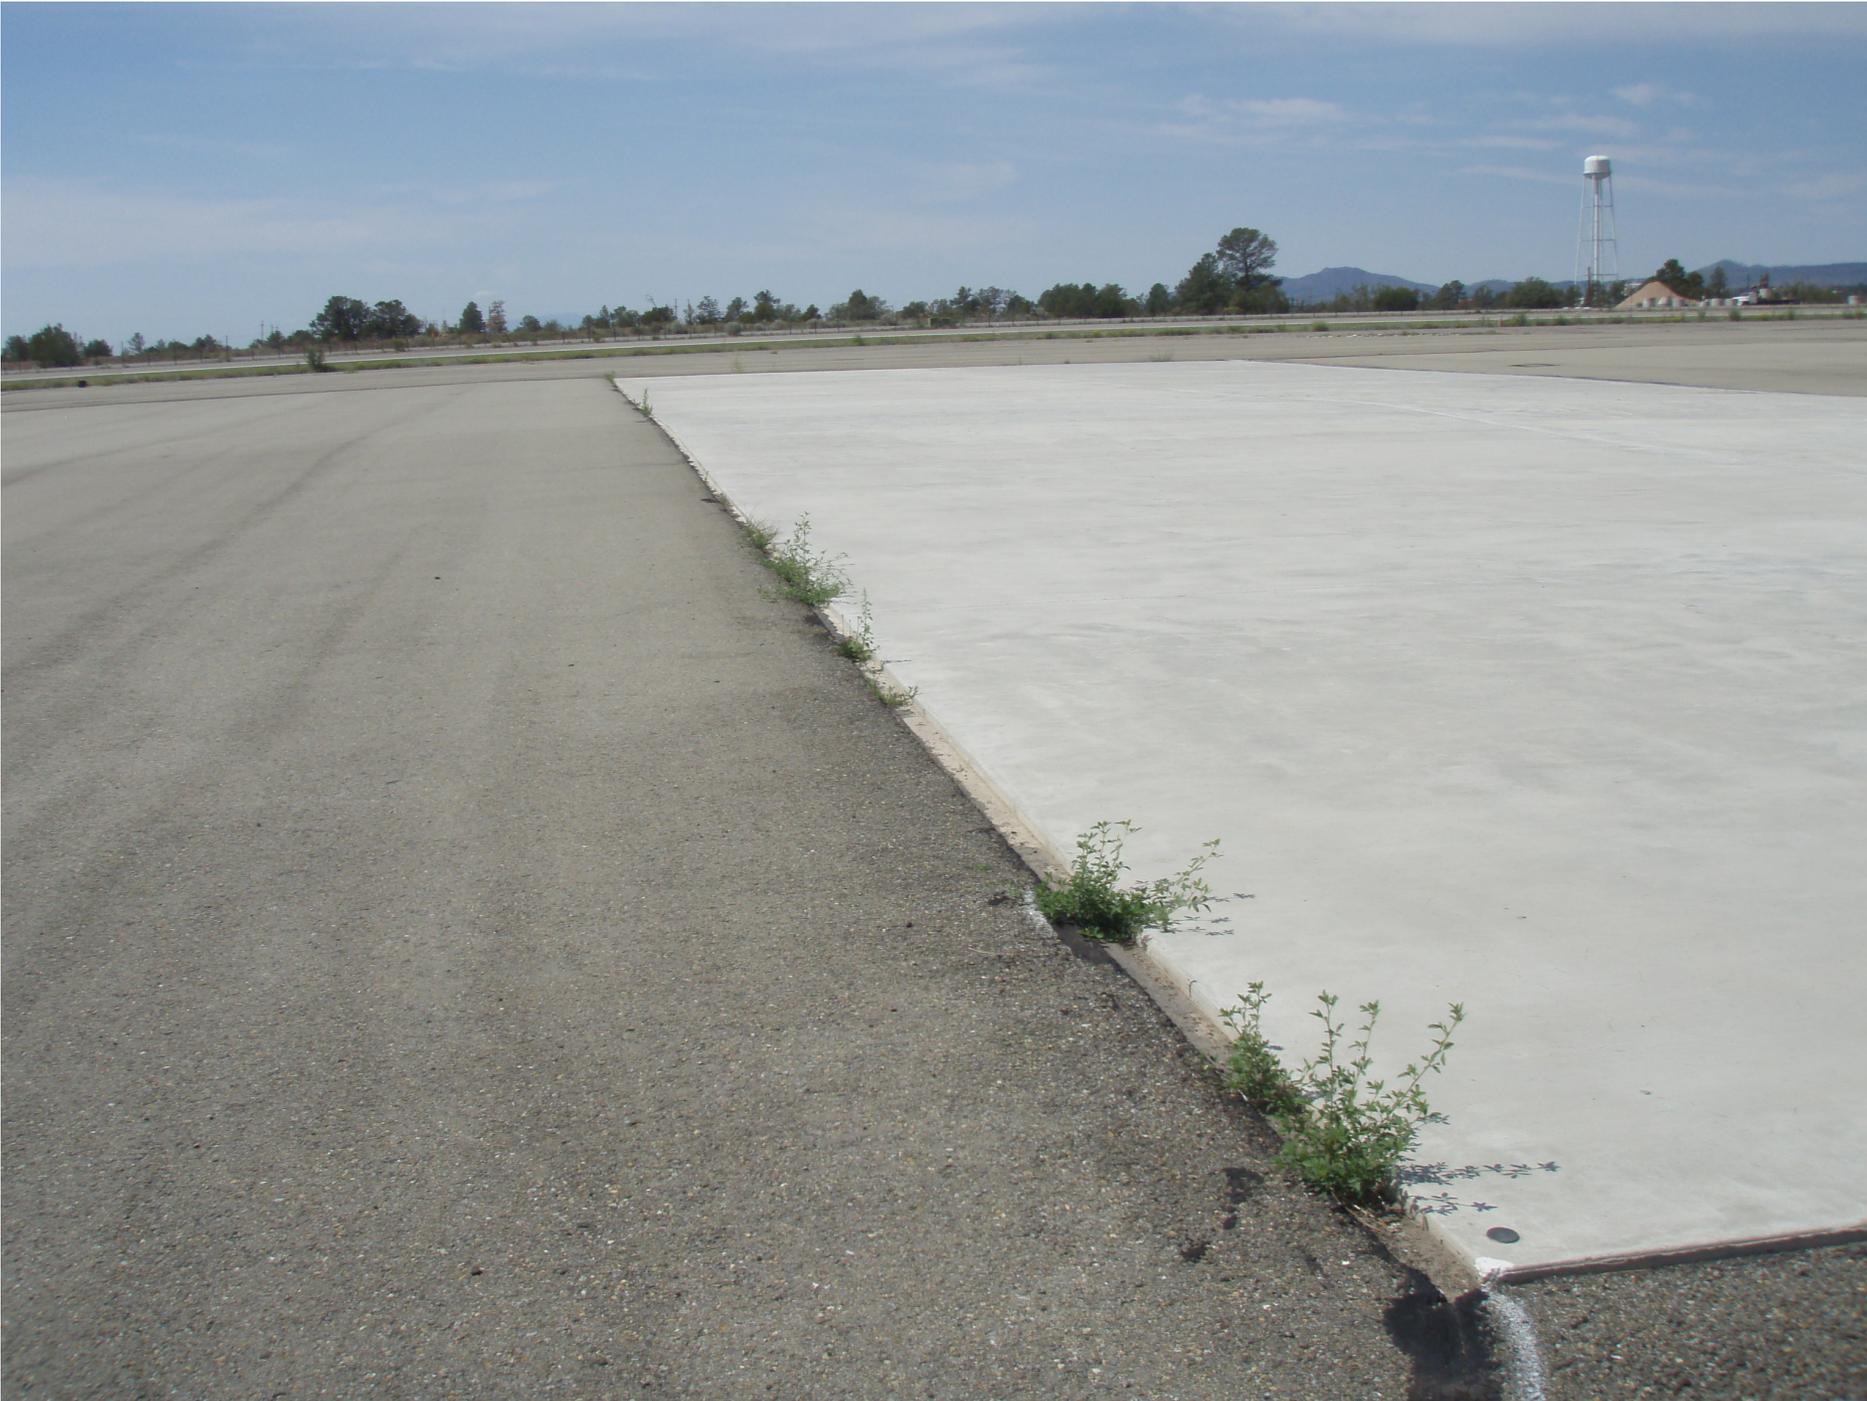
Photo 5: Vegetation growing between MatCon pavement and concrete Pad 4.

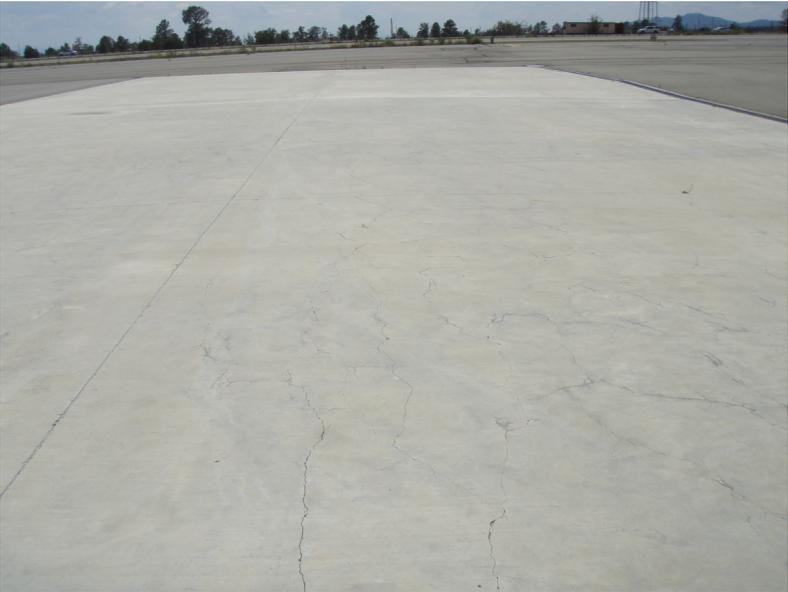
Photo 3: Pad 1 cracking in North-South orientation

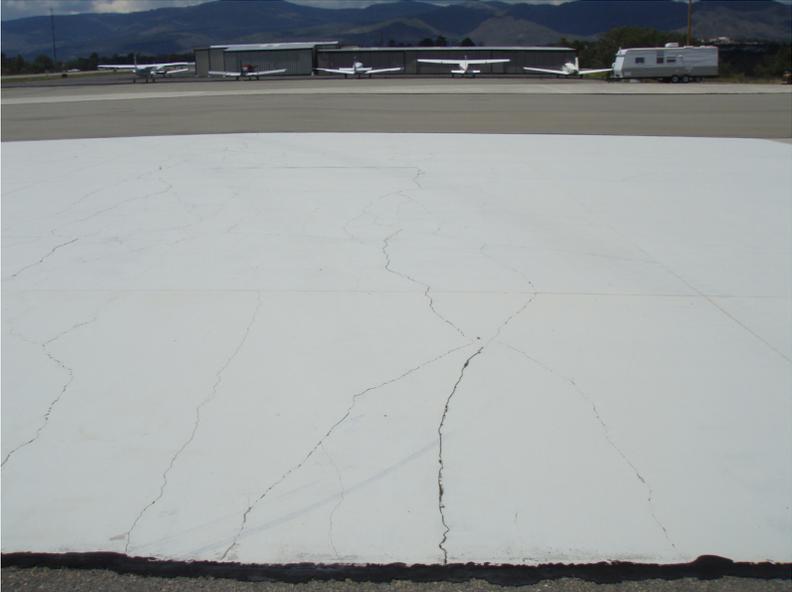
Photo 8: Cracking in Pad 2
