Subject: Submittal of the 2013 Annual Inspection Report for Los Alamos County Airport Landfill, Solid Waste Management Units 73-001(a) and 73-001(d), Technical Area 73

**2013 Annual Inspection Report for
Los Alamos Country Airport Landfill,
Solid Waste Management Units
73-001(a) and 73-001(d),
Technical Area 73**

Prepared by the Los Alamos Field Office

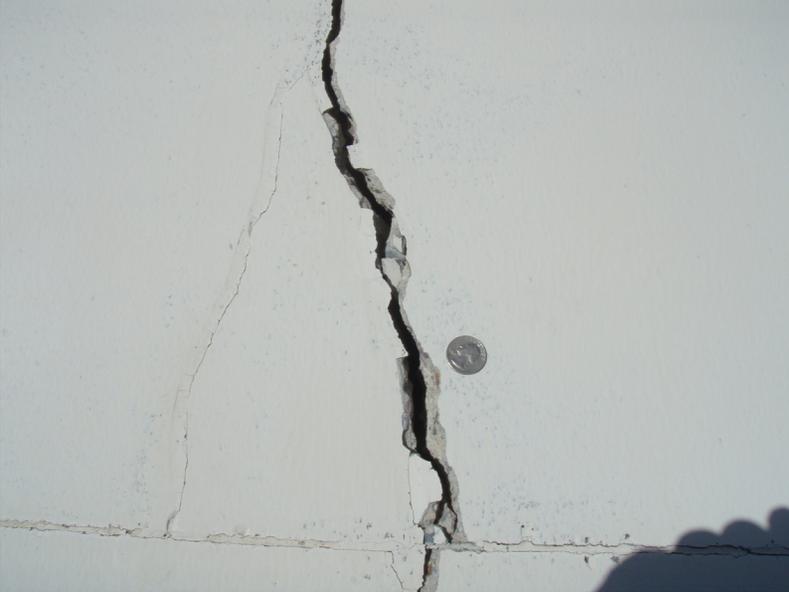
Photo 9: Close-up of crack

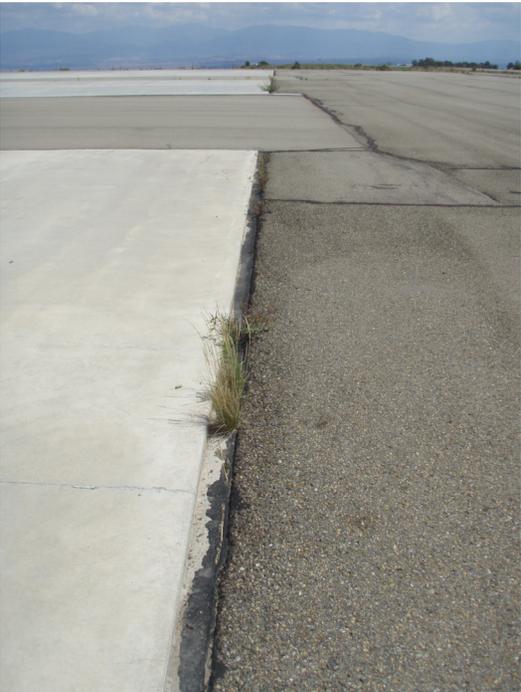
Photo 12: Subsidence of MatCon & trench drain

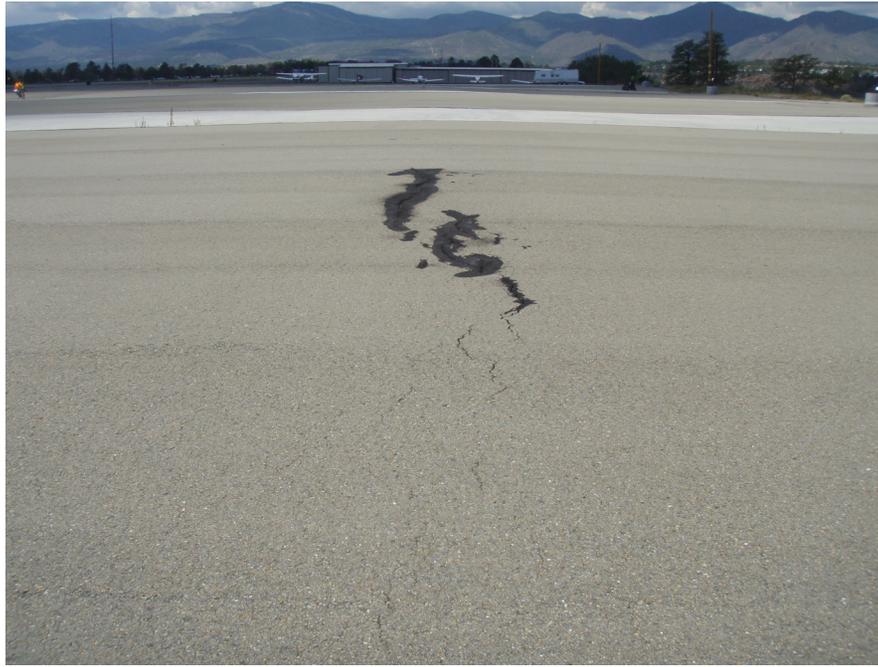
Photo 14: Cracks along hinge line

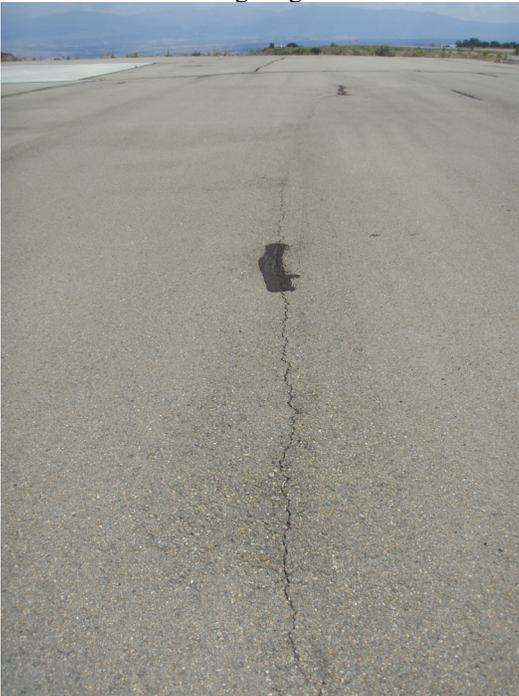
Photo 15: Cracks along hinge line

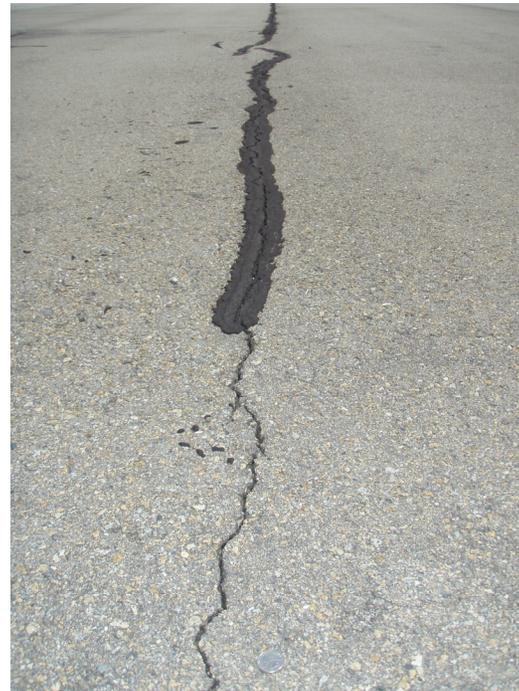
Photo 16: Cracking along paving lane

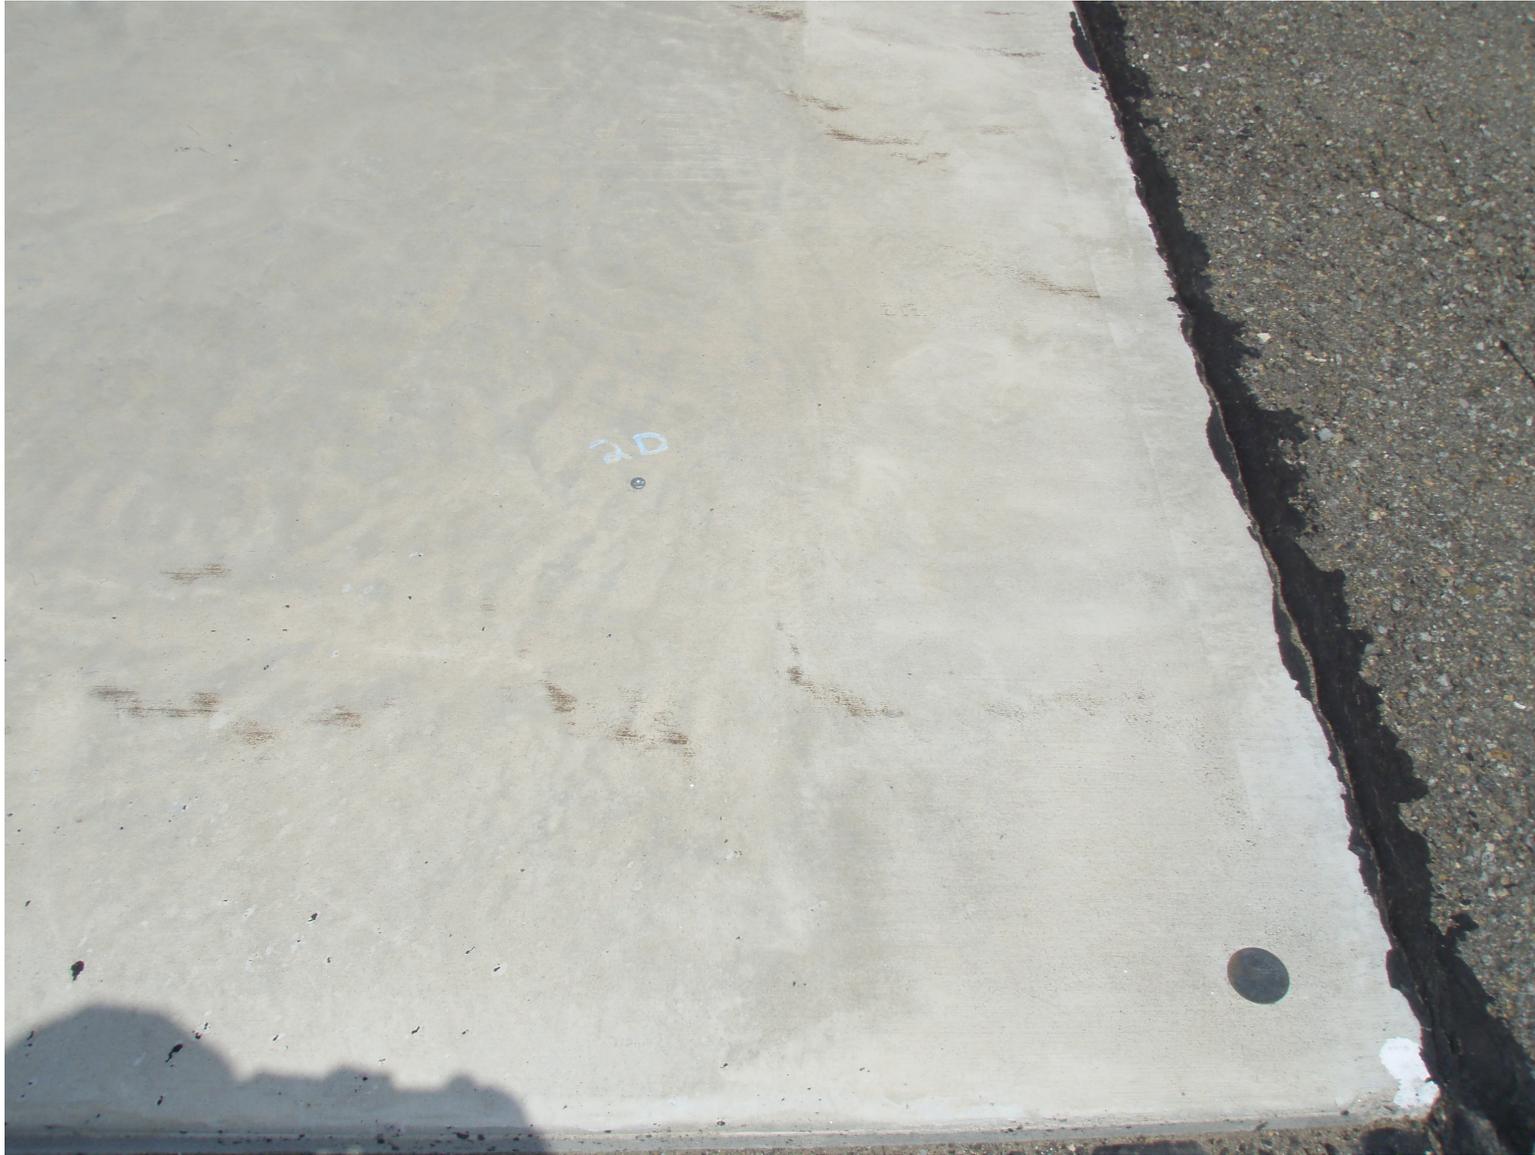
Photo 17: extension of crack in MatCon

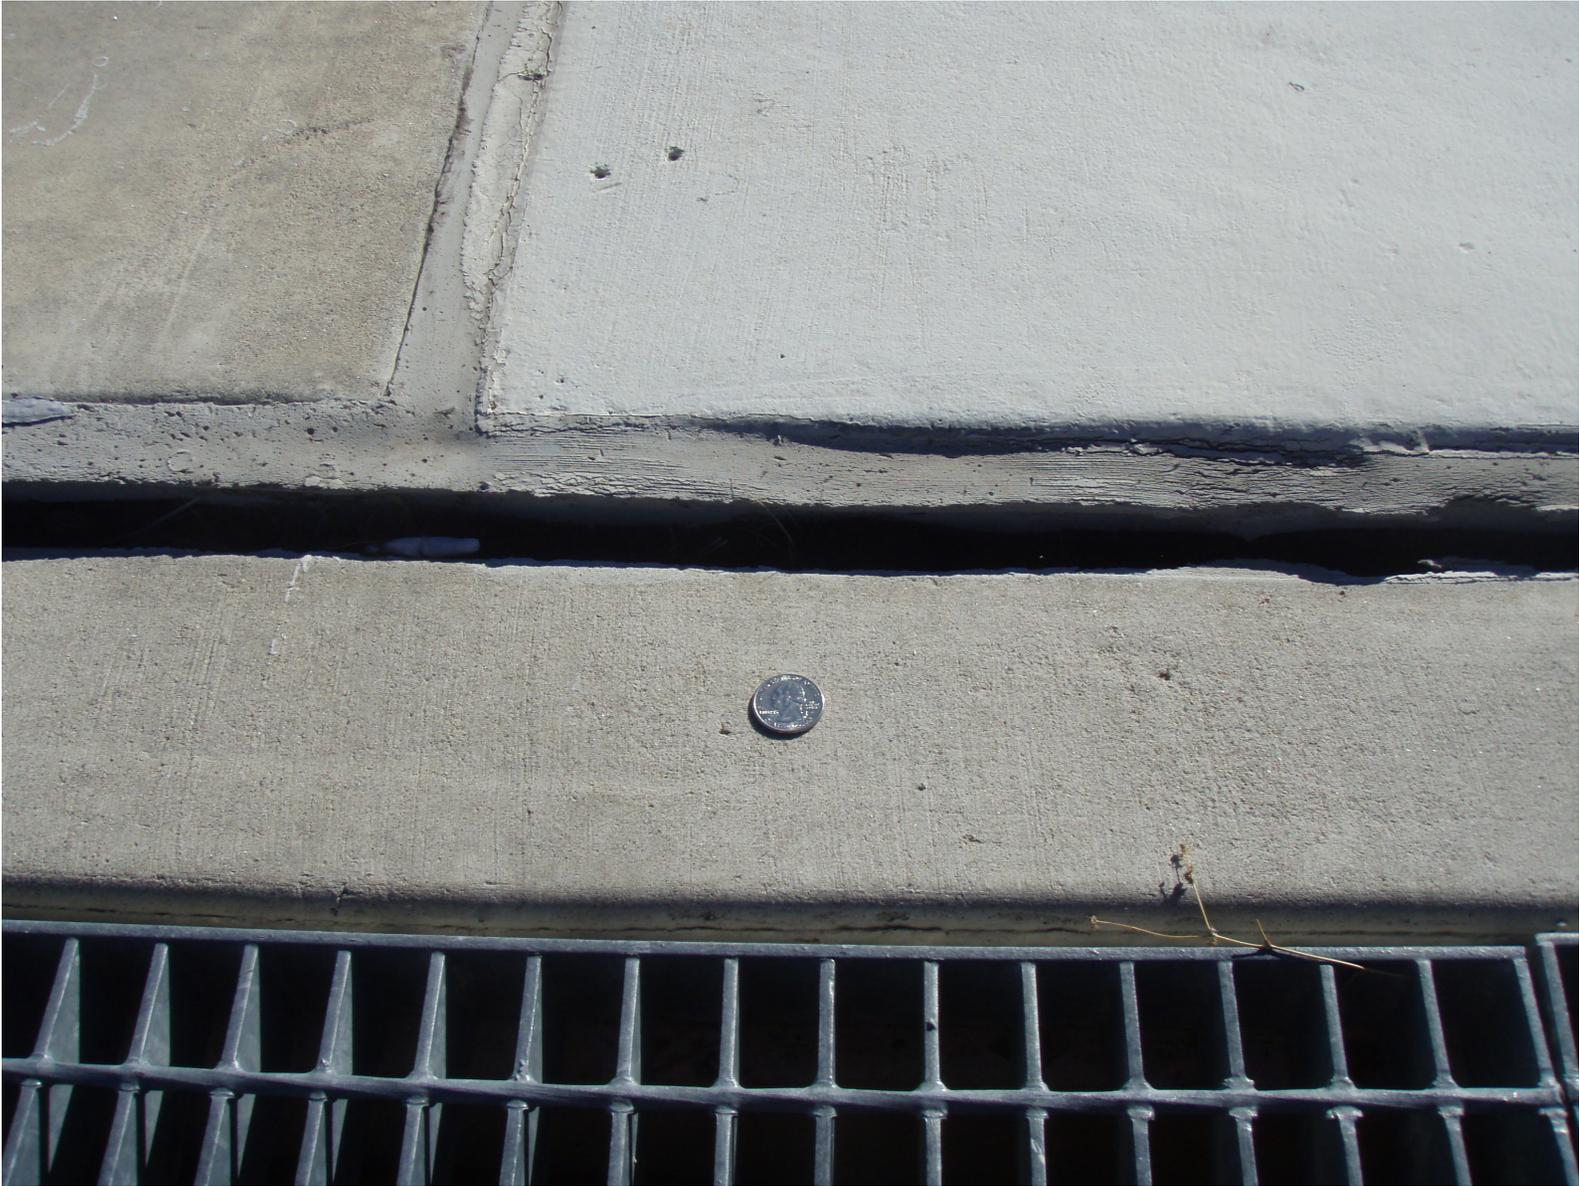
Photo 5: Separation of hangar pad and trench drain

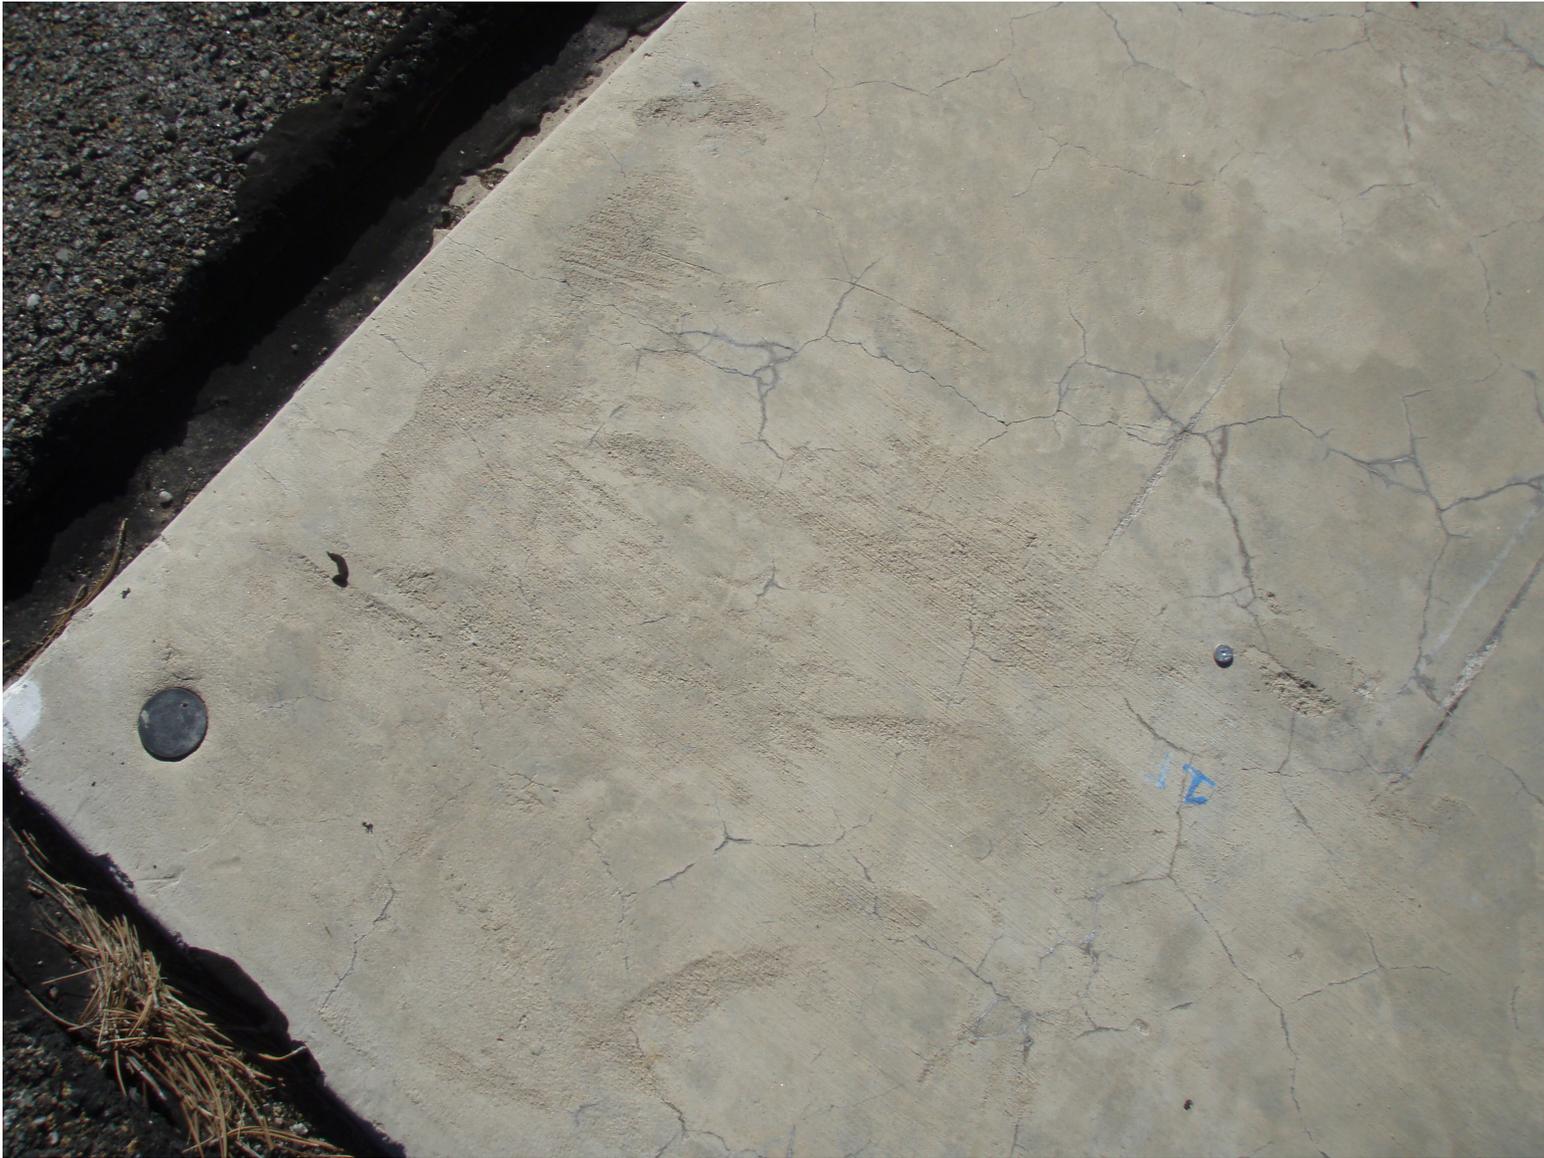
Photo 8: Crack in hangar pad 3

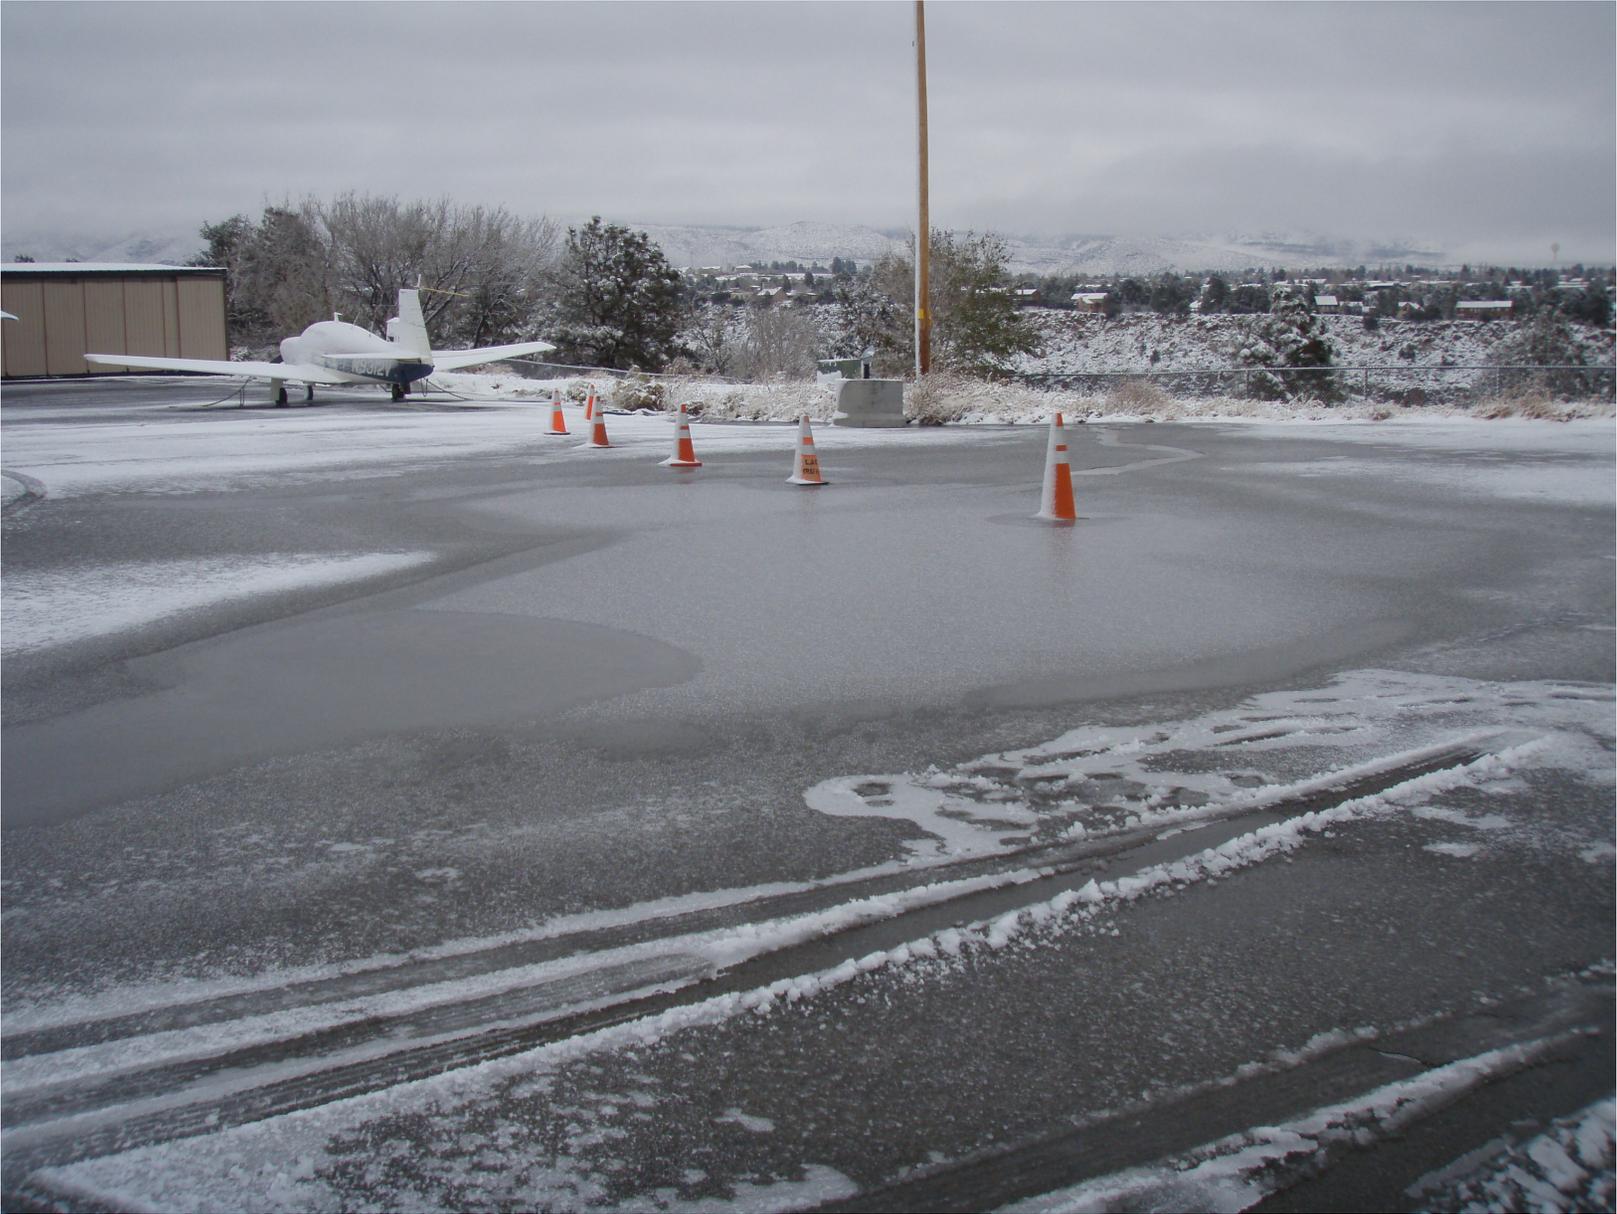
Photo 1: Frozen puddle on MatCon west of hangar pad

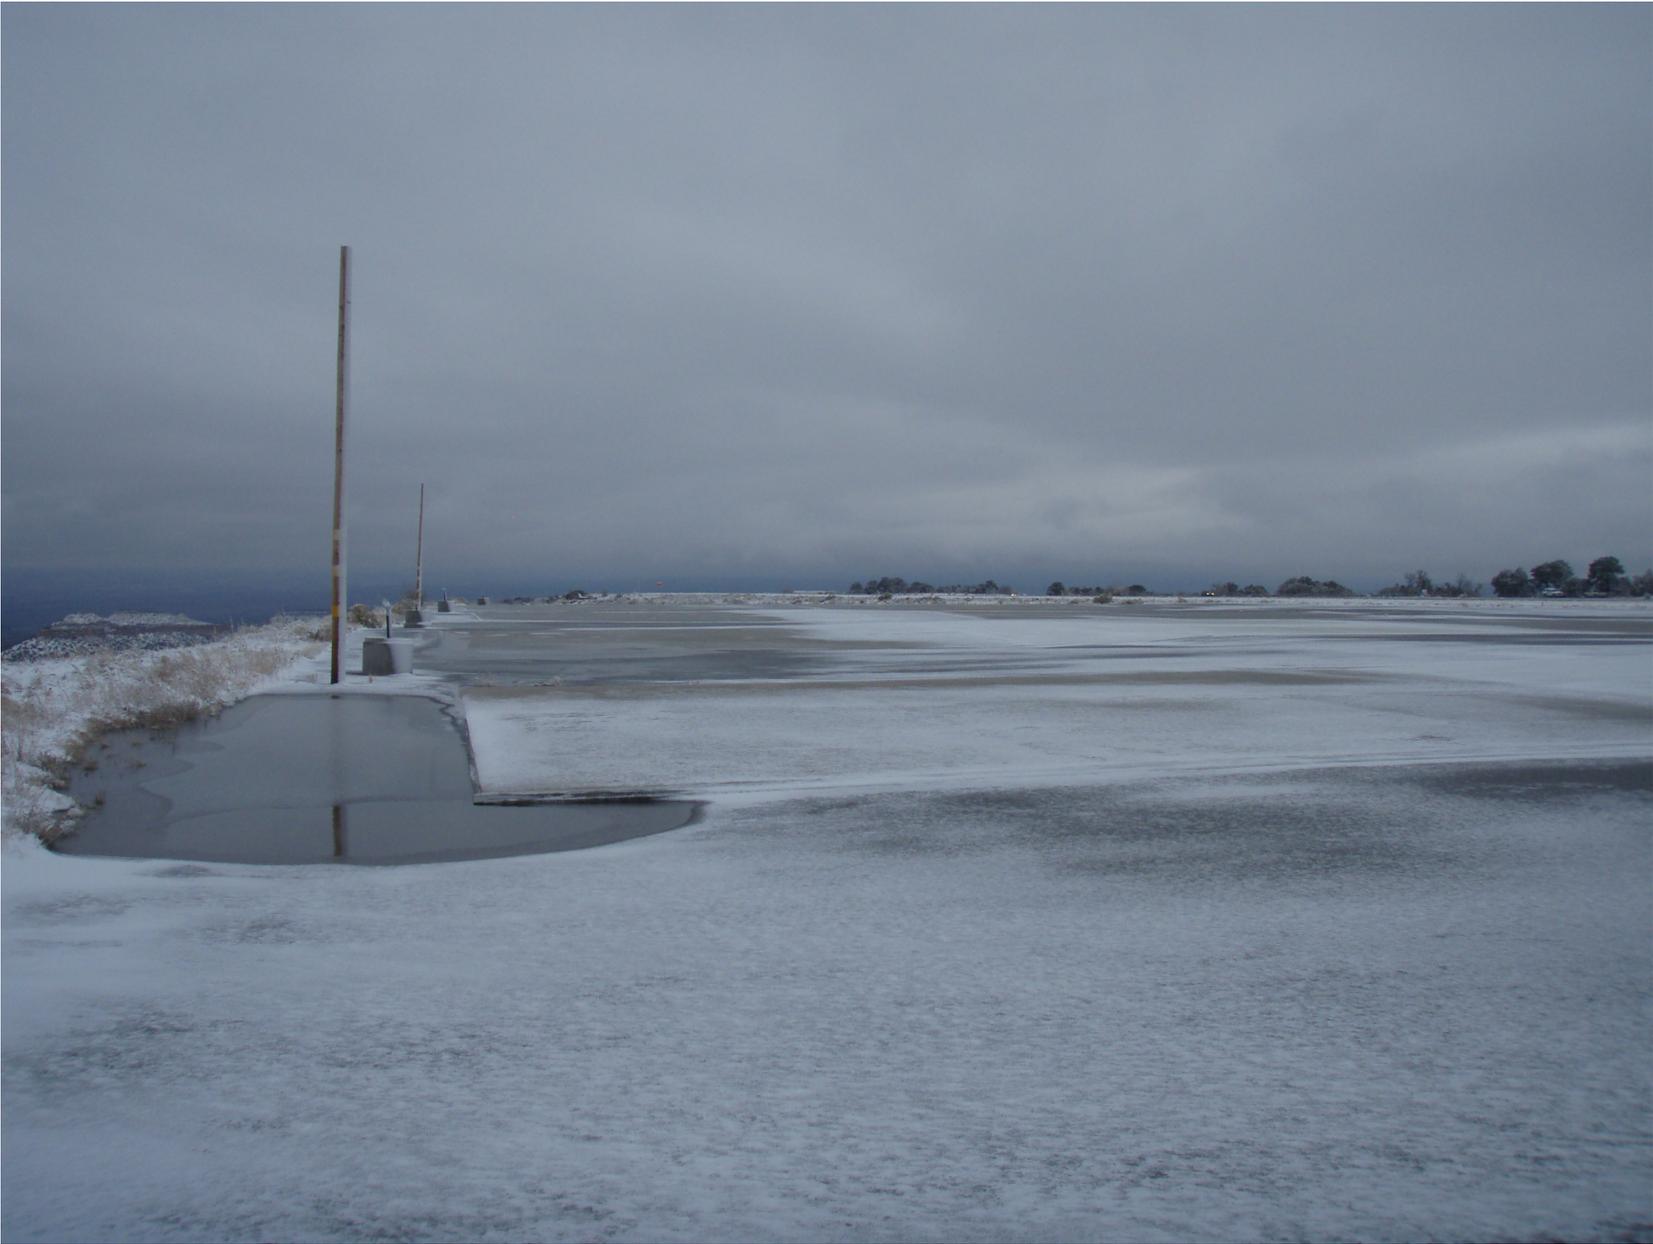
Photo 2: Puddle at NE corner of hangar pad 2

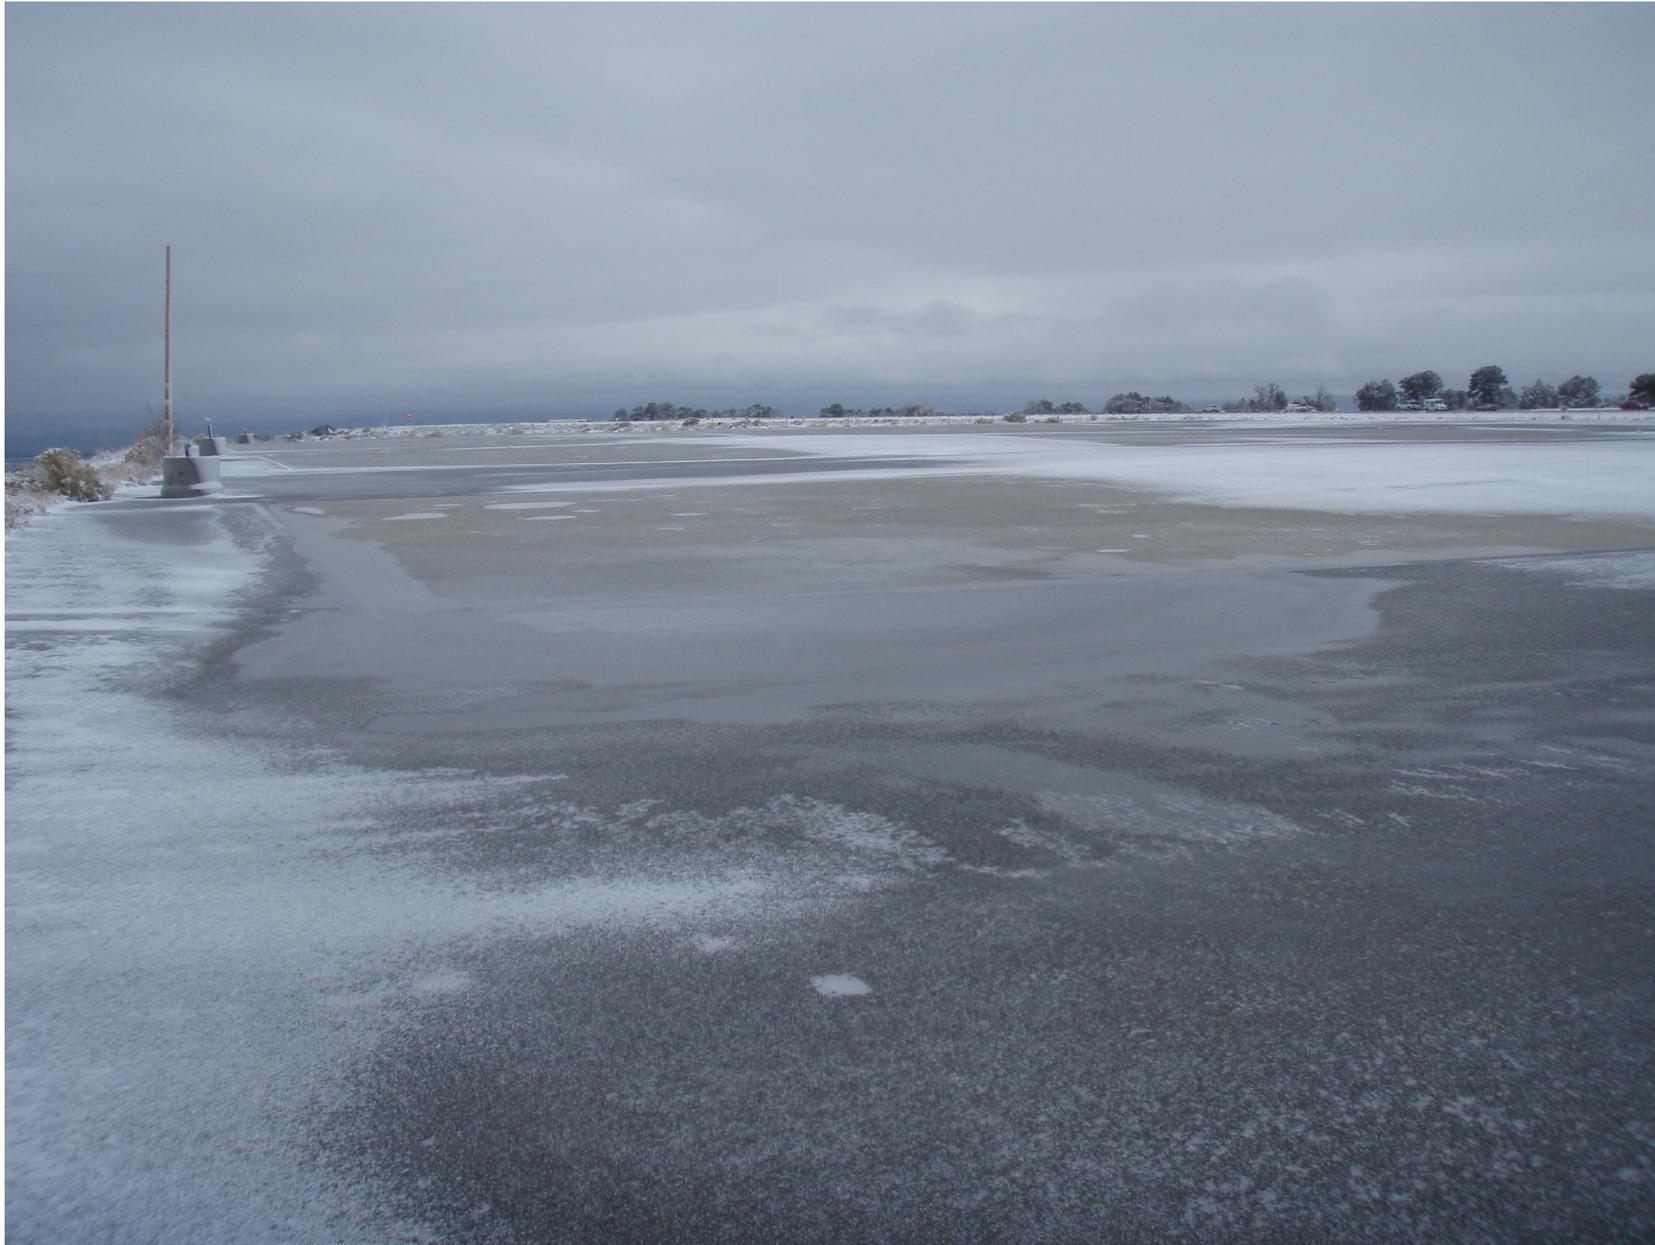
Photo 3: Puddle NW corner hangar pad 3. Note pad and MatCon subsidence.

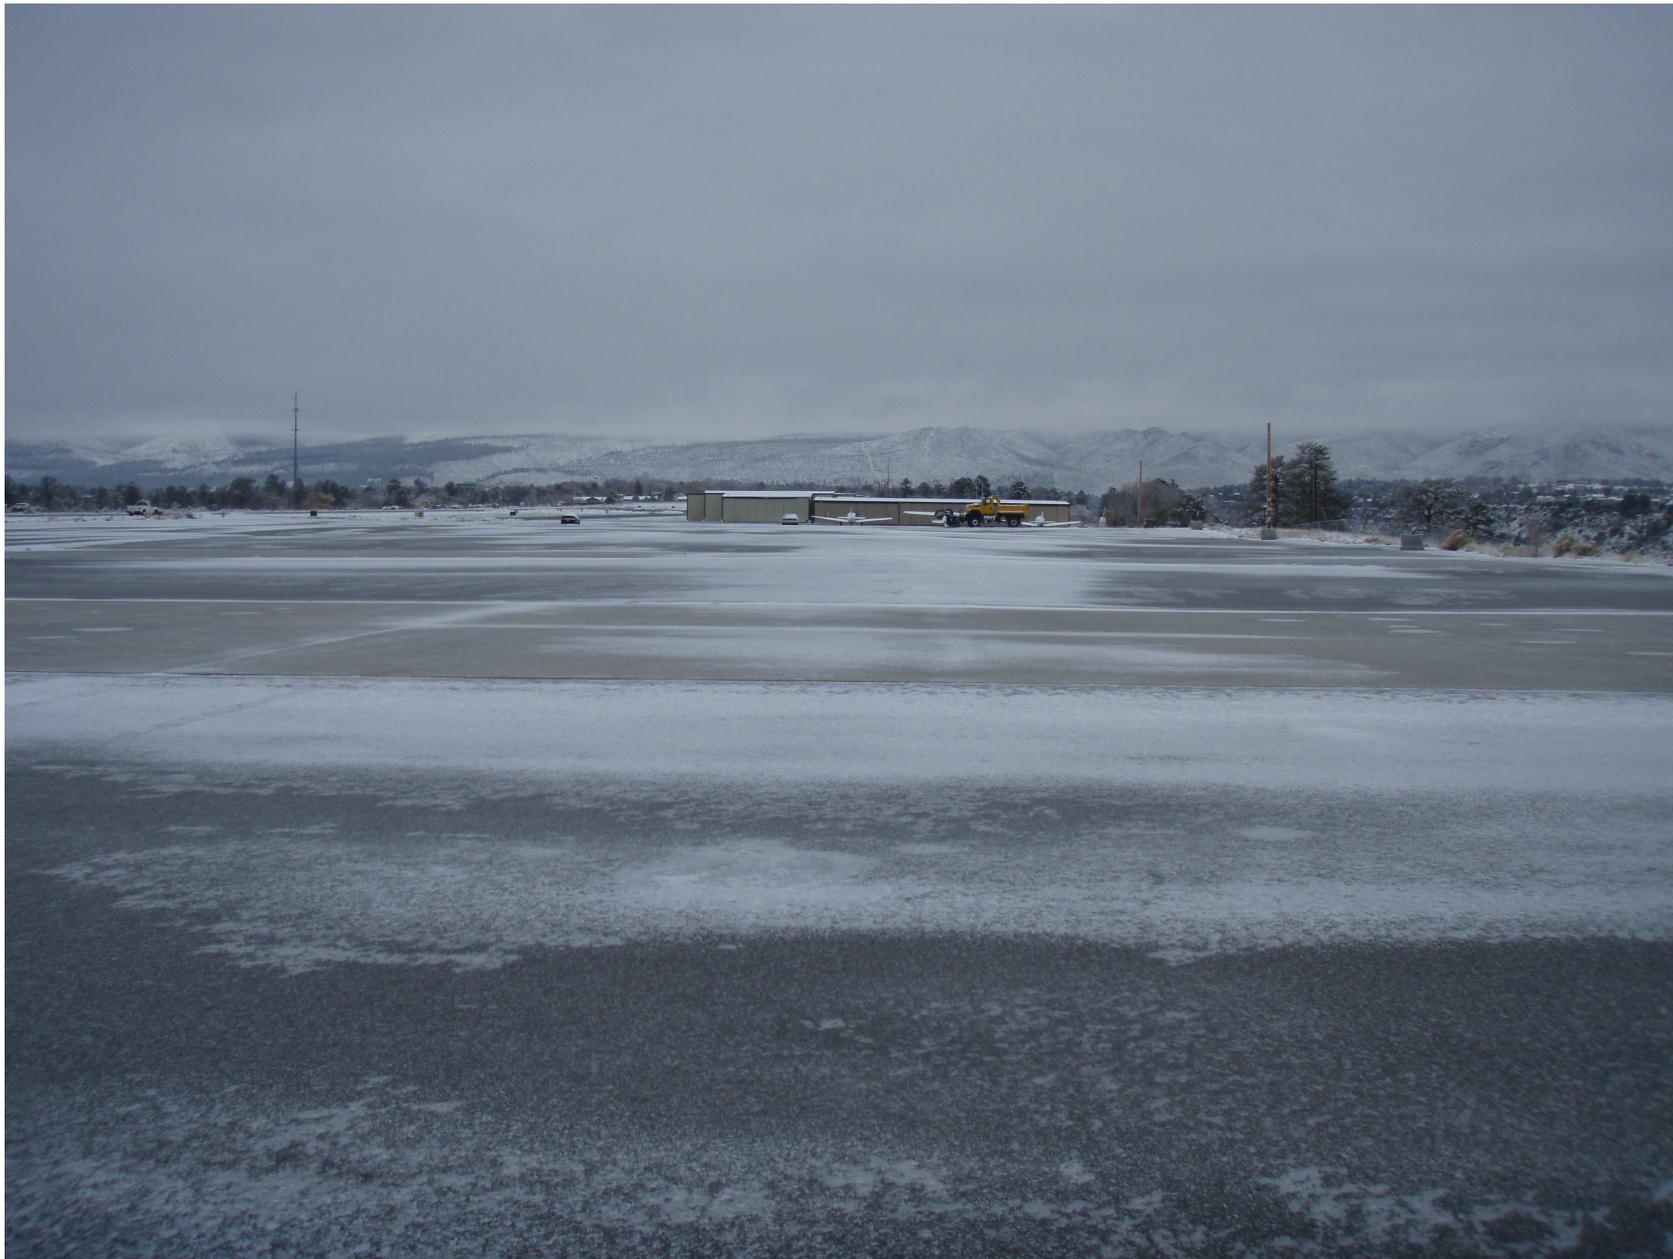
Photo 4: Looking west across MatCon and hangar pads. Note hinge line down middle of photo.

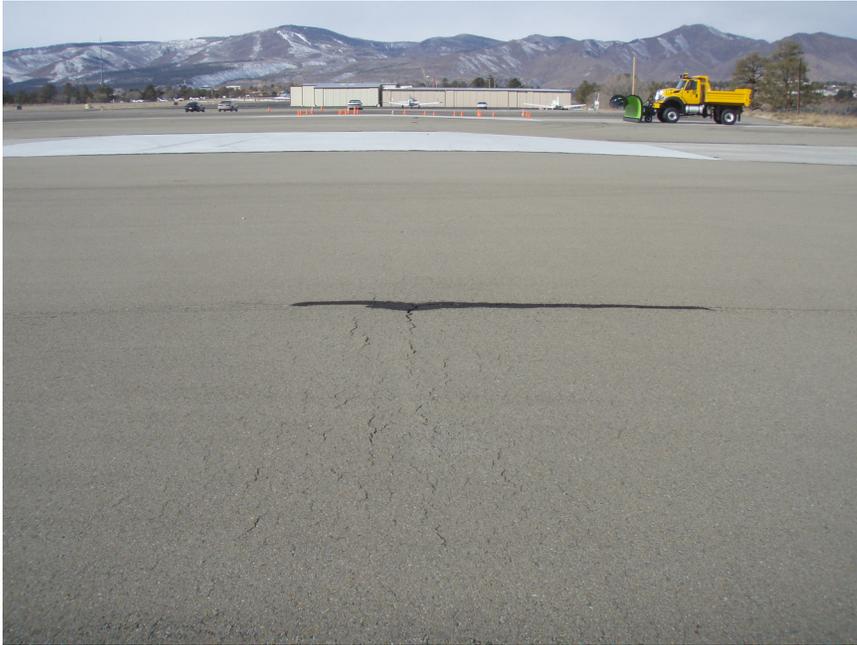
Photo 3: New cracks between Pads 3 & 4.

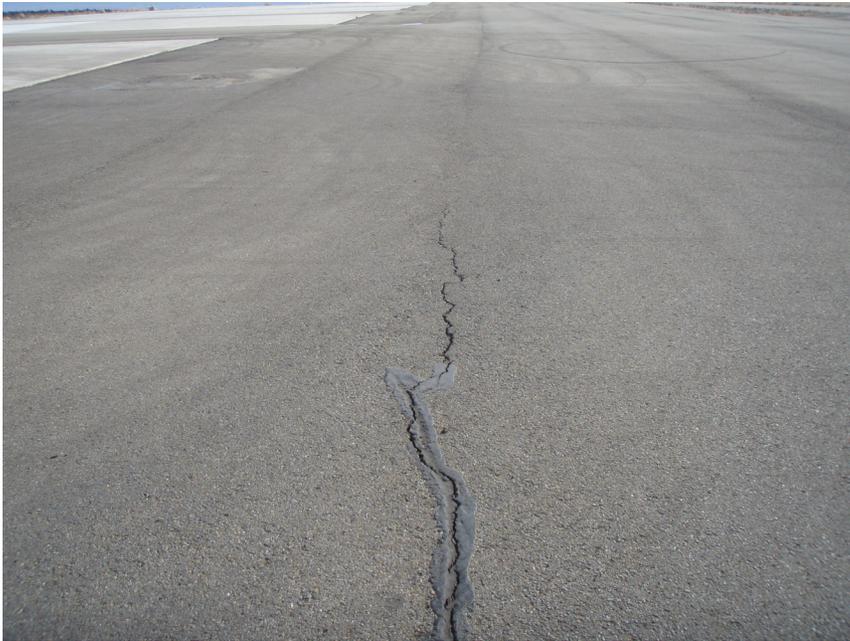
Photo 4: Extension of crack from previously hot sealed crack

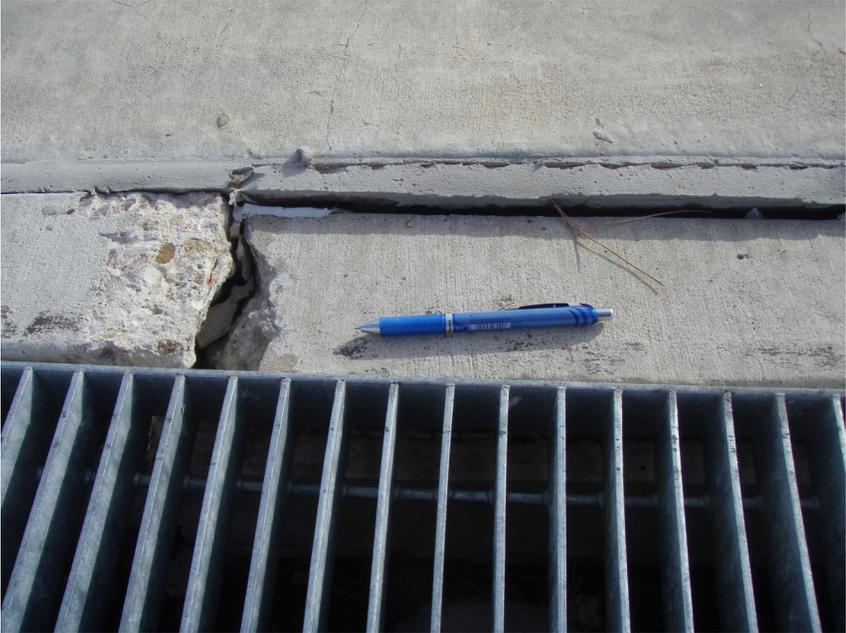
Photo 6: Separation of pad and trench drain with cracking at Pad 1

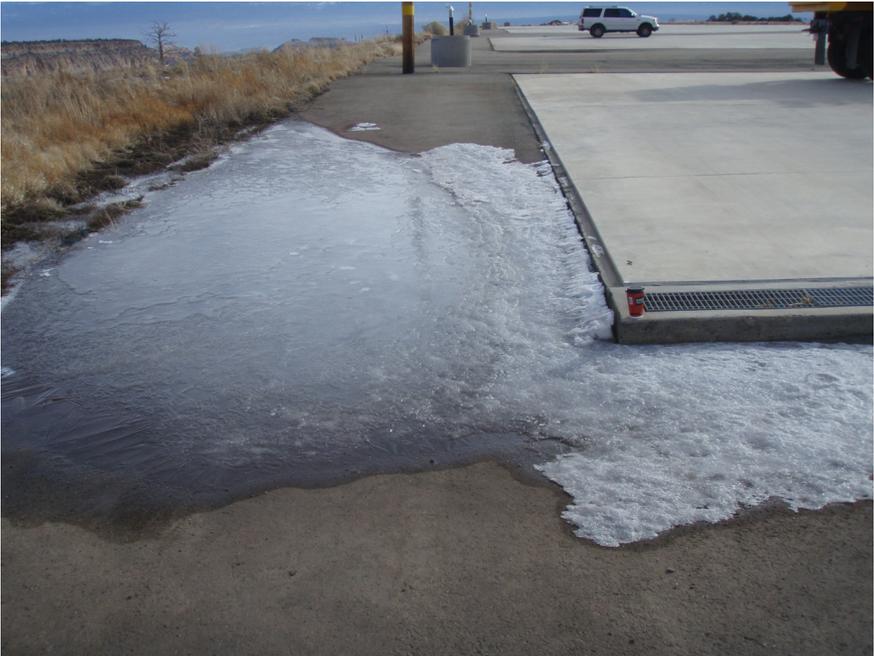
Photo 8: subsidence at NW corner of Pad 2

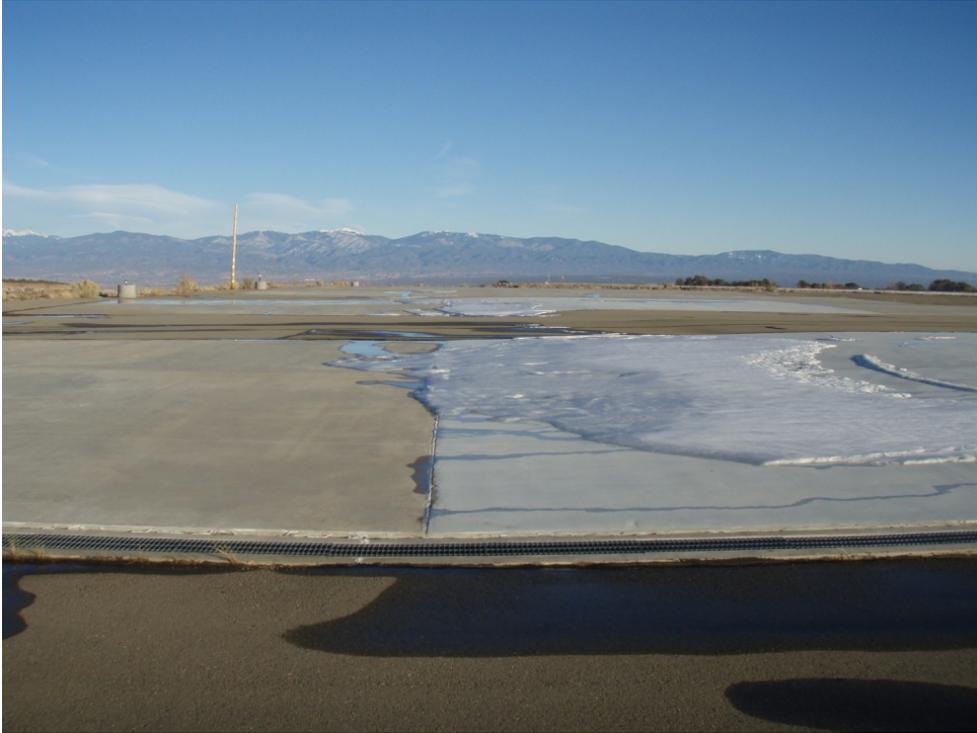
Snow/ice along hinge point

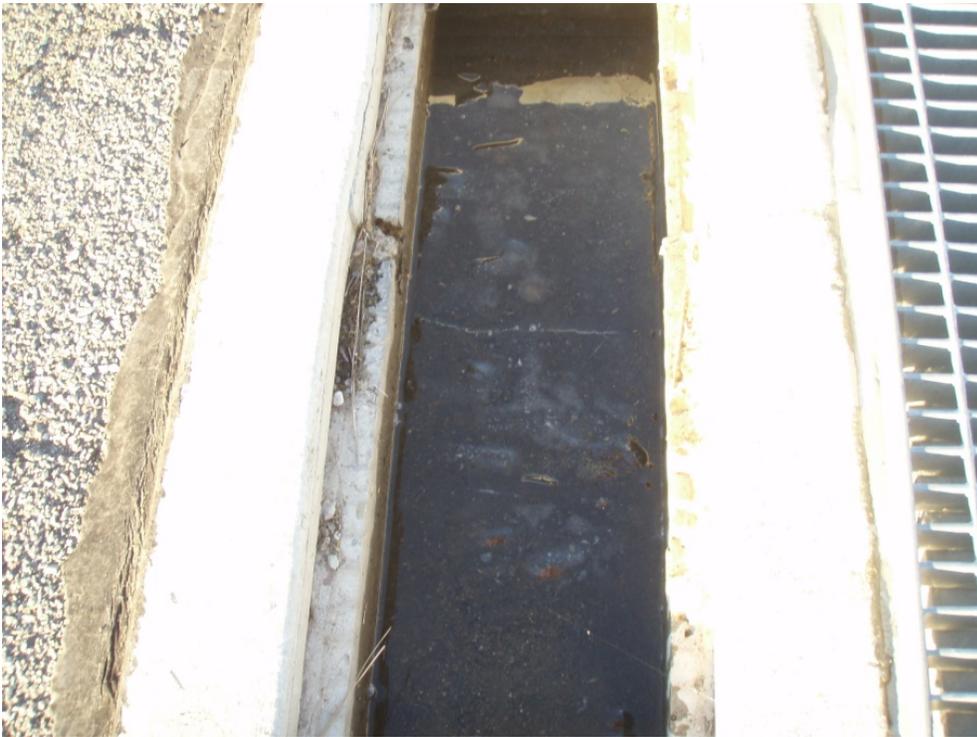
- 1. Trench drains associated with hangar pads 1-5 contain standing water at northern third of drain.**
- 2. Monitoring not completed along eastern and northern vegetated slopes due to snow and saturated soil conditions.**
- 3. Manhole at DC-8 covered with snow and could not be located.**

Water and ice in trench drain

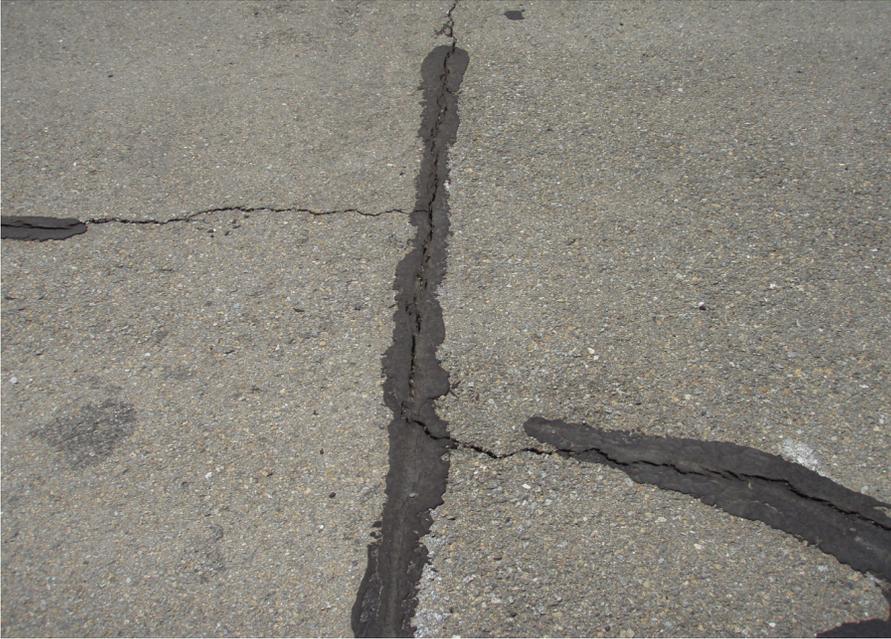
Photo 1: Cracking of MatCon pavement.

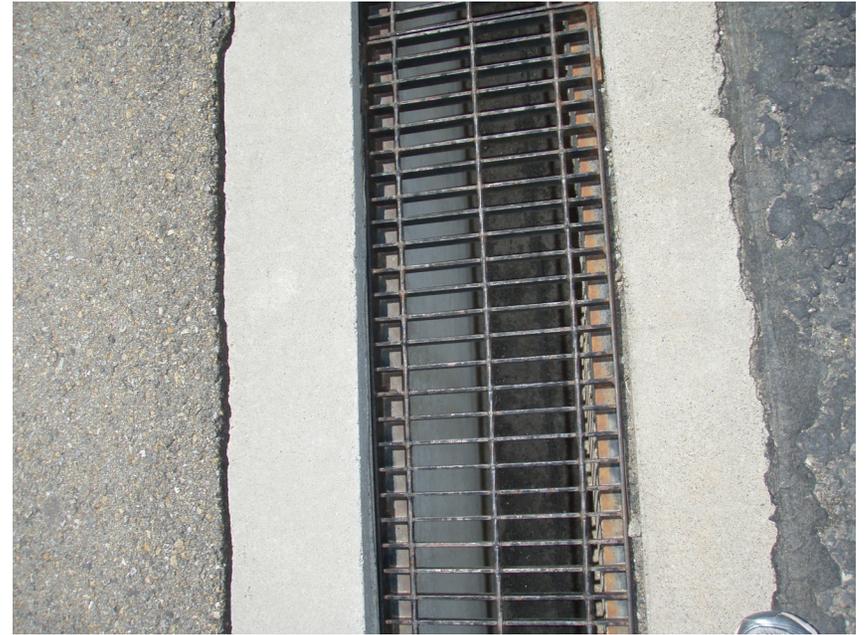
Photo 2: Separation of MatCon and trench drain

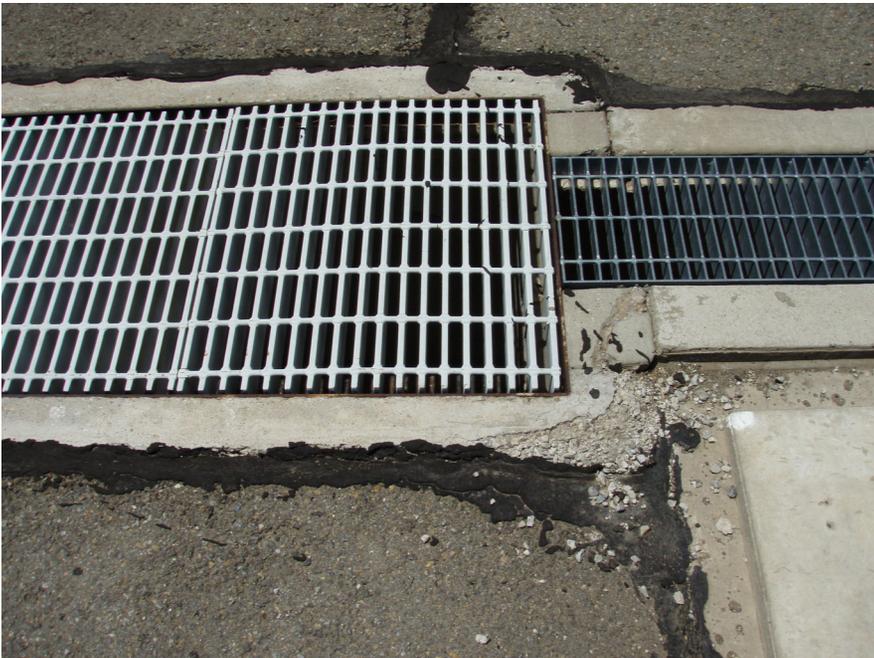
Photo 3: Concrete failing at trench drain drop inlet structure.

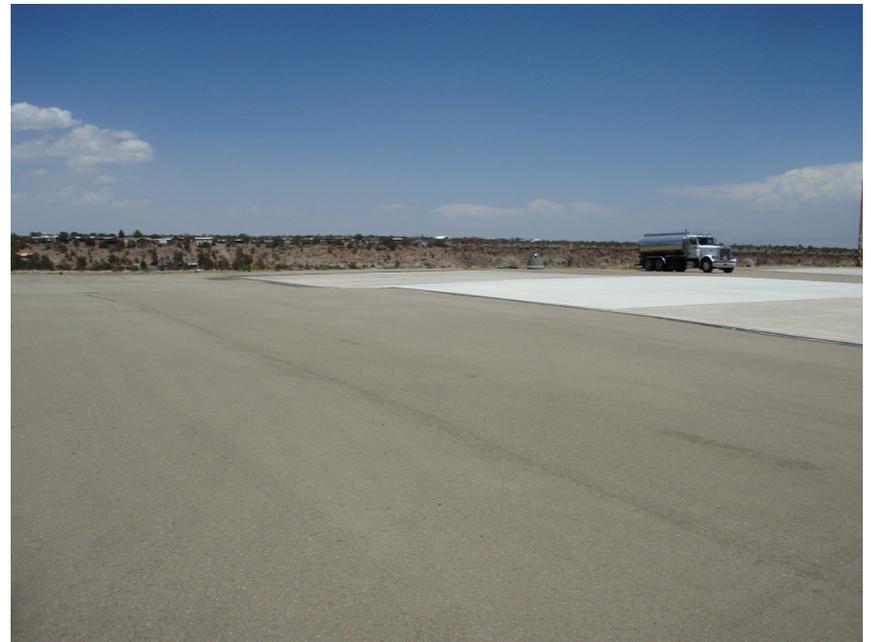
Photo 4: Subsidence of MatCon and Pad #4.

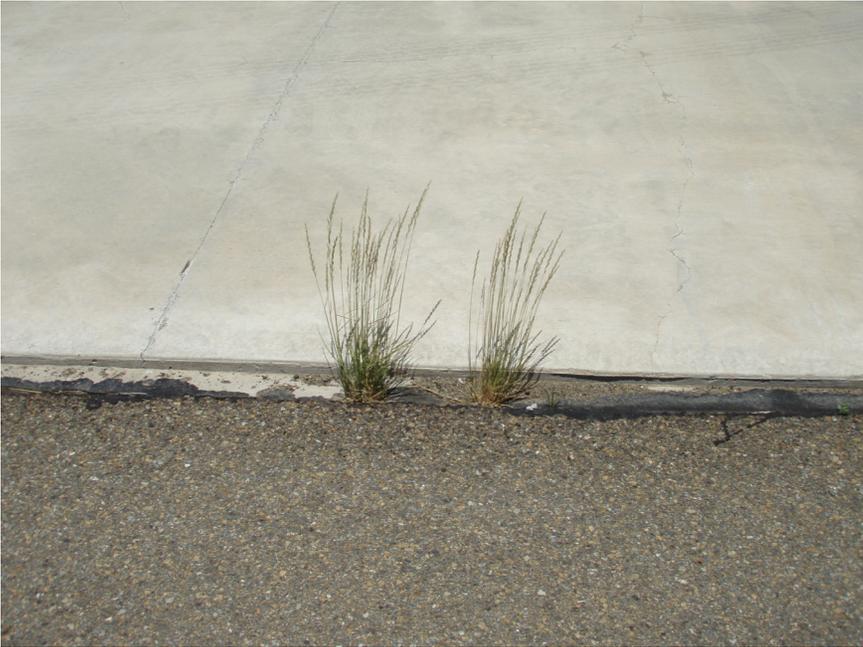
Photo 5: Weeds growing between MatCon and pad.

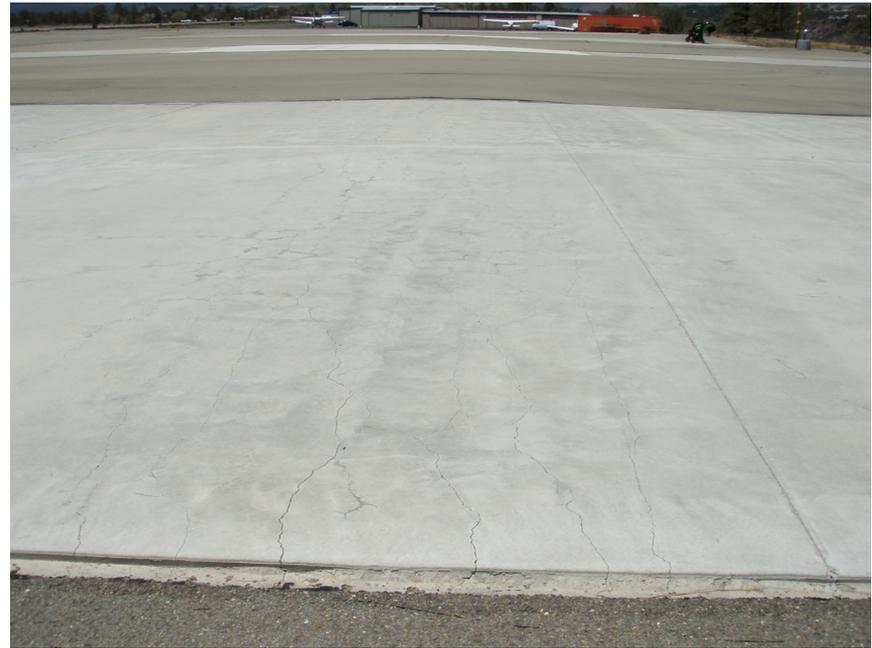
Photo 18: Cracks in concrete hangar pad.
