Subject: Submittal of the 2013 Annual Inspection Report for Los Alamos County Airport Landfill, Solid Waste Management Units 73-001(a) and 73-001(d), Technical Area 73

**2013 Annual Inspection Report for
Los Alamos Country Airport Landfill,
Solid Waste Management Units
73-001(a) and 73-001(d),
Technical Area 73**

Prepared by the Los Alamos Field Office

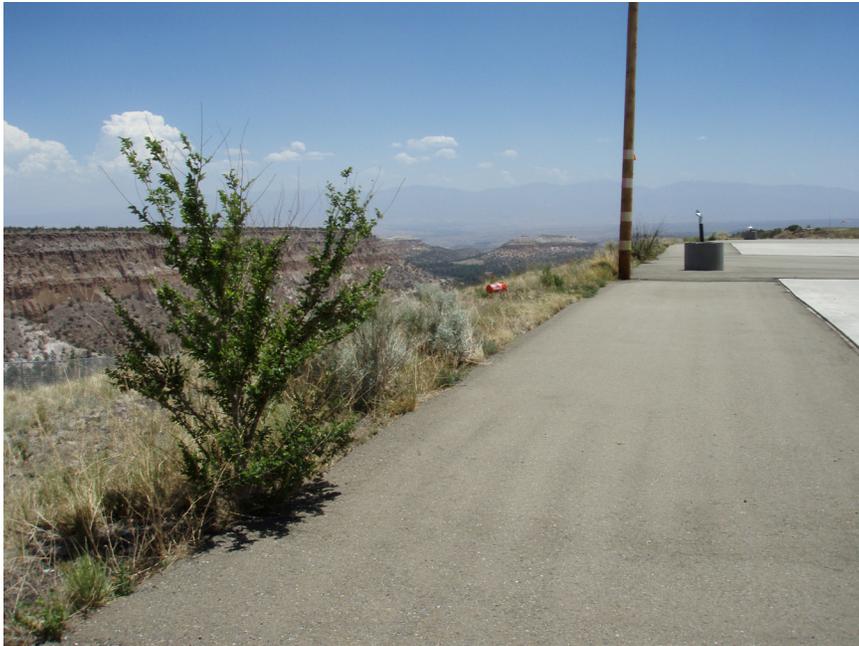
Photo 19: Tree growing along north side of pads.

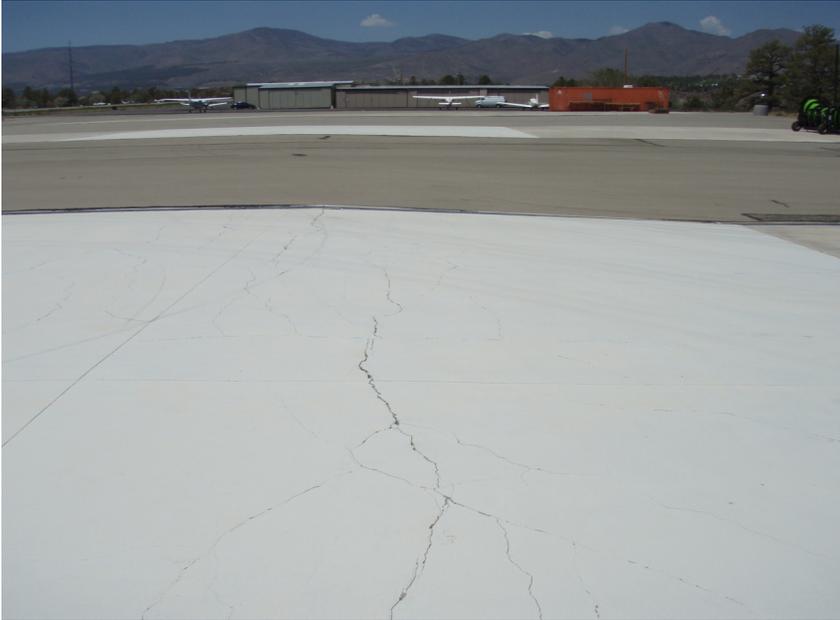
Photo 21: Large cracks in Pad #3 along hinge line.

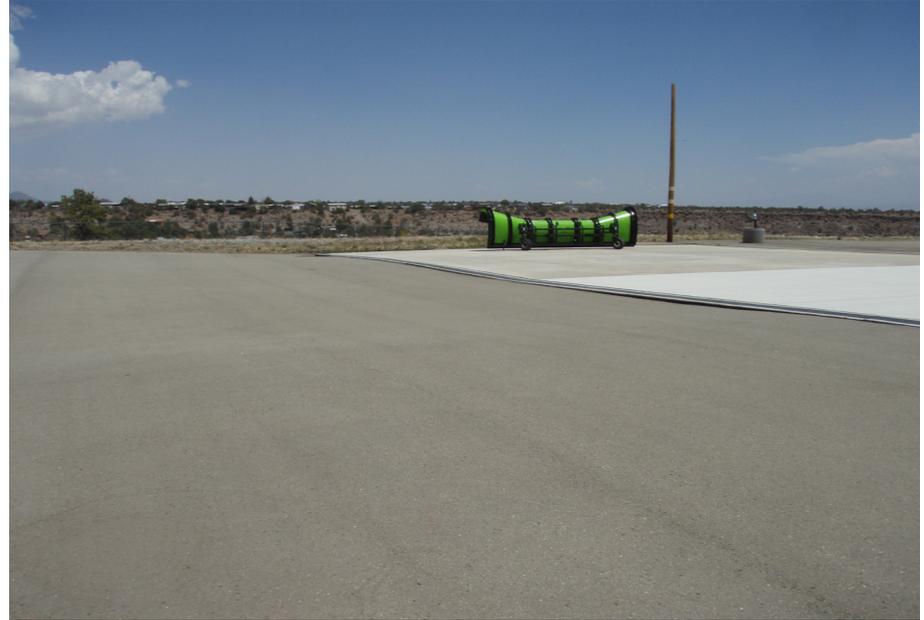
Photo 22: Subsidence of MatCon and pad.

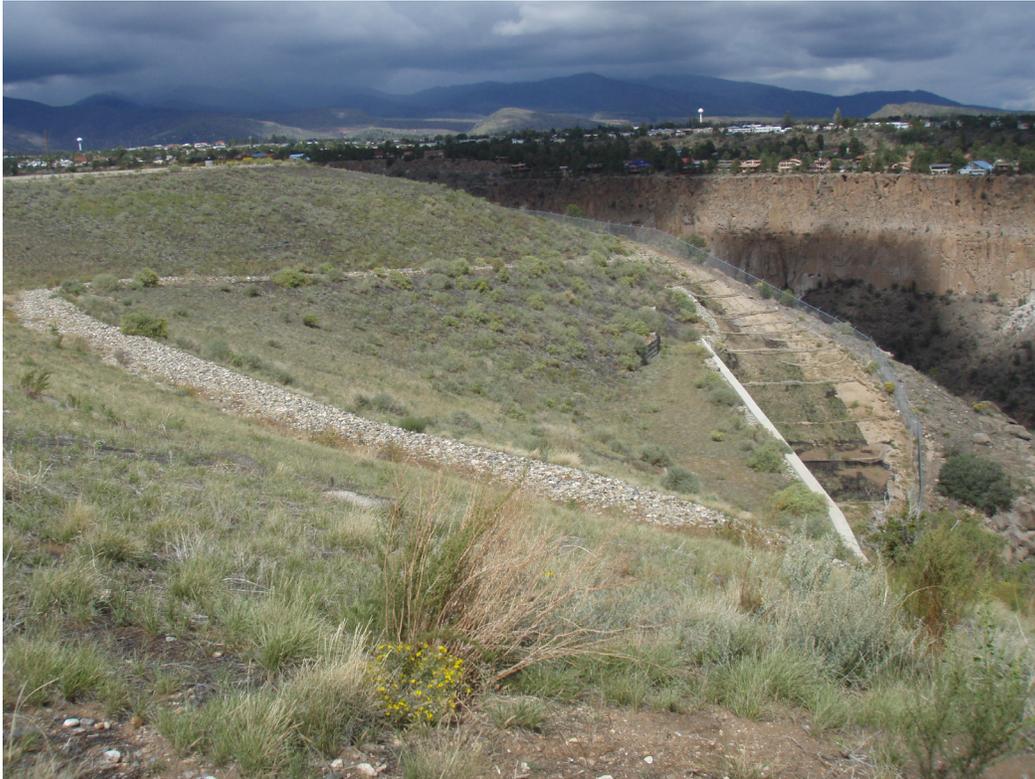
Photo 1. View of vegetated slopes. Minor rilling was observed across area.

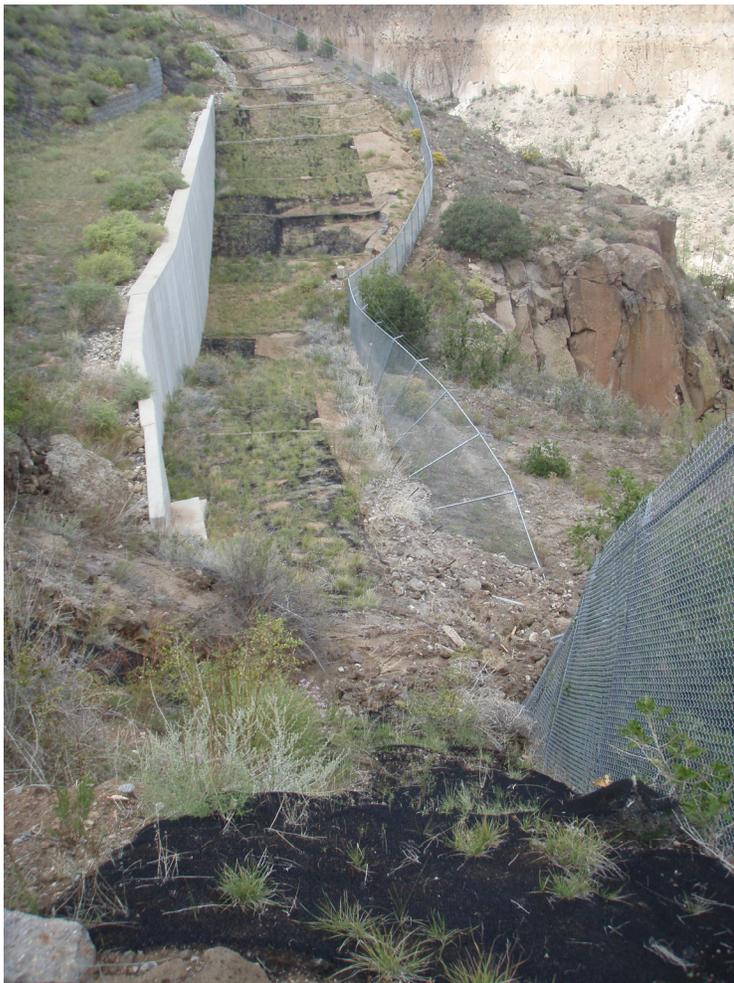
Phot0 12. Perimeter fence impacted from erosion of slope.

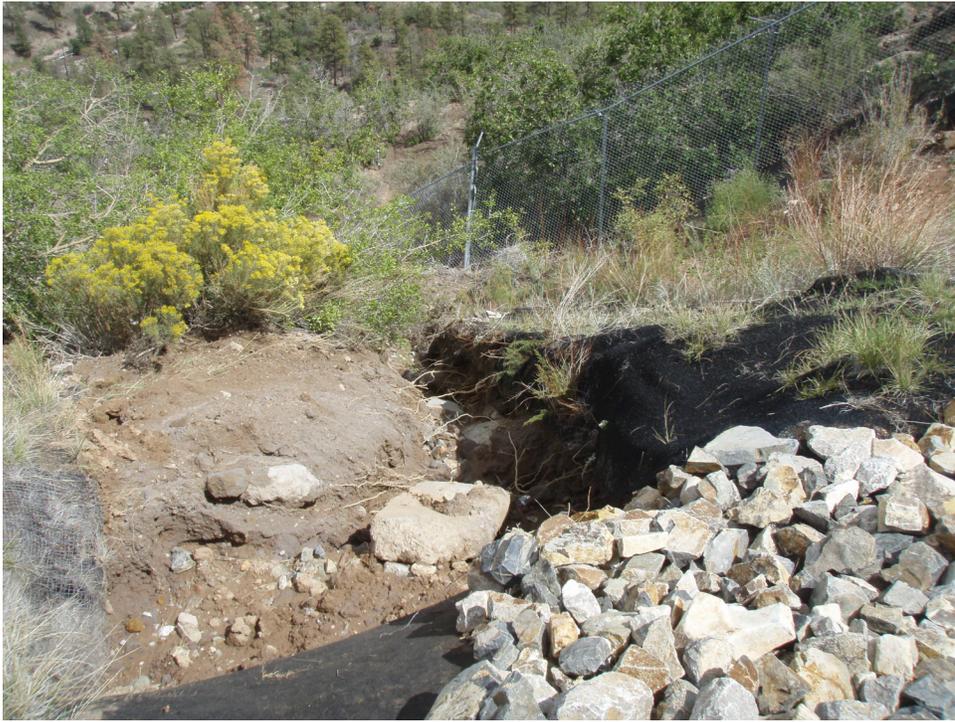
Photo 13. Erosion channel at east end of mid-slope rock drainage channel.

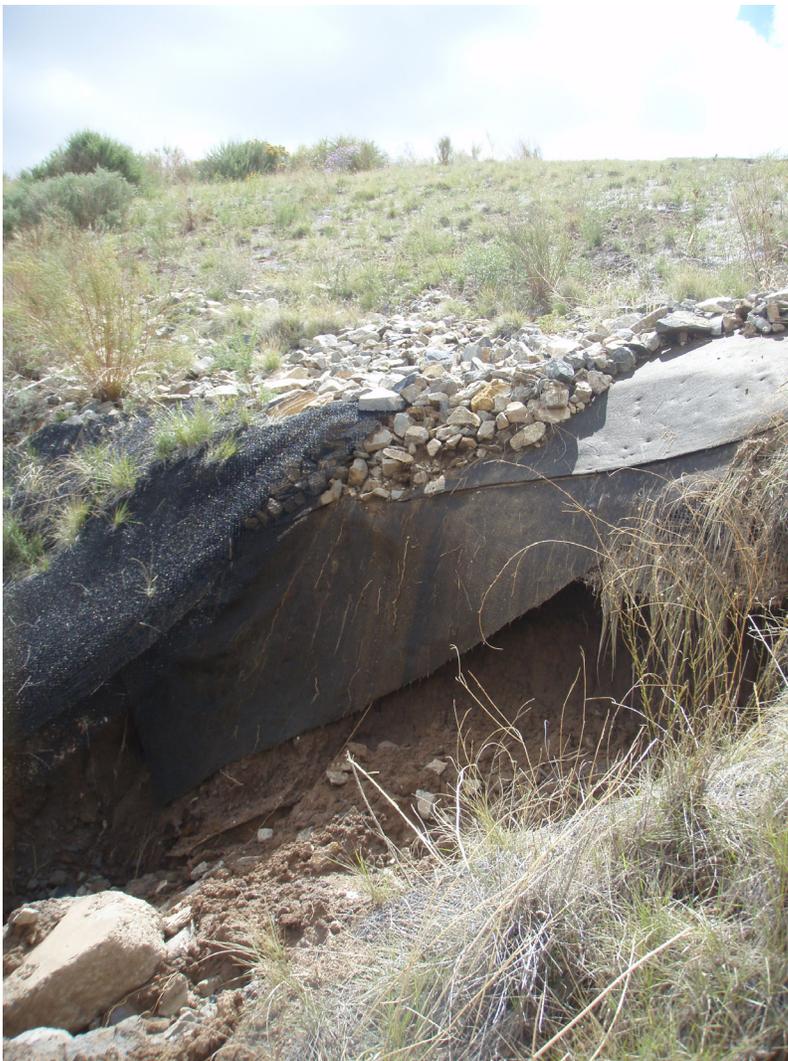
Photo 14. Erosion at east end of mid-slope rock drainage channel.

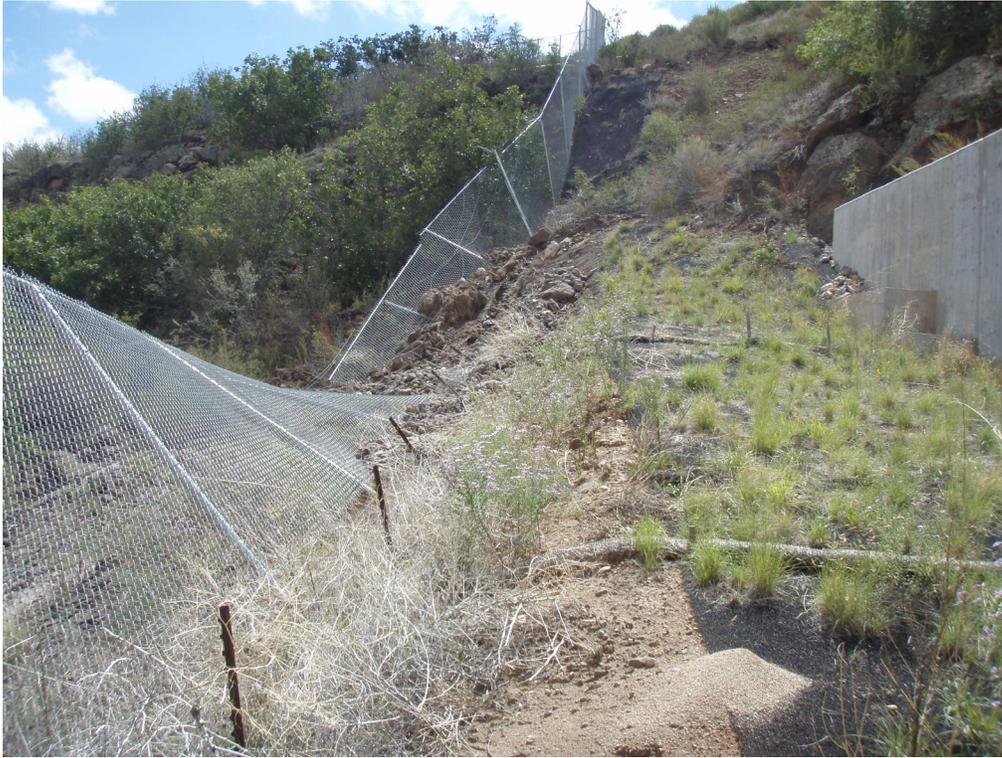
Photo 15. Perimeter fence damage.
