National Nuclear Security Administration

Appendix A of the MWL CMI Report is the MWL Alternative Cover Construction Quality Assurance (CQA) Report, which is a two volume report prepared by the independent third-party CQA Contractor. The MWL Alternative Cover CQA Report is certified by a New Mexico registered Professional Engineer and provides all construction quality control and CQA data and documentation. Volume 1 contains tables, figures, as-built drawings, etc. Volume 2 of this report provides supporting documentation in the form of attachments and is provided electronically on a compact disc at the end of the report. A separately bound hard copy of Volume 2 is provided for the NMED Hazardous Waste Bureau document library as previously discussed with Mr. William Moats of your staff. Additional hardcopies of the MWL Alternative Cover CQA Report Volume 2 will be maintained at the DOE/Sandia Document Repository (Public Reading Room, Zimmerman Library at the University of New Mexico) and the SNL/NM Customer Funded Records Center, formerly known as the SNL/NM Environment, Safety & Health and Security Records Center.

Document title: **Mixed Waste Landfill Corrective Measures Impleme

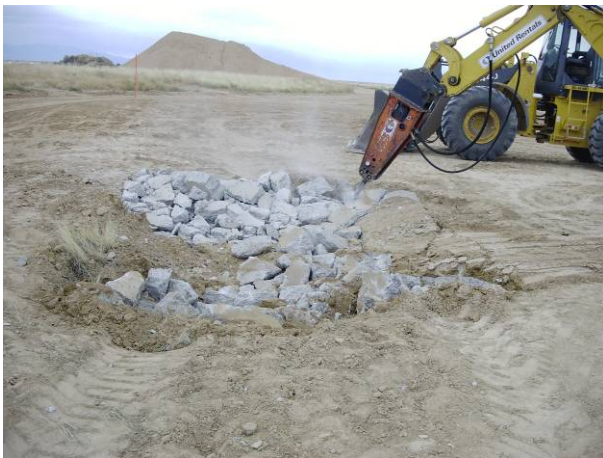
Description: Soil subsidence above a classified area pit after removal of concrete cap before backfilling and compacting to grade

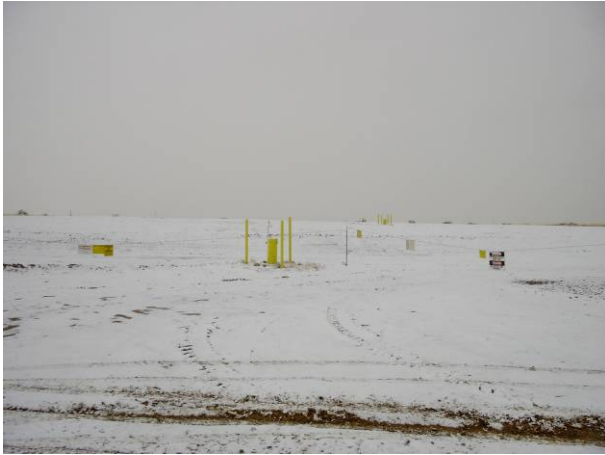
Description: No personnel on site due to snow, material too wet to perform final grading.

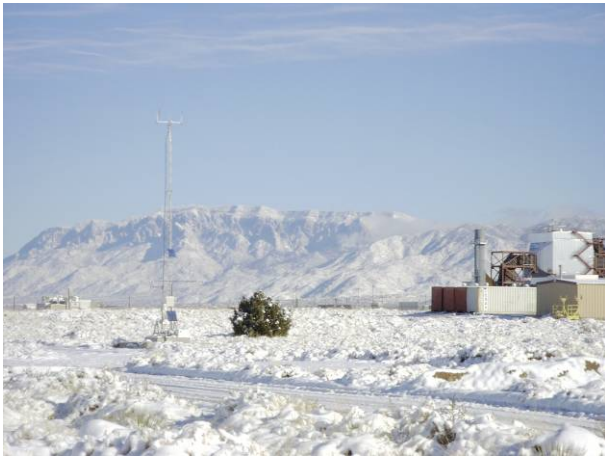
Description: No personnel on site due to snow, material too wet to perform final grading.

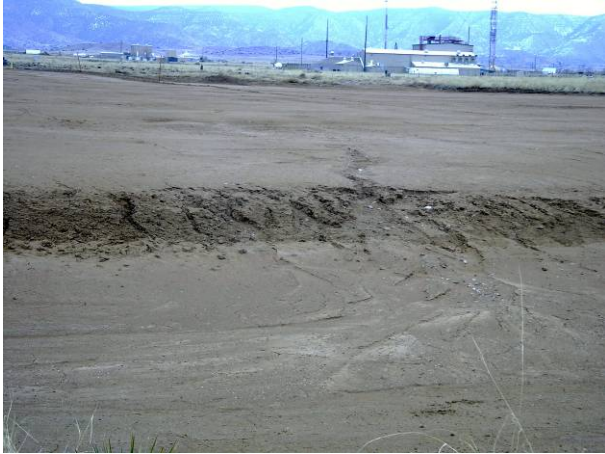
Description: Erosion of Subgrade slopes following snow melt.

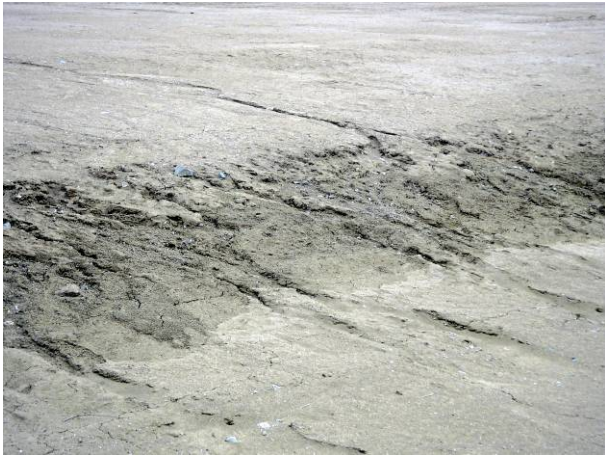
Description: Erosion of Subgrade slopes following snow melt.

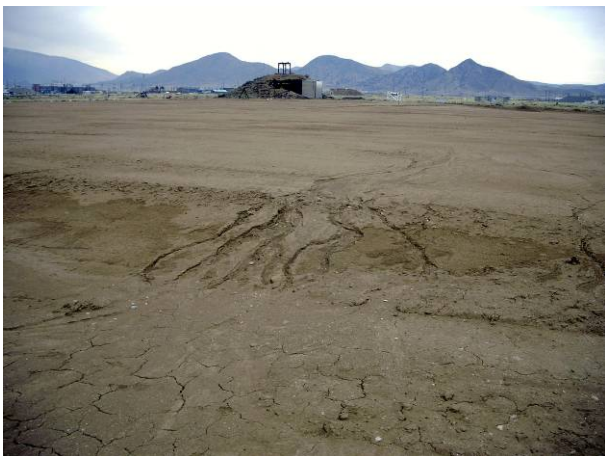
Description: Erosion of Subgrade slopes following snow melt.

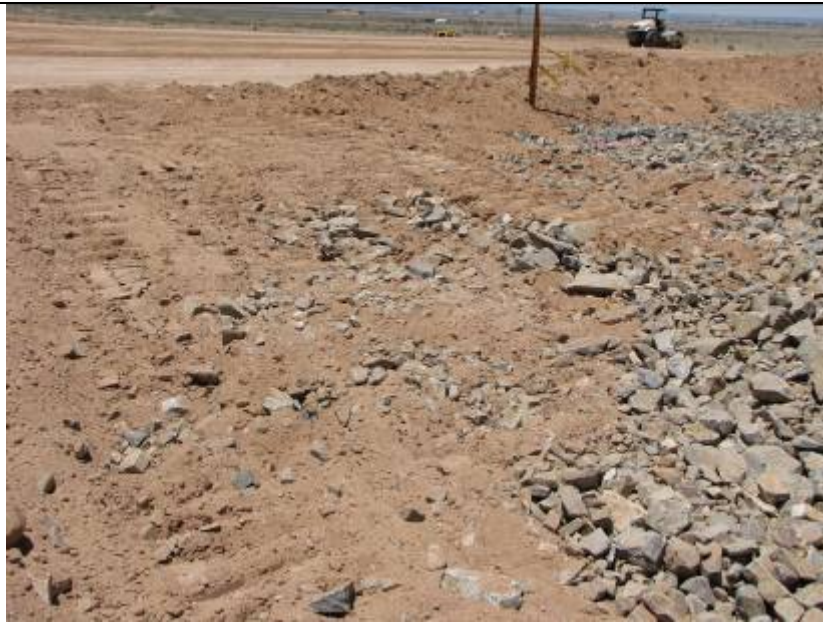
Description: Close up of the dry, loose soil filling voids in the upper part of the Biointrusion Layer

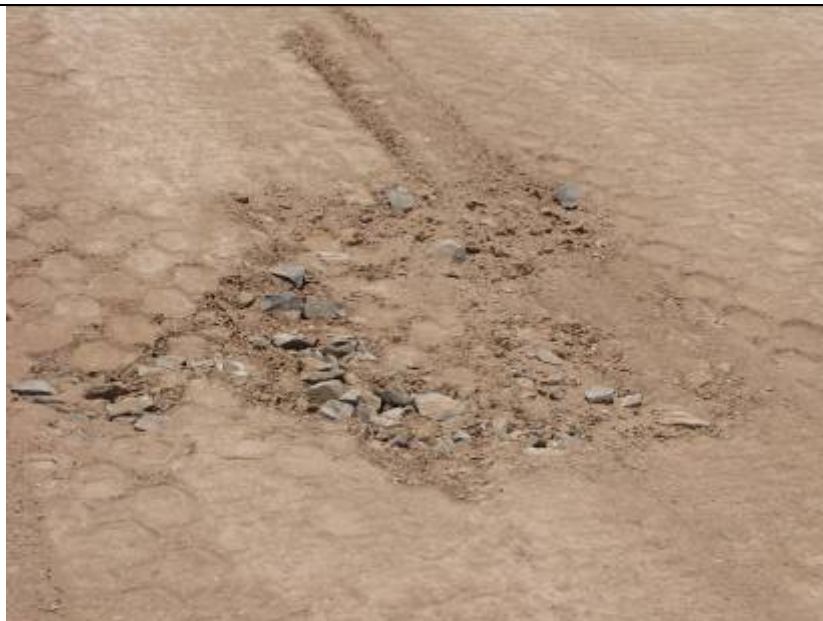
Description: Dry loose soil penetrating down into the rock layer filling the voids at the northwest corner

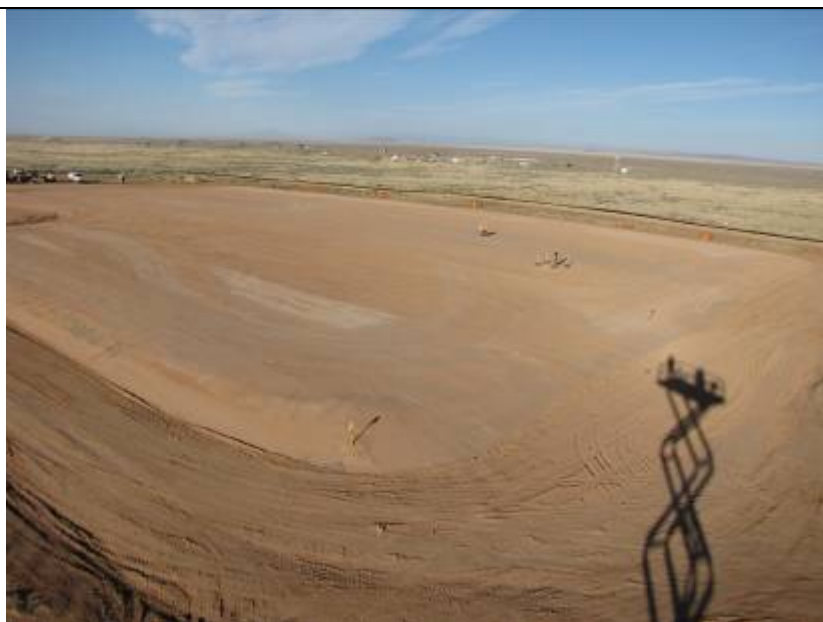
Description: Biointrusion rock showing through the thin soil layer – location was scraped with the grader to make sure the overlying soil layer was as thin as possible

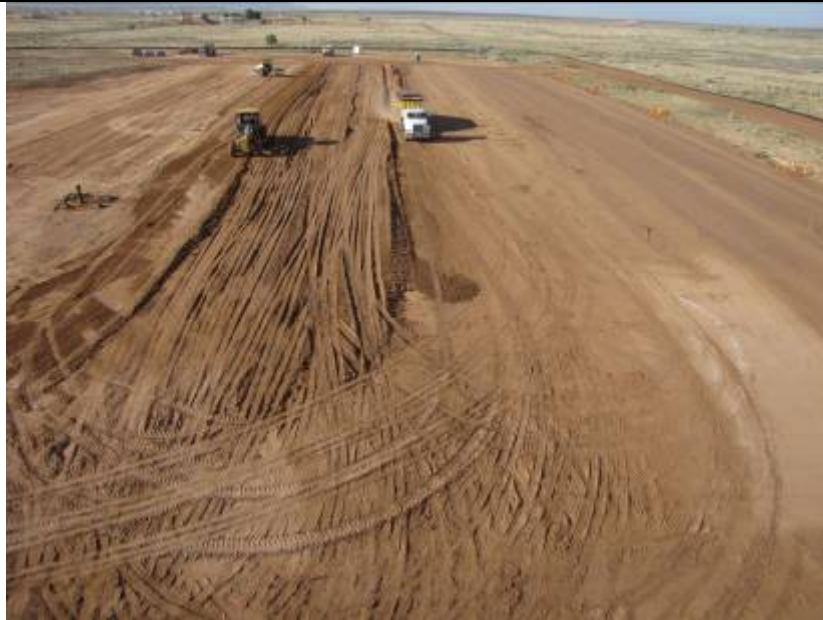
Date: 07/07/09 Time: 1604
Photo Taken by: J. Schermerhorn
Description: Adding water to increase the moisture to Lift 5 soil (grid blocks 1 and 2) after area ripped with grader scarifier shanks to a depth of ~6 inches after initial field compaction tests failed for moisture content
Facing: South

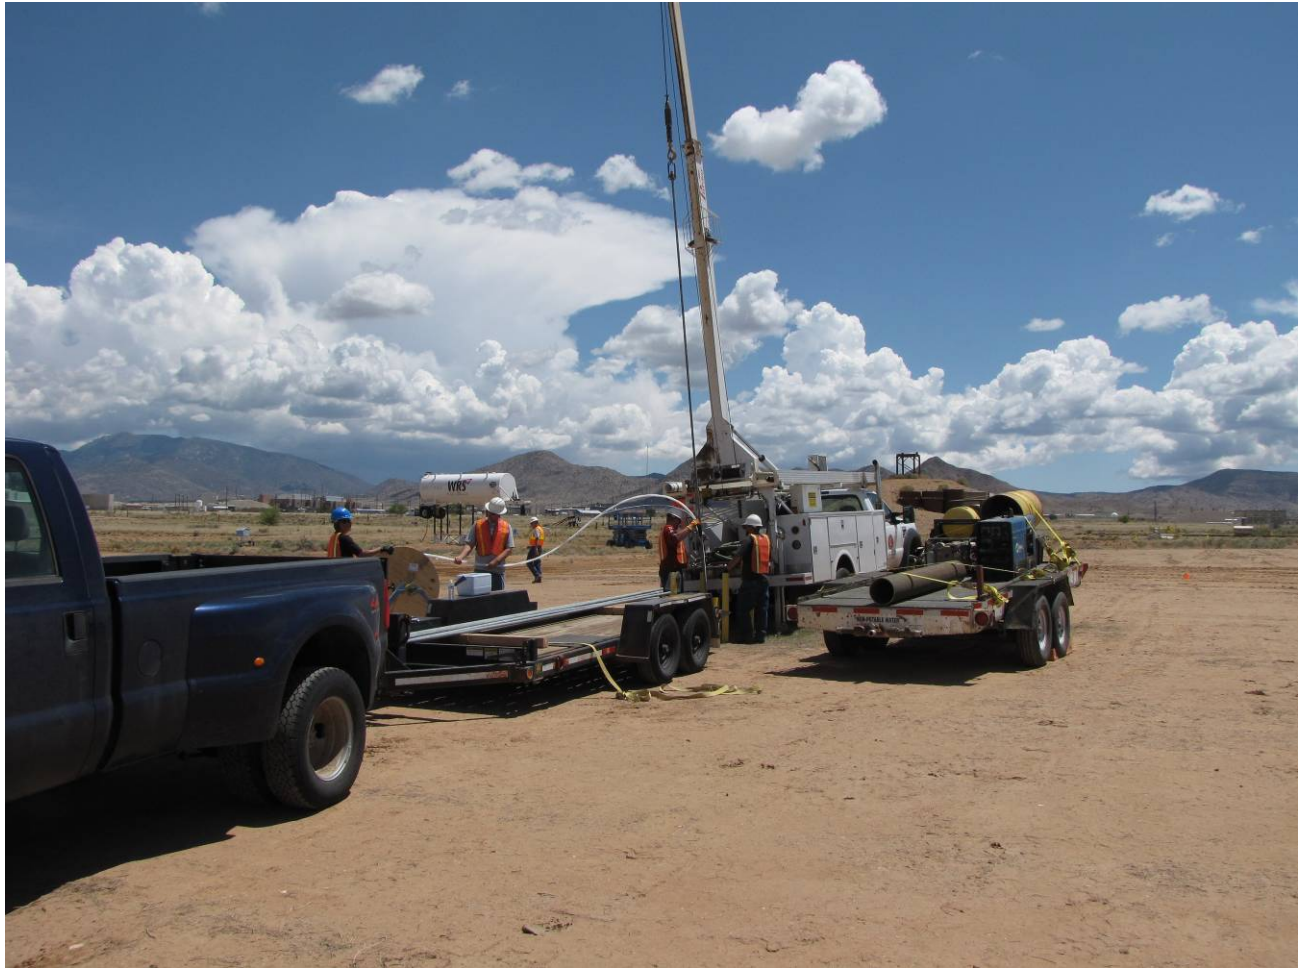
Figure 2-1
Removing the packer assembly from well MWL-MW4,
May 27, 2009. View to the east.

The MWL-MW4 well extension task consisted of removing the packer and then extending both the inner PVC well casing and the outer steel PC. On May 27, 2009, personnel and a monitoring well development rig provided by WDC were mobilized to the MWL. The development rig was positioned next to MWL-MW4 so that the packer could be pulled from the well. SNL/NM personnel from the ER Field Office assisted in the packer removal operation. The packer bladder was deflated, and the packer and pipe were removed from the well. The packer removal operation is shown in Figure 2-1. An SNL/NM Radiological Control Technician (RCT) also completed a radiological screening survey of the packer and pipe to verify the absence of radiological contamination as the equipment was removed from the well (Figure 2-2). The screening survey confirmed there was no radiological contamination on the packer or pipe.

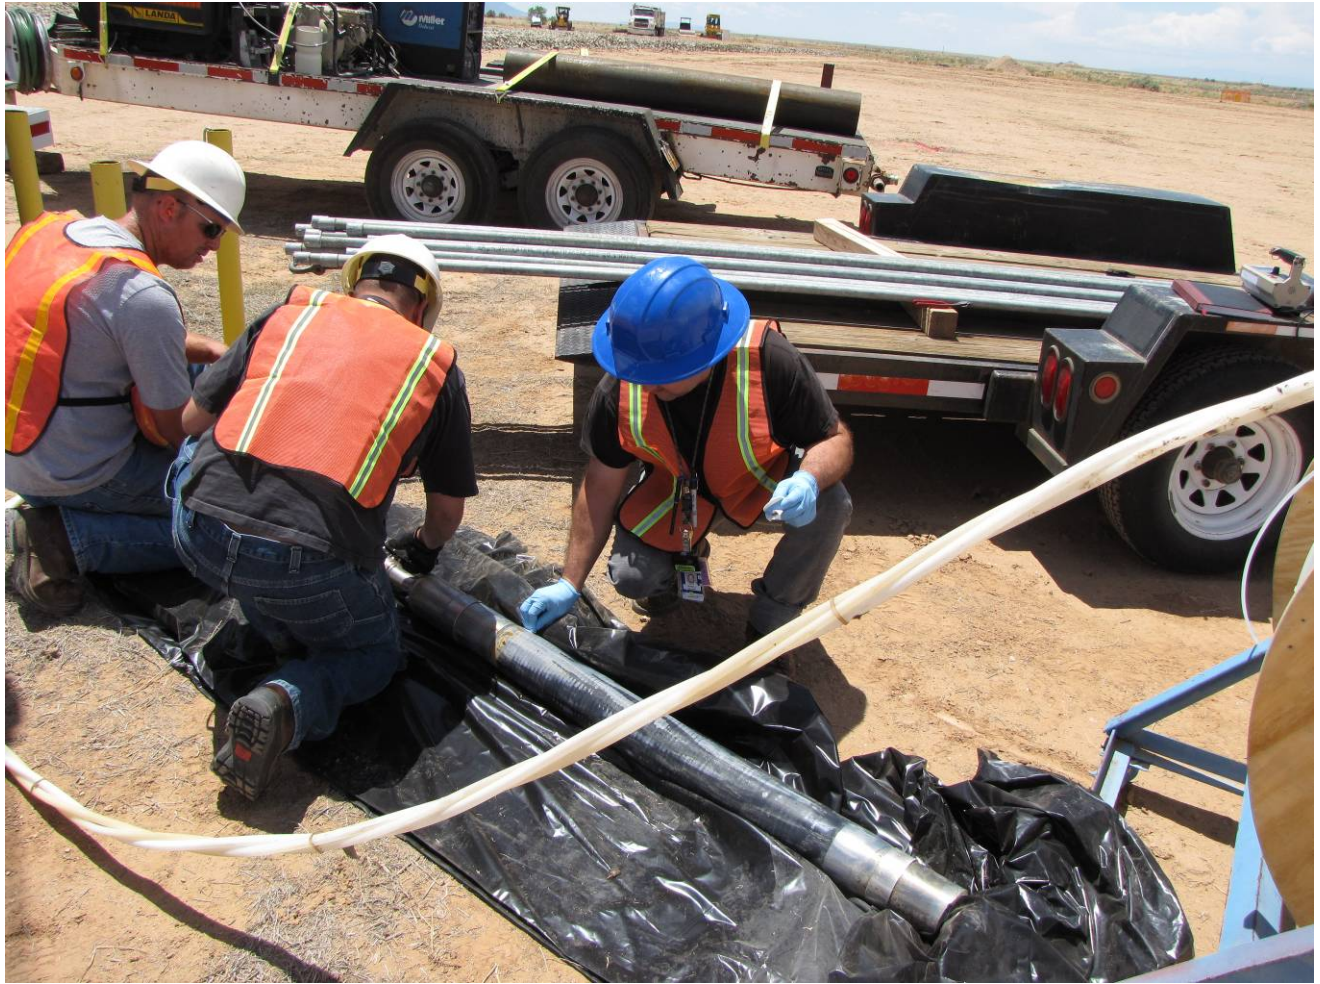
Figure 2-2
Screening the MWL-MW4 packer for radiological contamination by an RCT,
May 27, 2009. View to the south.

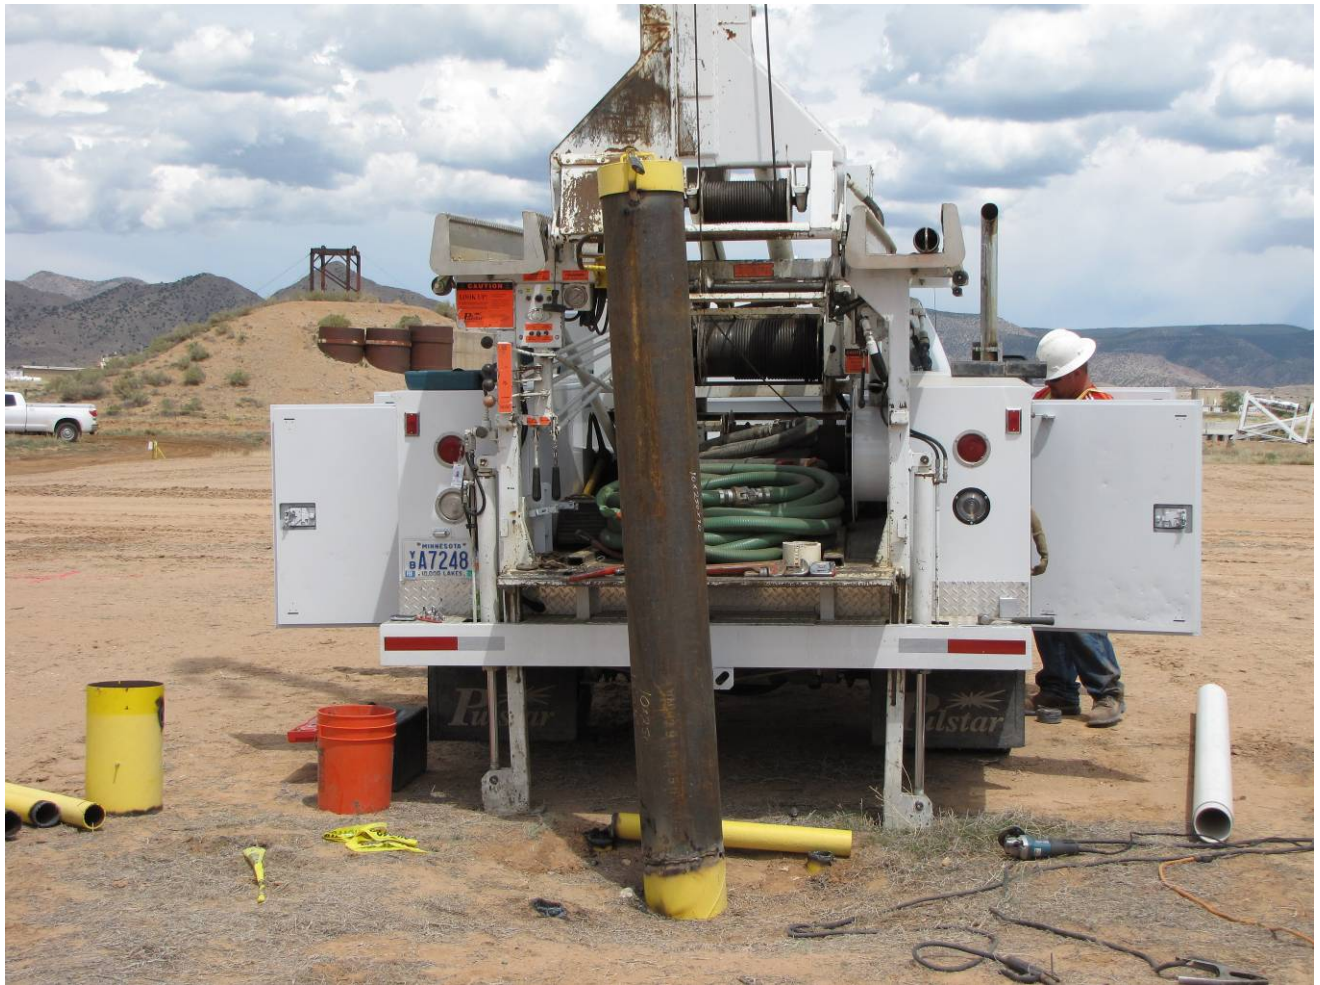
Figure 2-4
MWL-MW4 protective surface casing extension, welded to the
existing protective surface casing, May 27, 2009. View to the east.

The final well extension step consisted of extending the steel PC above the top of the extended PVC casing. This was accomplished by lowering an approximate 8-ft-length of 10.75-inch OD steel PC over the extended PVC and welding it to the top of the PC (Figure 2-4). The final height of the extended PC is 8.39 ft above the original MWL surface, 2.50 ft above the completed ET Cover surface, and approximately 1 ft above the top of the extended PVC casing. The length of the extended PC was planned such that the new top of the PC would end up at approximately 3 ft above the final finished grade of the ET Cover. A well cap was installed to seal the PVC casing, and the outer locking well cap that was attached to the original well PC was reattached and locked with a keyed padlock.
