Mixed Waste Landfill Alternative Cover Construction Quality Assurance Report January 2010

Mixed Waste Landfill Alternative Cover Construction Quality Assurance Report

URS

JANUARY 2010

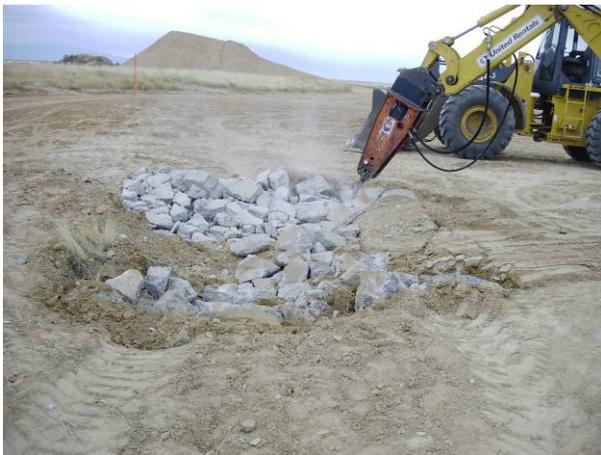
Description: Soil subsidence above a classified area pit after removal of concrete cap before backfilling and compacting to grade

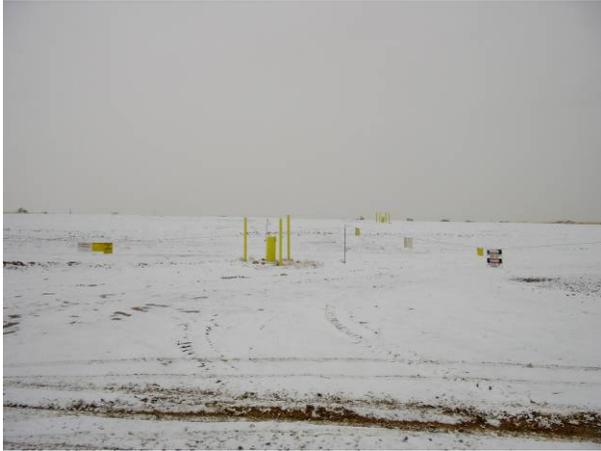
Description: No personnel on site due to snow, material too wet to perform final grading.

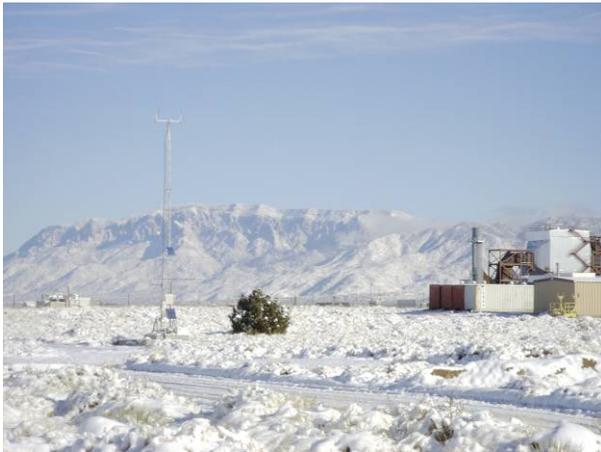
Description: No personnel on site due to snow, material too wet to perform final grading.

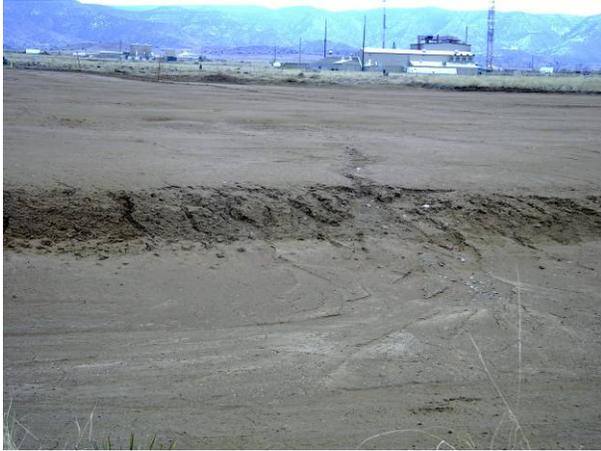
Description: Erosion of Subgrade slopes following snow melt.

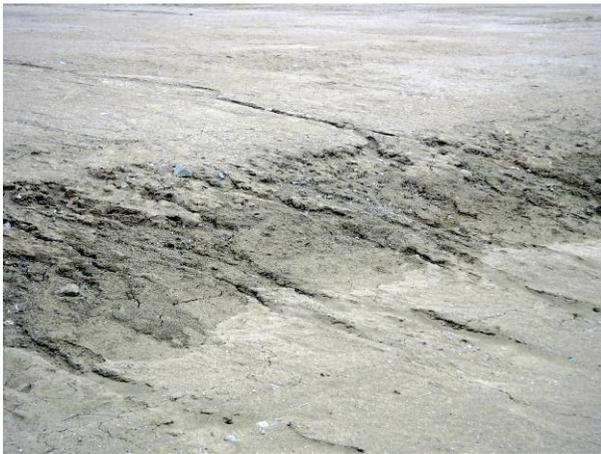
Description: Erosion of Subgrade slopes following snow melt.

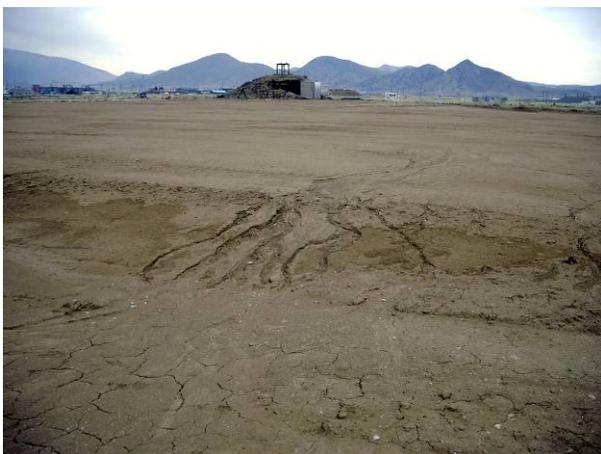
Description: Erosion of Subgrade slopes following snow melt.

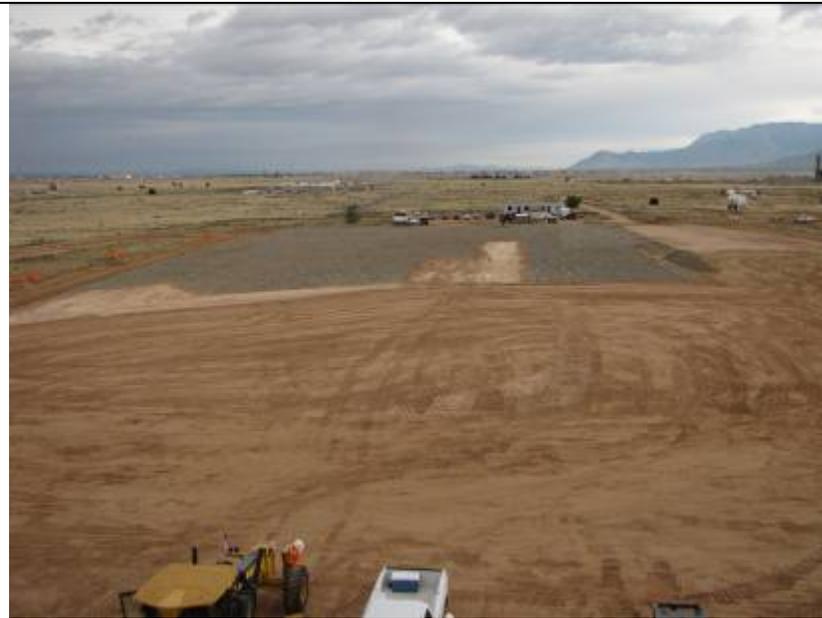
Description: Spreading the thin soil layer over the Biointrusion Layer with the grader to fill in voids and make a level surface

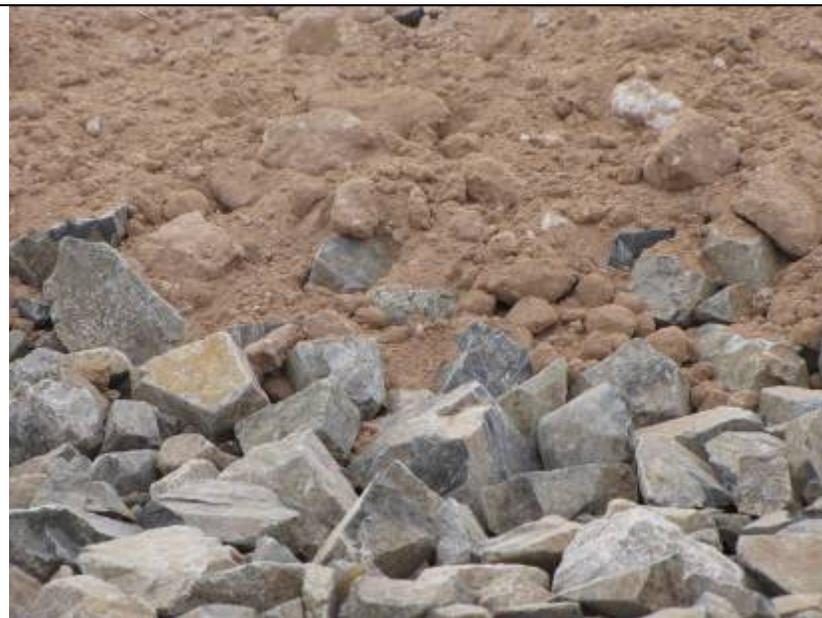
Description: The southern half of the MWL covered with the thin soil layer overlying the Biointrusion layer

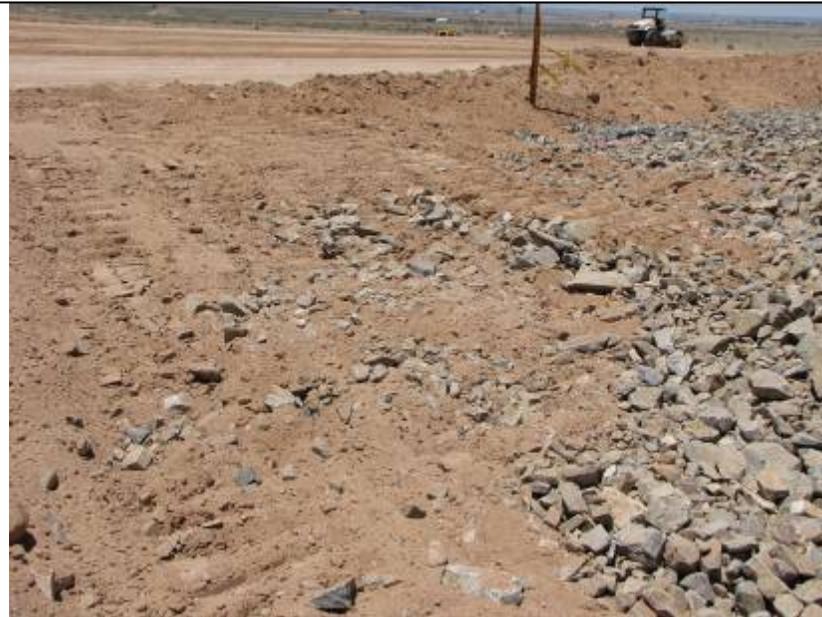
Description: Close up of the dry, loose soil filling voids in the upper part of the Biointrusion Layer

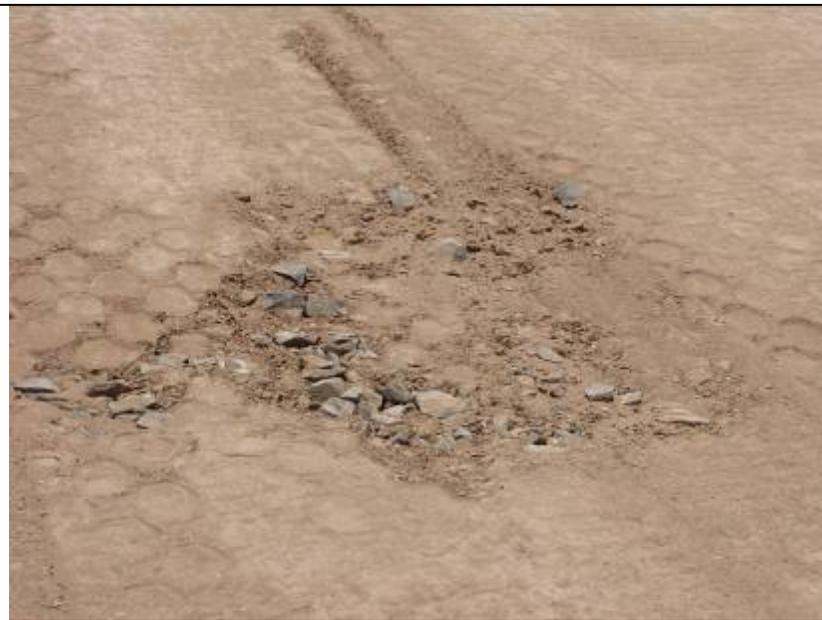
Description: Dry loose soil penetrating down into the rock layer filling the voids at the northwest corner

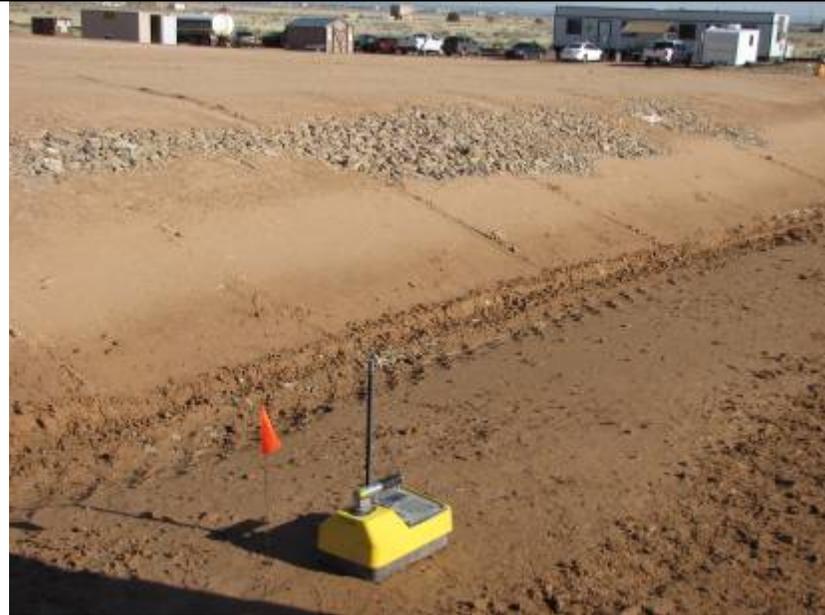
Description: The completed thin soil layer overlying the Biointrusion Layer before installation of the Native Soil Layer – view of northeast corner of MWL – note steep side slopes

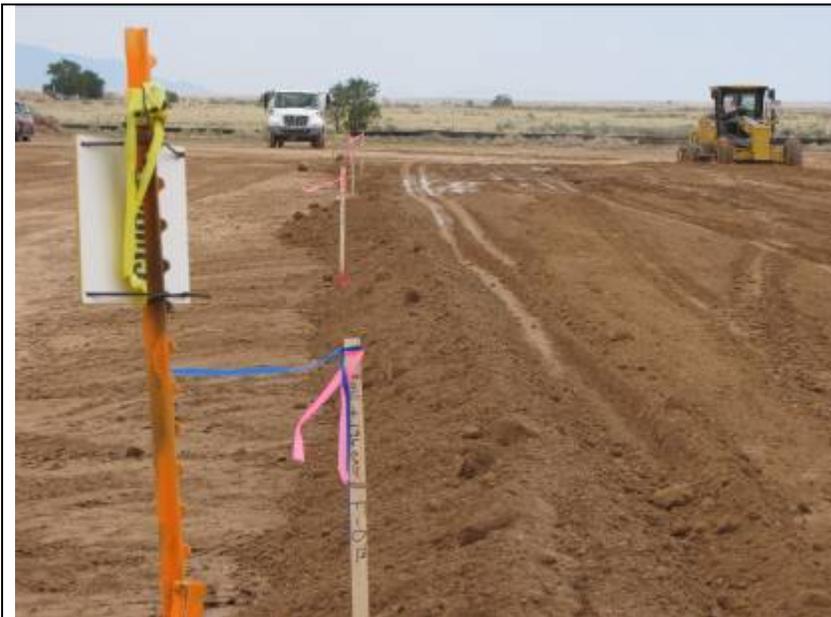
Description: Building north end side slope of the cover during initial Native Soil Layer installation – survey stakes show extent of the slope (i.e., the toe)

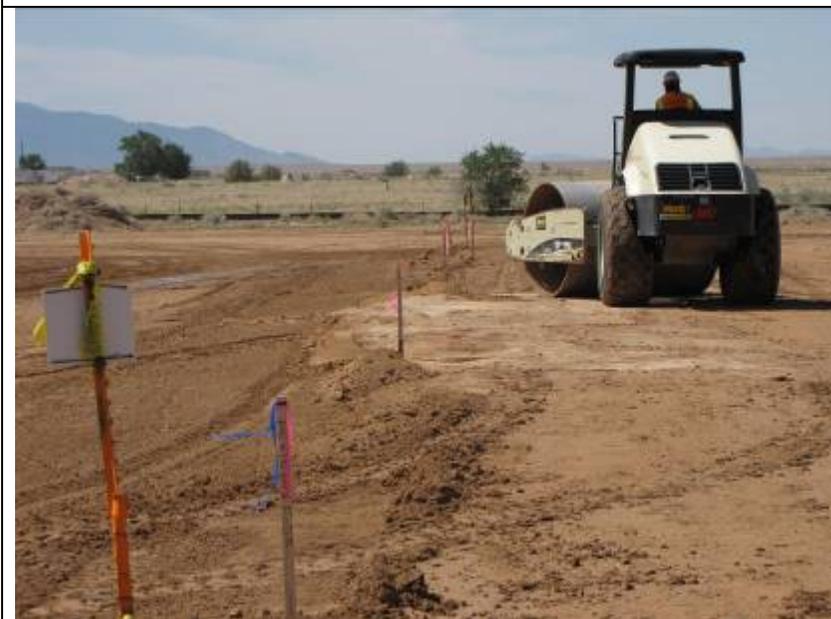
Description: Survey stakes outlining area of Wedge Lift 1

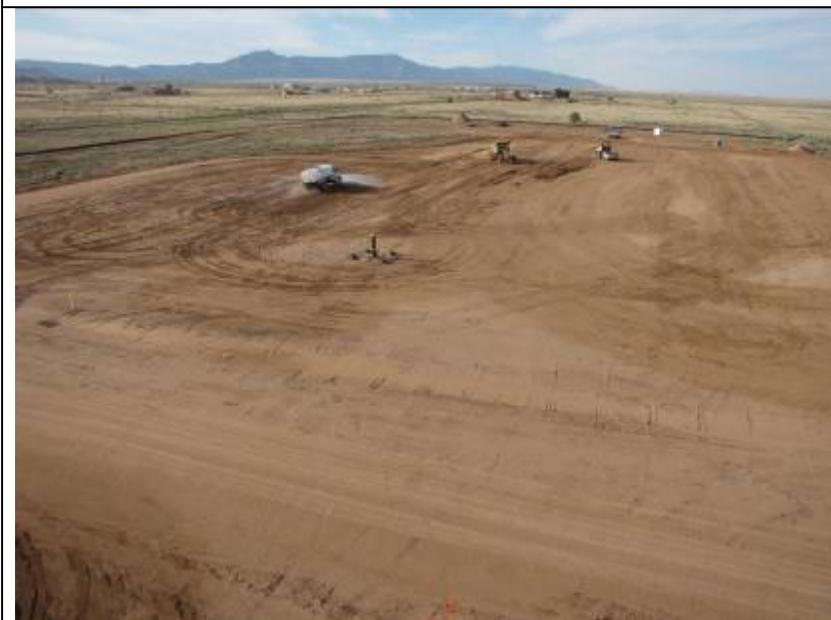
Description: Compacting placed material in Wedge Lift 1

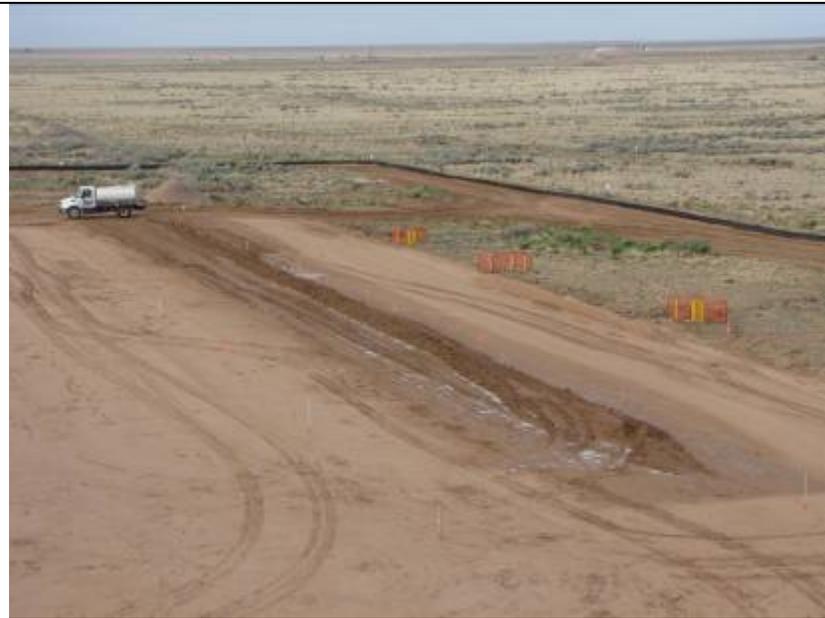
Description: Constructing Lift 3 – grading lift to proper thickness based on survey grade stakes

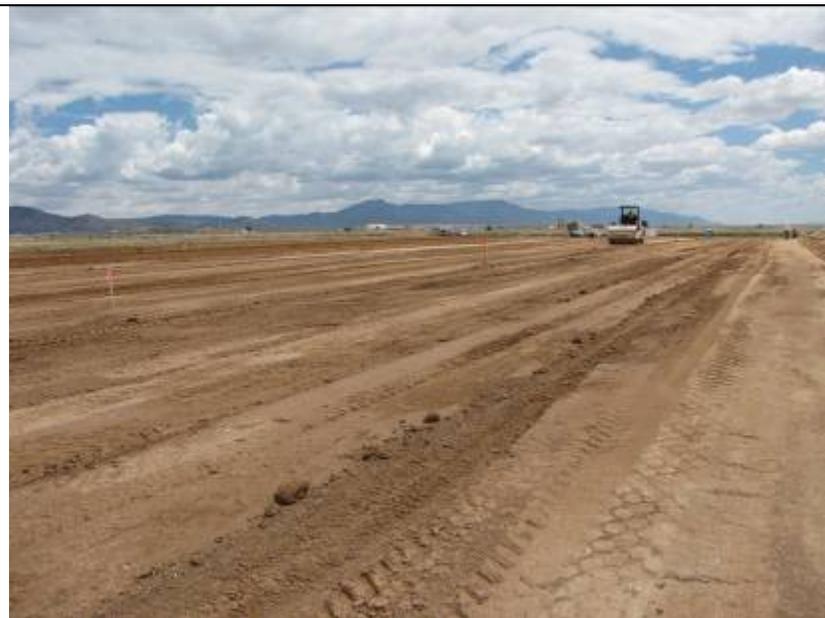
Description: Adding water to placed soil fill material on west side of cover for Lift 4.

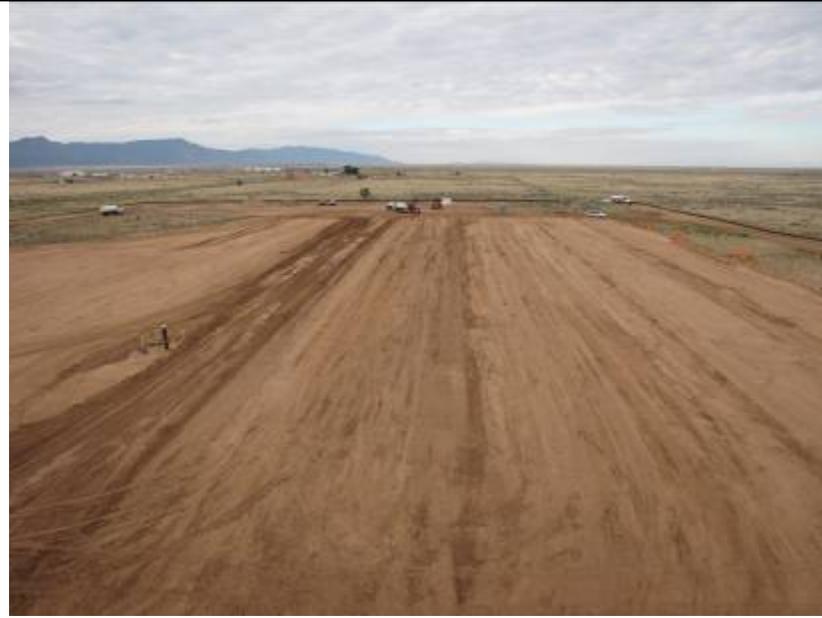
Description: Compacting soil material during Lift 4 installation

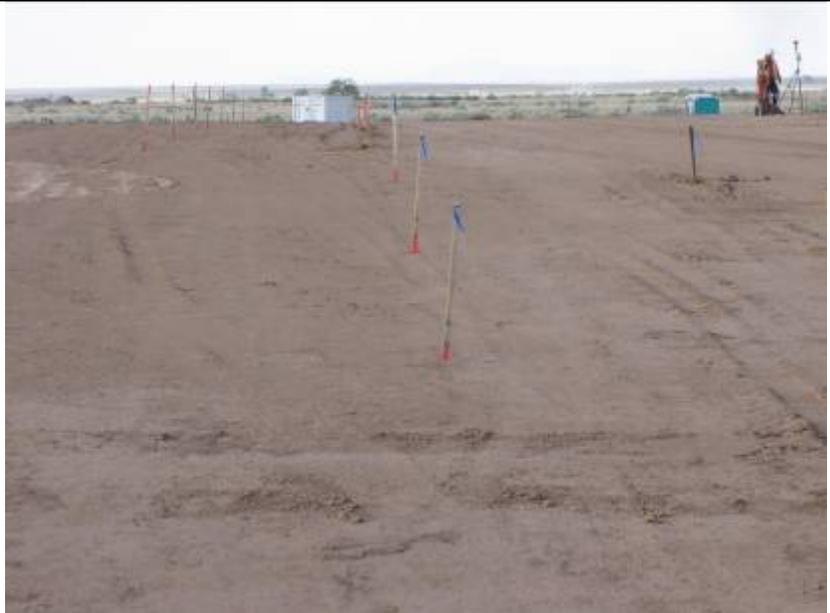
Description: Compacting Native Soil Lift 6 on the west slope – note groundwater monitoring wells in background (orange fencing surrounds them)

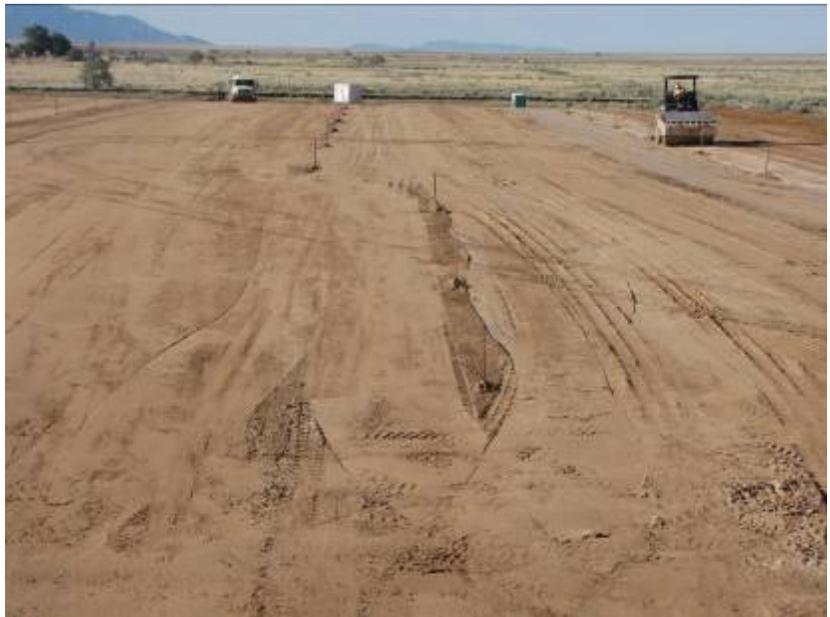
Description: Grade stakes showing the thickness of soil to be placed for the next Native Soil Layer Lift (Lift 7)

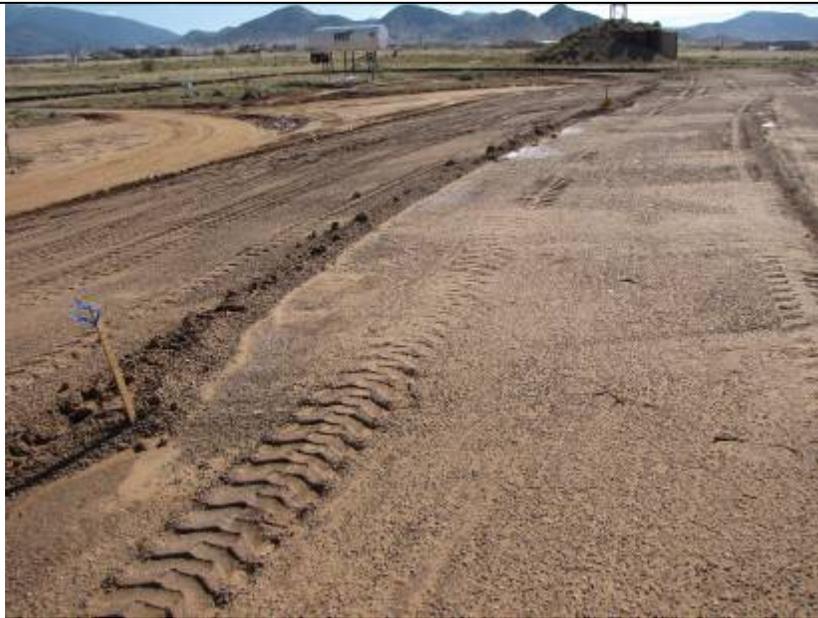
Description: Building the Topsoil Layer in one lift and applying water to moisture condition the soil and minimize dust generation

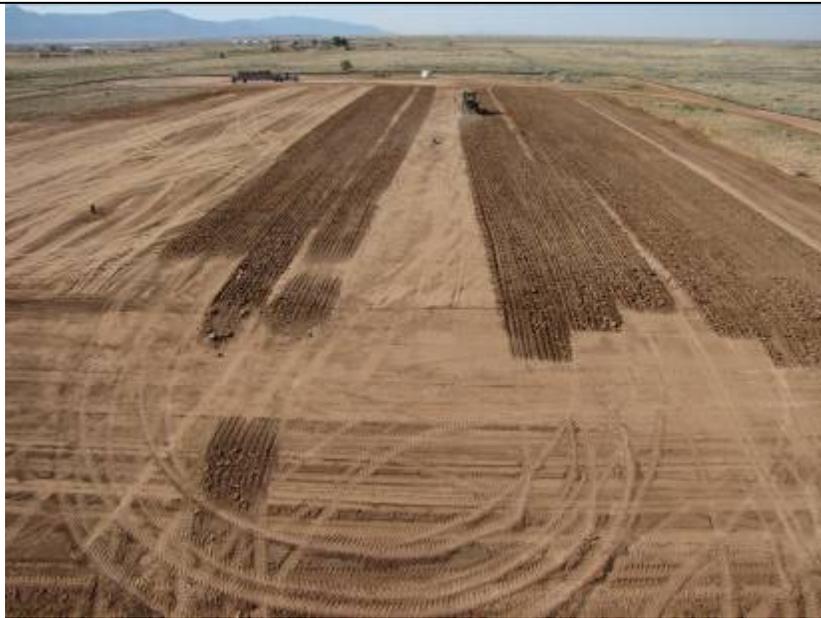
Description: MWL ET Cover after Topsoil Layer placement – final CQC and CQA survey verification of thickness and slopes completed

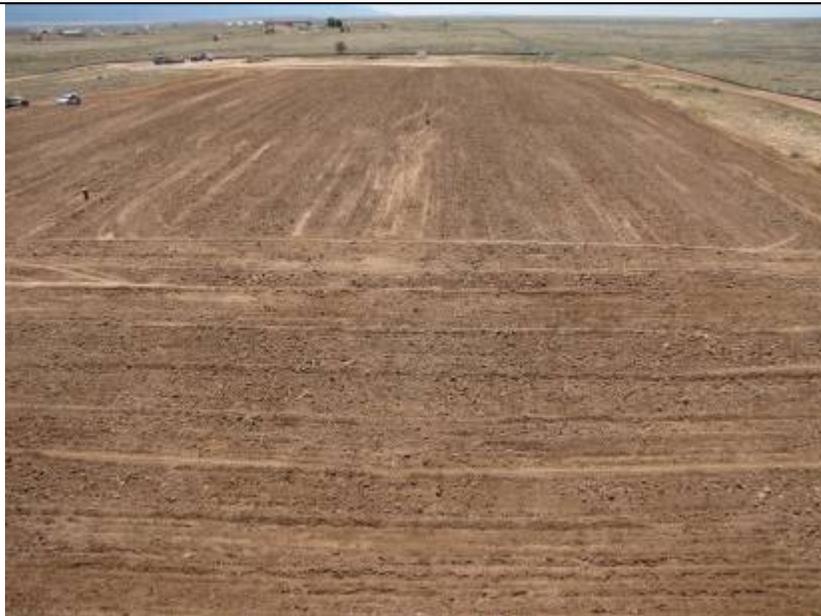
Description: Scarifying the Topsoil Layer with the scarifier shanks on the grader after approval of thickness and slopes in preparation for seeding

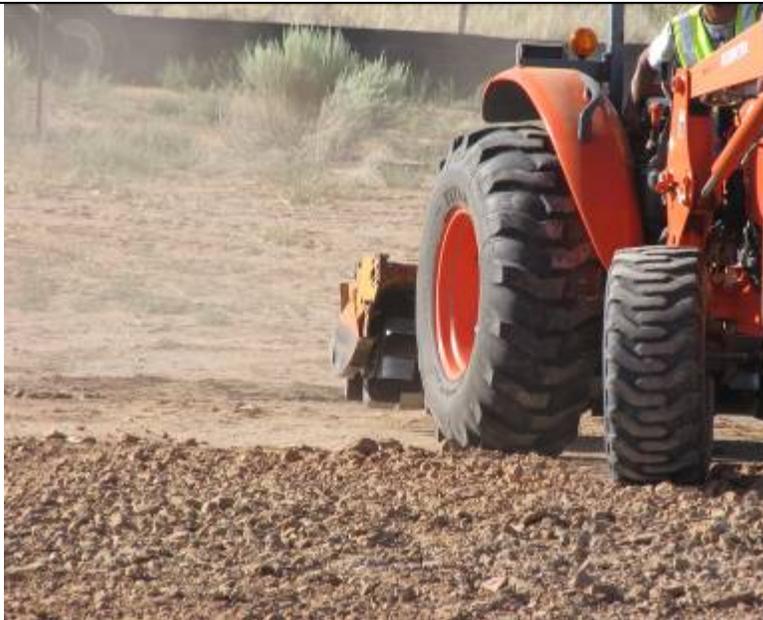
Description: Tilling the soil prior to seed placement to break up any large clumps of soil

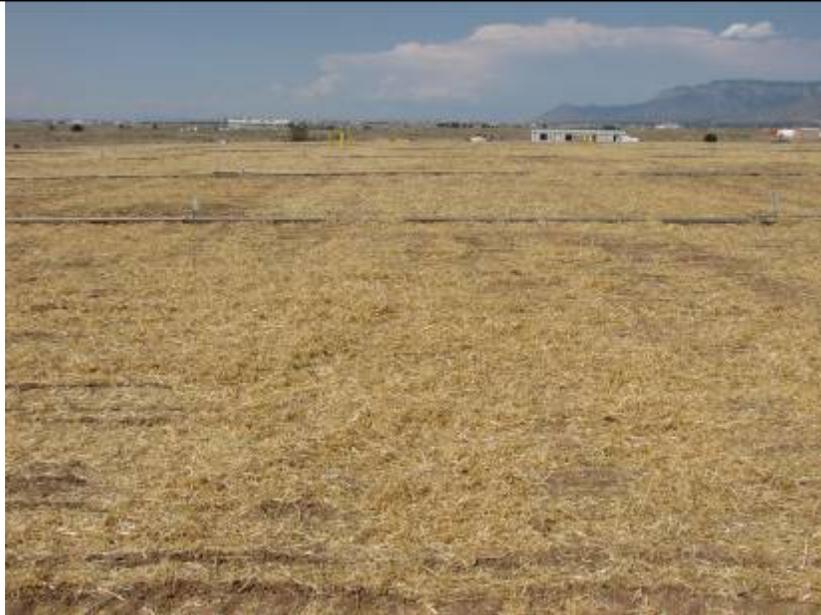
Description: Crimping the straw mulch into the soil on the north slope of the ET Cover to keep it from blowing away

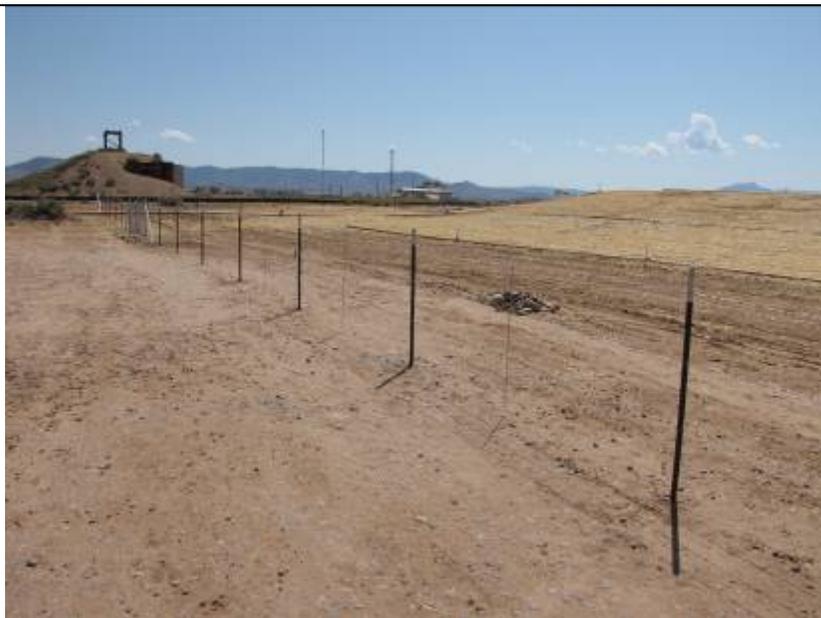
Description: Installing the T-posts for the barbed wire Administrative Security Fence around the site

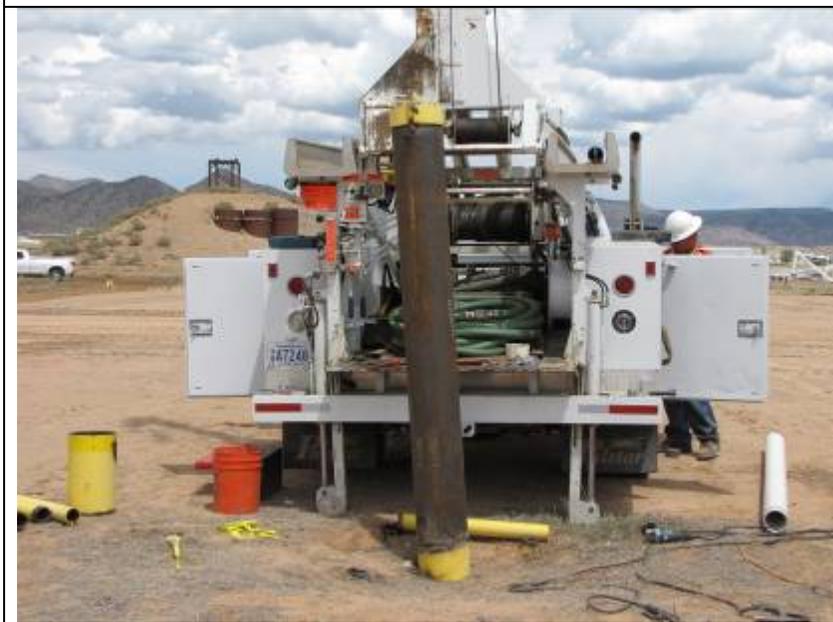
Description: Groundwater monitoring well MWL-MW4 PVC casing being extended prior to installation of Biointrusion Layer on this part of the ET Cover – outer steel casing cut near ground surface (yellow) and white extended PVC well casing shown

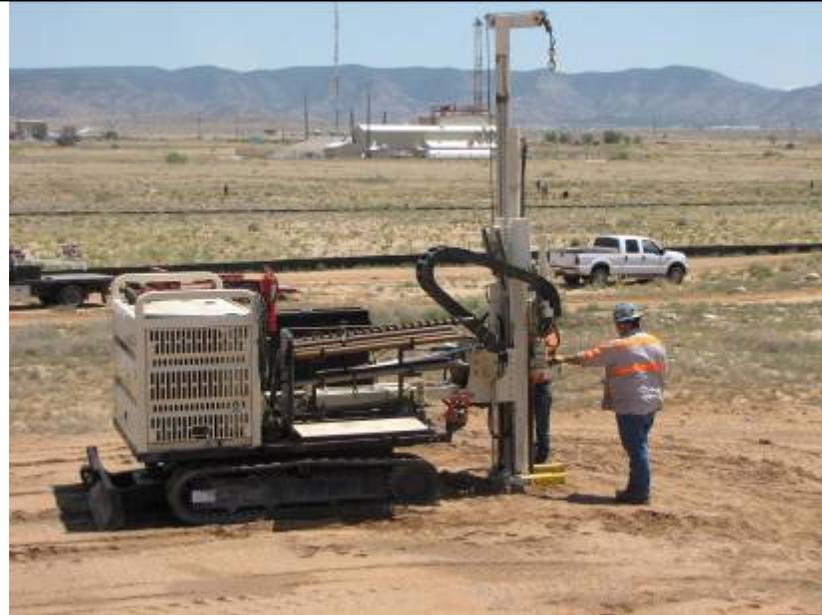
Description: MWL-MW4 outer steel protective casing extended to accommodate the ET Cover thickness

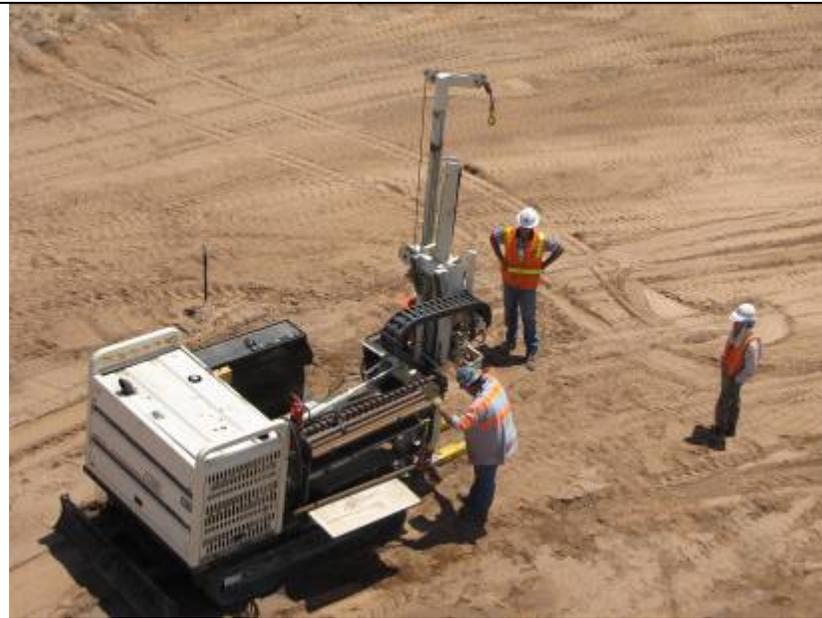
Description: Installation of Soil-Vapor Well MWL-SV2 in the northeast corner of the MWL during Topsoil Layer installation prior to seeding and mulching

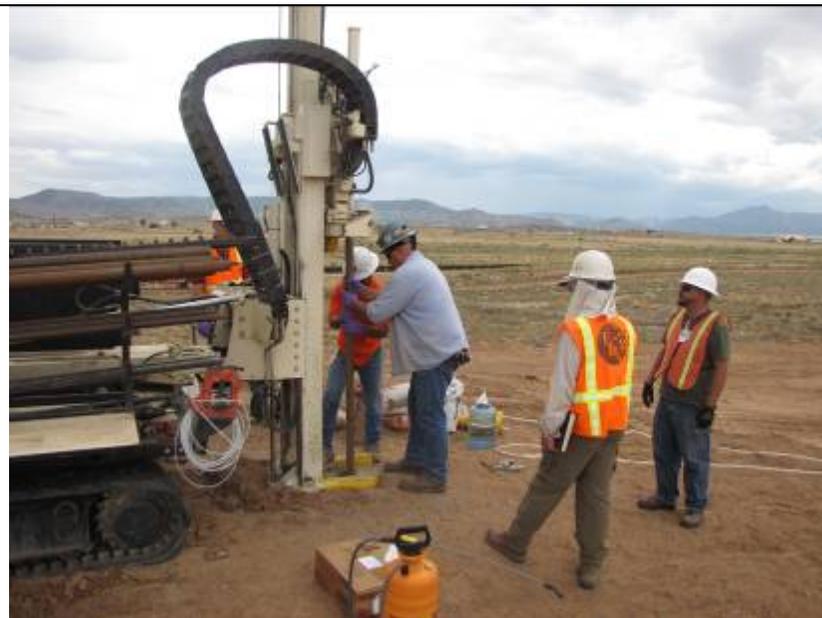
Description: Aerial picture of installation of Soil-Vapor Well MWL-SV2 Soil-Vapor Well MWL-SV2

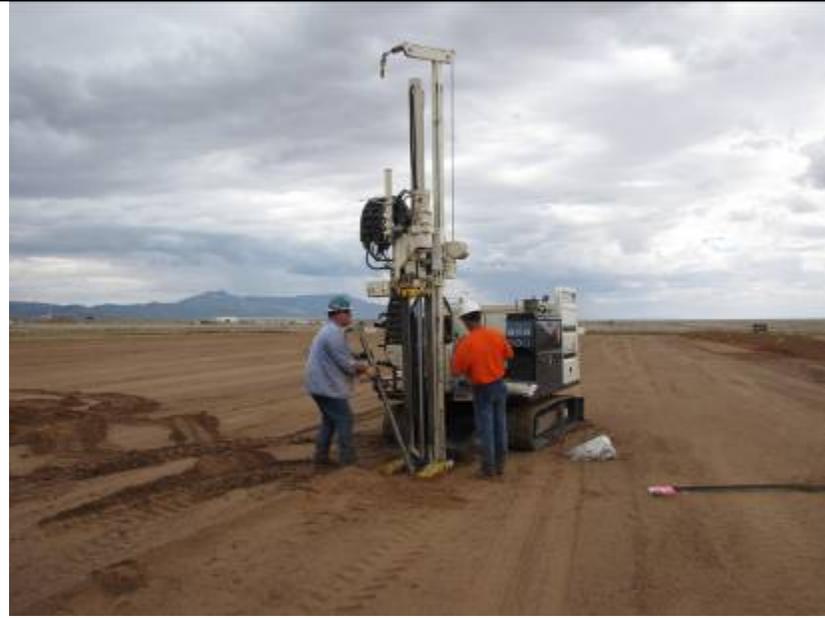
Description: Installing Soil-Vapor Well MWL-SV2

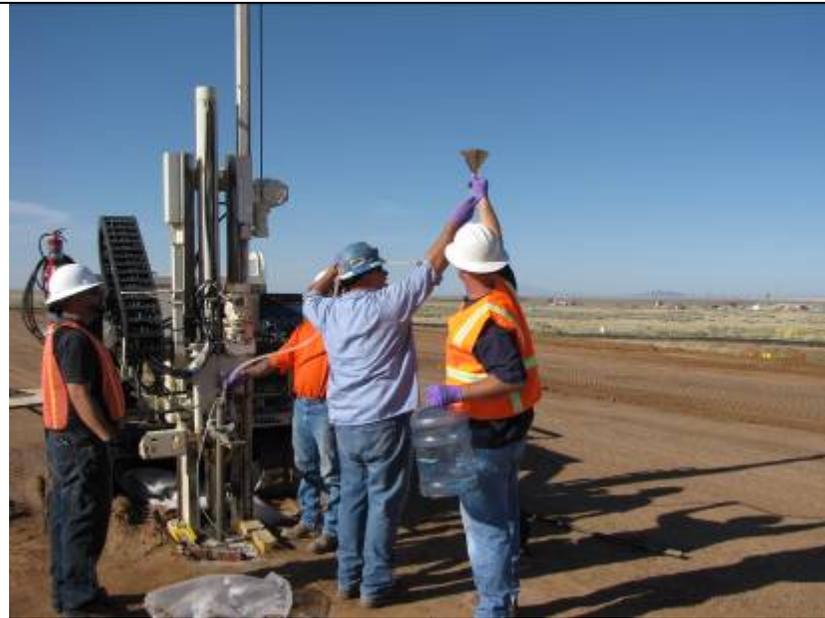
Description: Installation of Soil-Vapor Well MWL-SV1

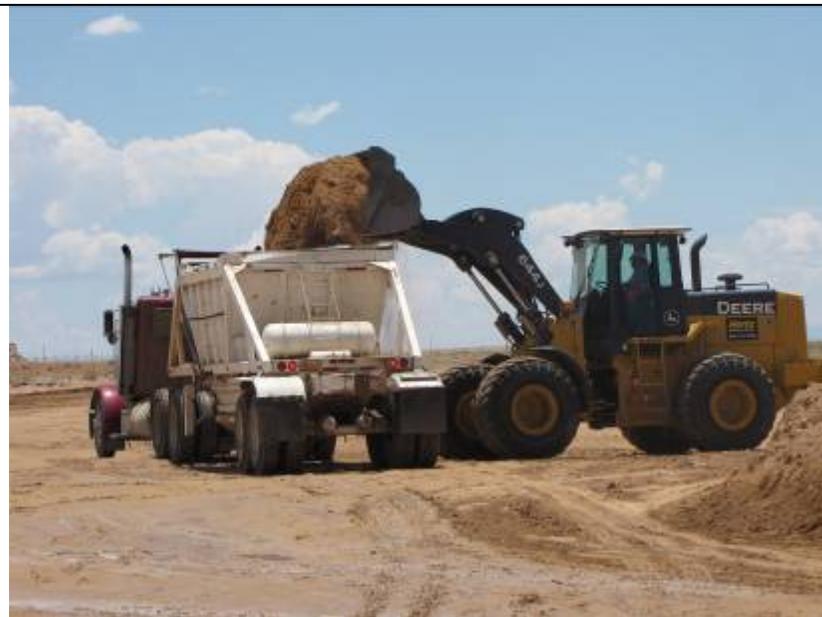
Description: Constructing the drive-off pad on the south side of the MWL Borrow Pit

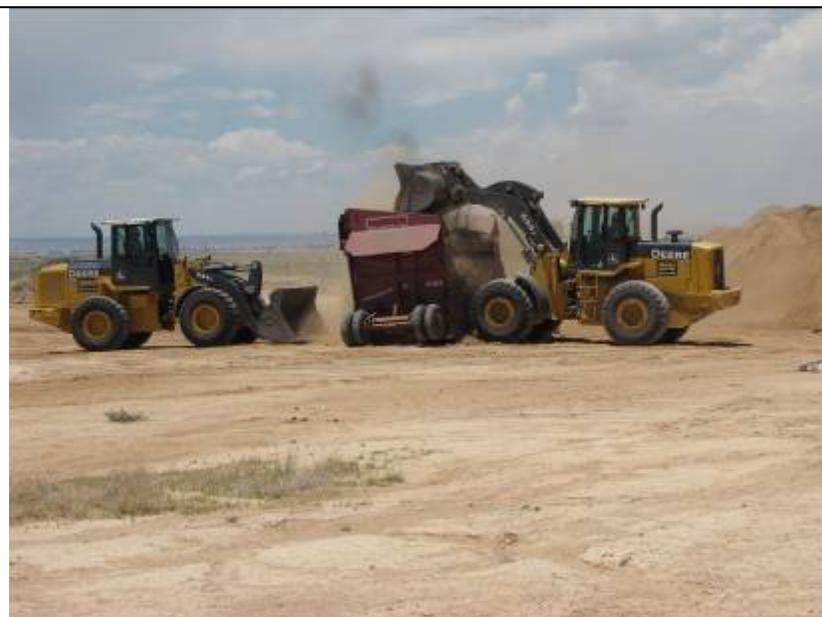
Description: Loading native soil fill into a bottom-dump truck at the MWL Borrow Pit for transport to the MWL site

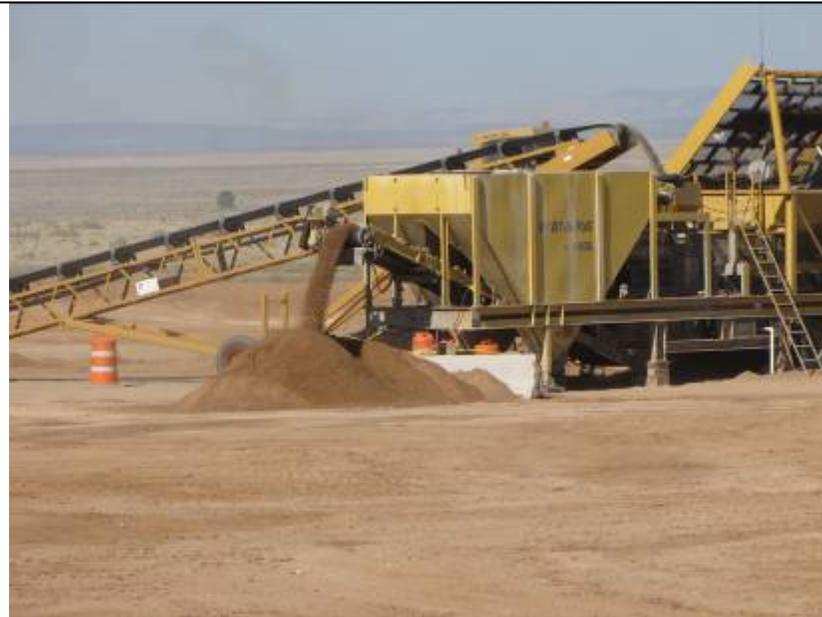
Description: Screening soil to 2-inch minus and stockpiling at the MWL Borrow Pit

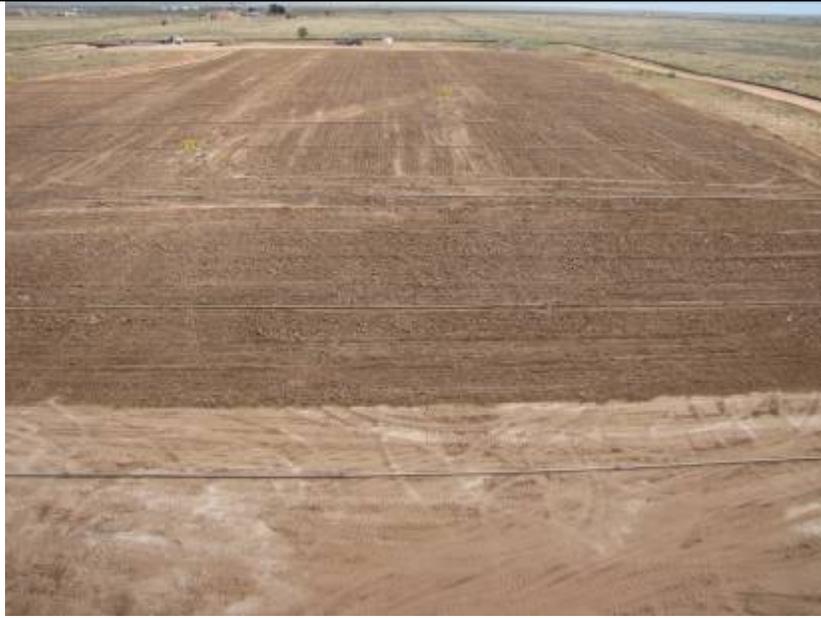
Description: MWL Borrow Pit after completion of construction activities and grading to ensure proper drainage

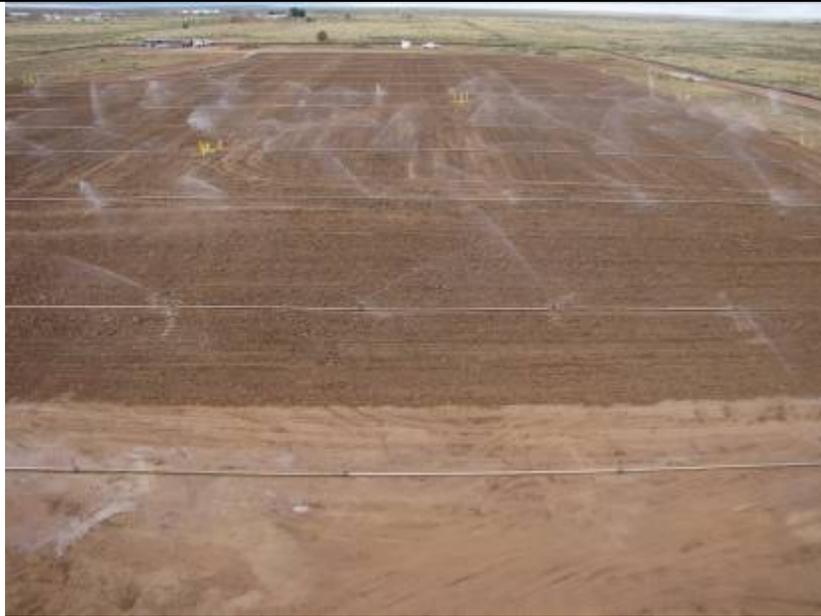
Description: MWL ET Cover with irrigation pipe installed for the supplemental watering system

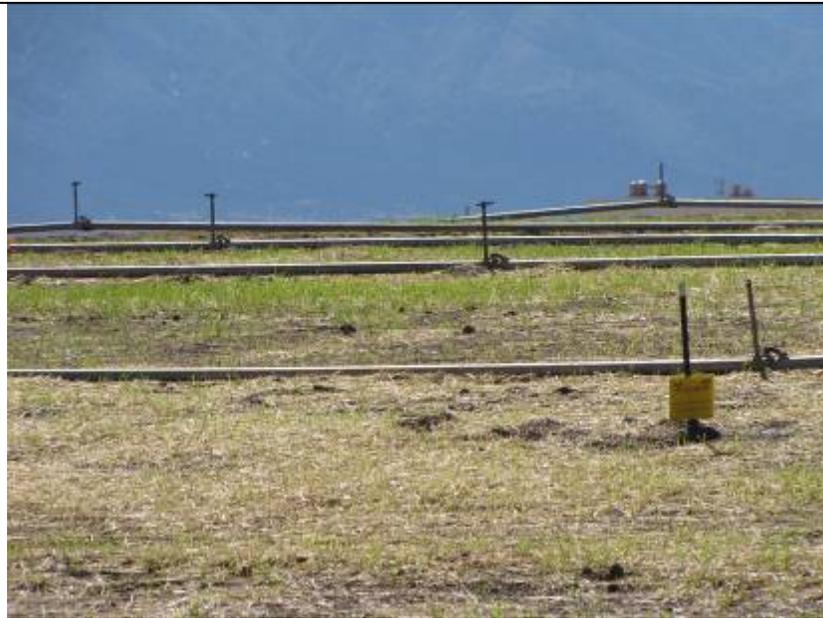
Description: MWL ET Cover with seed and mulch in place – grass seedling growth indicated by green areas
